**DEPARTMENT OF TRANSPORTATION**

Contract #: 04-0120F4Cty: SF/ALA Rte: 80 PM: 13.2/13.9File #: 13.28**WELDING INSPECTION REPORT****Resident Engineer:** Pursell, Gary**Address:** 333 Burma Road**City:** Oakland, CA 94607**Report No:** WIR-010606**Date Inspected:** 02-Dec-2009**Project Name:** SAS Superstructure**OSM Arrival Time:** 1000**Prime Contractor:** American Bridge/Fluor Enterprises, a JV**OSM Departure Time:** 1830**Contractor:** Oregon Iron Works Clackamas, Or.**Location:** Clackamas, OR

Hinge-K Pipe Beam Assembly 102A-3: 12/2/09

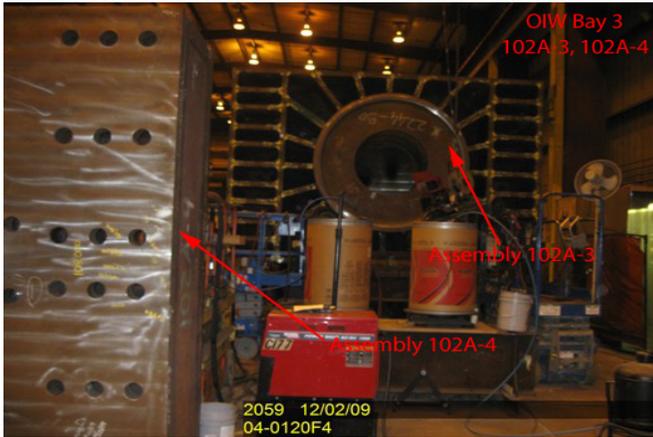
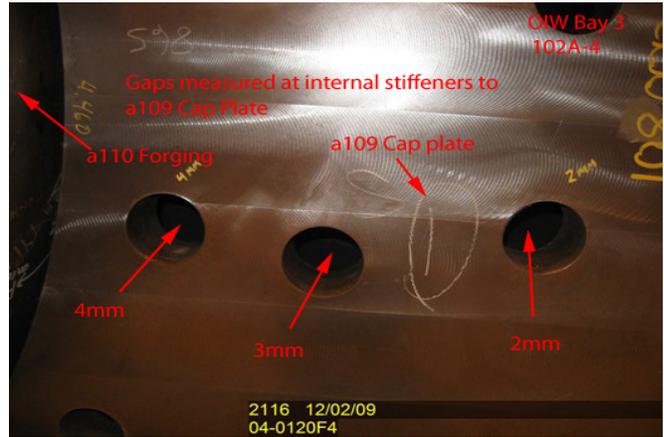
Lead QA Inspector Joe Adame notified QA Inspector that there were bearing gaps present, between the completed HPS 485W stiffeners and the a109 Post Tension Cap plate, on forging assembly 102A-4. QA Inspector randomly measured the bearing gaps, utilizing a taper gauge and noted that the gaps measured from 0-4mm, with the 4mm gaps present on the radial stiffeners, closest to the forging. See attached pictures below.

Note: QA Inspector noted that these gaps occurred after and/or during the completion of weld joints #W2-19 (a109/a106), W2-20 (a110/a106), W2-23 (a110/ab106) and W2-24 (a109/ab106). QA Inspector and QC Inspector Jose Salazar had previously measured the mill to bear surface, after the above mention weld joints were fit-up/ FCAW tack welded with multiple threaded rods in place, (to prevent movement and distortion of the a109 Cap plate), during welding. QA Inspector previously noted that there was approximately 100% contact between the

stiffeners and Cap Plate, in accordance with AWS D1.5 and contract requirements. Mr. Adame explained that OIW PM Bill Pender was notified of this and a resolution is still pending.
