**DEPARTMENT OF TRANSPORTATION**

Quality Assurance and Source Inspection

Contract #: 04-0120F4Cty: SF/ALA Rte: 80 PM: 13.2/13.9File #: 69.28**WELDING INSPECTION REPORT****Resident Engineer:** Pursell, Gary**Address:** 333 Burma Road**City:** Oakland, CA 94607**Report No:** WIR-010646**Date Inspected:** 06-Dec-2009**Project Name:** SAS Superstructure**OSM Arrival Time:** 1900**Prime Contractor:** American Bridge/Fluor Enterprises, a JV**OSM Departure Time:** 700**Contractor:** Zhenhua Port Machinery Company, Ltd (ZPMC), Changxing Island **Location:** Shanghai, China**CWI Name:** Li Yang**CWI Present:** Yes No**Inspected CWI report:** Yes No N/A**Rod Oven in Use:** Yes No N/A**Electrode to specification:** Yes No N/A**Weld Procedures Followed:** Yes No N/A**Qualified Welders:** Yes No N/A**Verified Joint Fit-up:** Yes No N/A**Approved Drawings:** Yes No N/A**Approved WPS:** Yes No N/A**Delayed / Cancelled:** Yes No N/A**Bridge No:** 34-0006**Component:** OBG**Summary of Items Observed:**

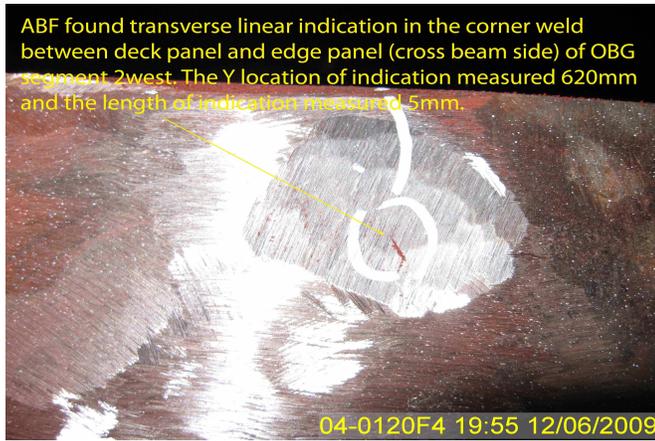
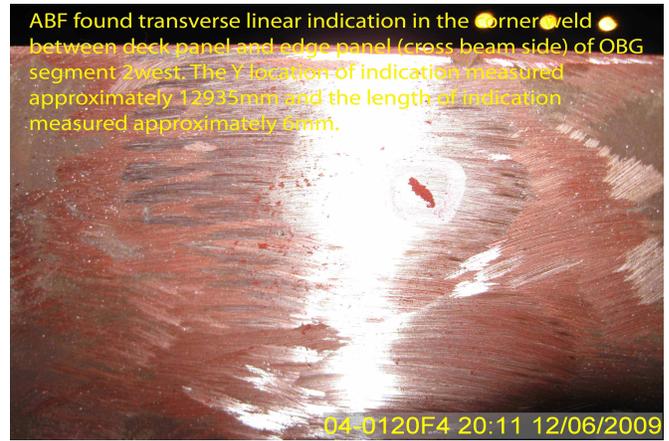
This Quality Assurance (QA) Inspector performed Magnetic Particle Testing (MT) in conjunction with ABF Magnetic Particle Testing (MT) department. Magnetic Particle Testing (MT) performed on repair areas of the corner weld between deck panel and edge panel (cross beam side) of OBG segment 2West (CA102-002, 004, 006). During the inspection American Bridge Fluor (ABF) found two transverse indications. Bridge Fluor (ABF) request number was 12052009-1. For more additional information see attached photos.
