**DEPARTMENT OF TRANSPORTATION**

Contract #: 04-0120F4Cty: SF/ALA Rte: 80 PM: 13.2/13.9File #: 69.28**WELDING INSPECTION REPORT****Resident Engineer:** Pursell, Gary**Address:** 333 Burma Road**City:** Oakland, CA 94607**Report No:** WIR-010661**Date Inspected:** 10-Dec-2009**Project Name:** SAS Superstructure**OSM Arrival Time:** 645**Prime Contractor:** American Bridge/Fluor Enterprises, a JV**OSM Departure Time:** 1845**Contractor:** Zhenhua Port Machinery Company, Ltd (ZPMC), Changxing Island **Location:** Shanghai, China

**Summary of Items Observed:**

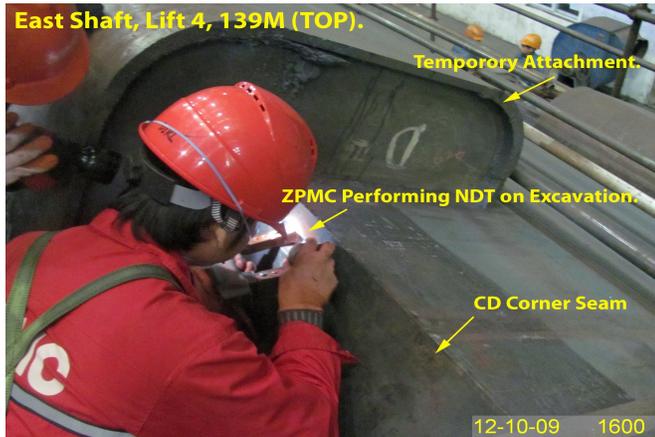
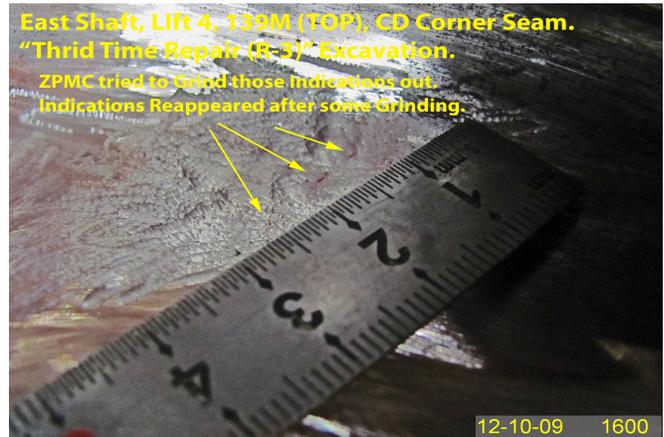
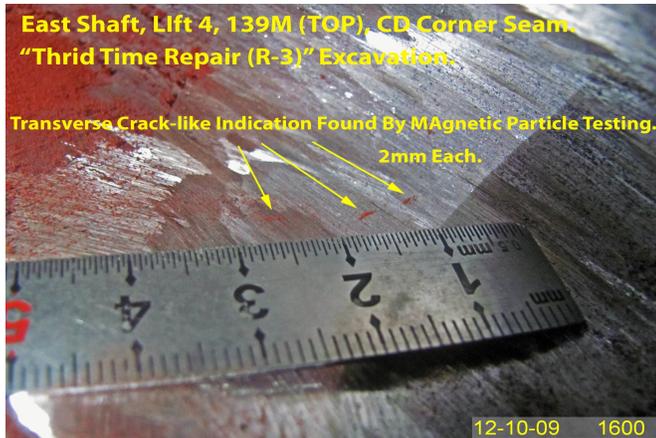
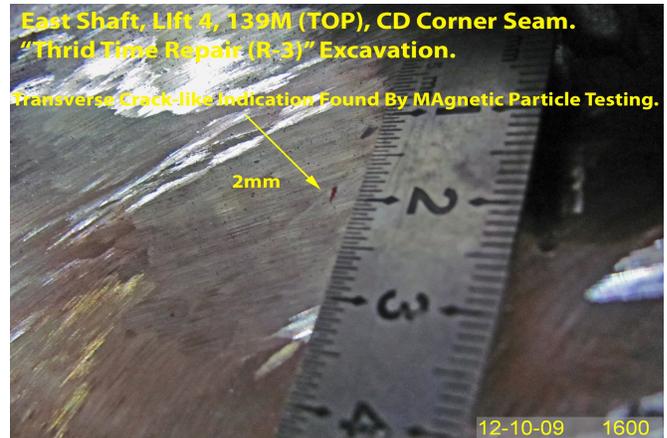
During random in-process inspection this Quality Assurance Inspector (QA) observed ZPMC working Grinding, Heating and Welding) at weld joints of Pad eyes on West Shaft, Lift 3. "Green Tag" has been issued for these Pad eyes on date 11-05-09(GREEN TAG # 11499). Incident Report has been written on this issue on the same date.

During random in-process inspection; This QA inspector observed ZPMC Perssonel Excavating a Third Time Repair (R-3) on East Shaft, Lift 4, CD Corner near 139M double diaphragm. ZPMC Ultrasonic Testing(UT) Personnel Rejected this location Third time (Reference : ZPMC UT REPORT # T-787-UT-2432R3). The Repair has been performed using Approved Critical Weld Repair Report (CWR) # T-CWR478. As per ZPMC UT Report; "The Y-location" of indication is 23730mm, Indication Rating was "-1" & 70mm in depth from Surface.

ZPMC Magnetic Particle Testing(MT) Perssonel carried out MT on this Excavated area after gouging & grinding. This QA inspector observed ZPMC MT Personnel found 'Transverse Crack-like Indications' at the inspection area. Incident Report has been written on this issue on the same date.
