DEPARTMENT OF TRANSPORTATION

Contract #: 04-0120F4Cty: SF/ALA Rte: 80 PM: 13.2/13.9File #: 69.28**WELDING INSPECTION REPORT****Resident Engineer:** Pursell, Gary**Address:** 333 Burma Road**City:** Oakland, CA 94607**Report No:** WIR-010707**Date Inspected:** 27-Nov-2009**Project Name:** SAS Superstructure**OSM Arrival Time:** 645**Prime Contractor:** American Bridge/Fluor Enterprises, a JV**OSM Departure Time:** 1845**Contractor:** Zhenhua Port Machinery Company, Ltd (ZPMC), Changxing Island **Location:** Shanghai, China

WELDING INSPECTION REPORT

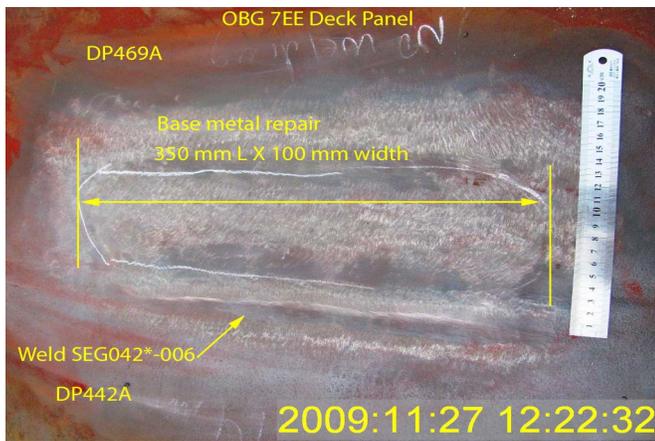
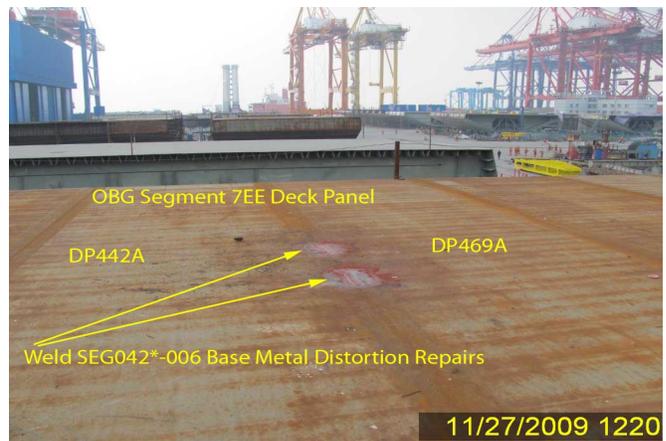
During Visual inspection prior to Magnetic Particle Testing (MT) as per NDT inspection notification sheet # 004740, this Caltrans Quality Assurance (QA) Inspector observed that base metal distortion repairs have been performed on deck panel DP469A. The repair areas were adjacent to deck panel Complete Joint Penetration (CJP) weld SEG042*-006 joining DP442A and DP469A. This base material distortion repair was performed without the approval of the Engineer. An Incident report was issued for the above mentioned anomaly.

The Y location, length and width of repair are as follows:

#1 at 'Y' location 6000 mm, approximately 350 mm long and 100 mm wide

#2 at 'Y' location 7180 mm, approximately 350 mm long and 100 mm wide
