DEPARTMENT OF TRANSPORTATION

Quality Assurance and Source Inspection

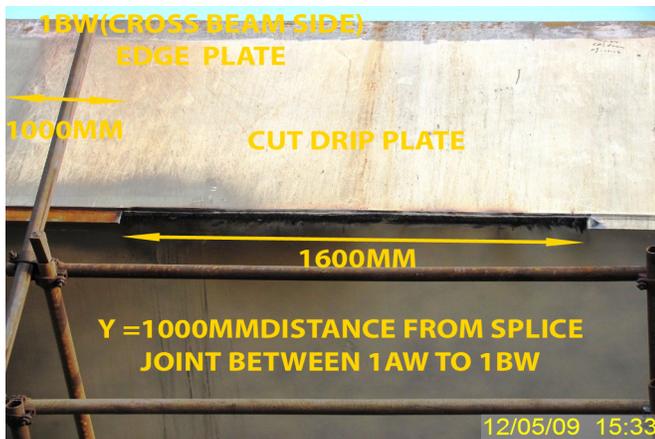
The Quality Assurance Inspector observed during random visual inspection the ZPMC personnel cut the drip plate length 1600mm at OBG Segment 1BW (both side at Y =1000mm from splice joint 1AW to 1BW).

For details please see the attached photo.
