DEPARTMENT OF TRANSPORTATION

Office of Structural Materials

Contract #: 04-0120F4Cty: SF/ALA Rte: 80 PM: 13.2/13.9File #: 69.28**WELDING INSPECTION REPORT****Resident Engineer:** Pursell, Gary**Address:** 333 Burma Road**City:** Oakland, CA 94607**Report No:** WIR-010763**Date Inspected:** 17-Dec-2009**Project Name:** SAS Superstructure**OSM Arrival Time:** 645**Prime Contractor:** American Bridge/Fluor Enterprises, a JV**OSM Departure Time:** 1845**Contractor:** Zhenhua Port Machinery Company, Ltd (ZPMC), Changxing Island **Location:** Shanghai, China**CWI Name:** Liu Fawen**CWI Present:** Yes No**Inspected CWI report:** Yes No N/A**Rod Oven in Use:** Yes No N/A**Electrode to specification:** Yes No N/A**Weld Procedures Followed:** Yes No N/A**Qualified Welders:** Yes No N/A**Verified Joint Fit-up:** Yes No N/A**Approved Drawings:** Yes No N/A**Approved WPS:** Yes No N/A**Delayed / Cancelled:** Yes No N/A**Bridge No:** 34-0006**Component:** Orthotropic Box Girder (OBG) & Tower Com**Summary of Items Observed:**

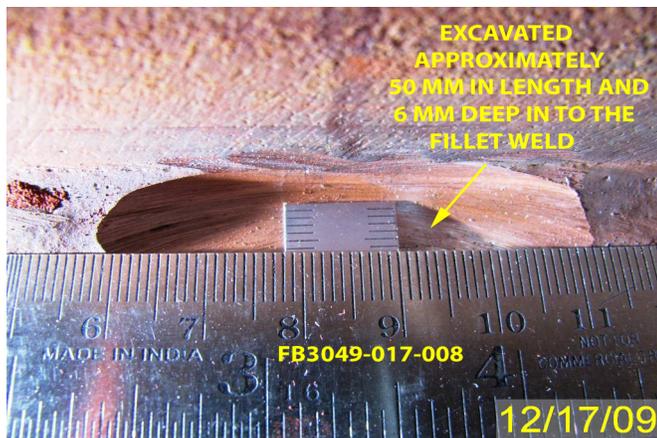
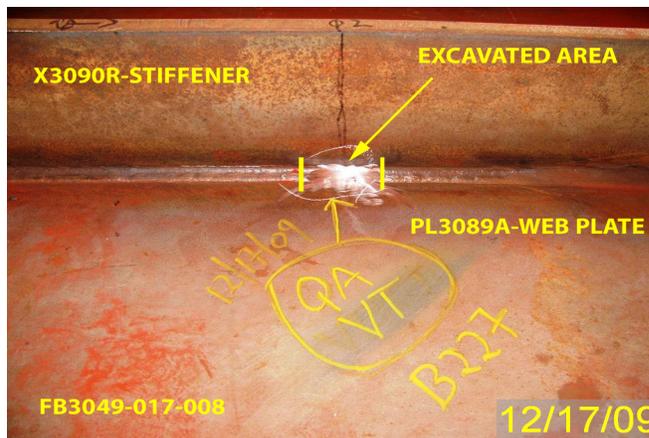
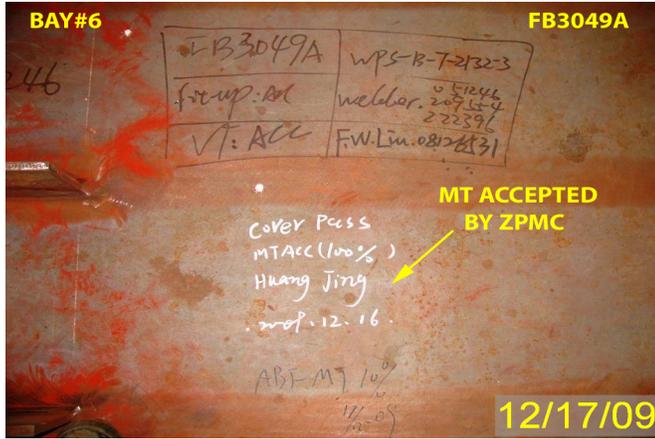
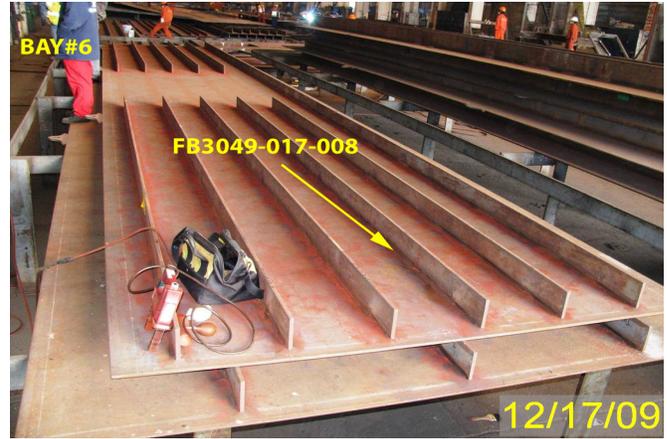
During a random in-process visual verification prior to performing Magnetic Particle Testing (MT) on a Floor Beam (FB) for Cross Beam CB17 located at Bay # 6, the Caltrans Quality Assurance (QA) Inspector observed a fillet weld that had been excavated approximately 50 mm in length and 6 mm in depth. The contractor (ZPMC) offered a formal NDT Inspection Notification Sheet, acknowledging the weld was complete and that ZPMC MT

technicians had tested and accepted 100% MT on this FB. Additional information identifying the non-conformance is listed below.

- The Floor Beam is identified as FB3049-017-008.
 - The fillet weld connects the FB Web Plate (PL3089A) to FB Stiffener (X3090R).
 - The fillet weld size is 6 mm in size per the approved contract drawings.
 - The NDT Inspection Notification Sheet request number was identified as: 004835
- For further information, please see the attached photos and applicable reference below.

AWS D1.5 (02) Section 6.6.3; "The Contractor shall comply with all requests of the QA Inspector to correct deficiencies in materials and workmanship, as specified in the contract documents."

AWS D1.5 (02) Section 6.7.3; "After repairs of discontinuities have been made, additional NDT inspection shall be performed to ensure that the repairs are satisfactory. This testing shall include the repaired area plus at least 50 mm [2 in.] on each side of the repaired area."
