DEPARTMENT OF TRANSPORTATION

Contract #: 04-0120F4Cty: SF/ALA Rte: 80 PM: 13.2/13.9File #: 69.28**WELDING INSPECTION REPORT****Resident Engineer:** Pursell, Gary**Address:** 333 Burma Road**City:** Oakland, CA 94607**Report No:** WIR-010838**Date Inspected:** 19-Dec-2009**Project Name:** SAS Superstructure**OSM Arrival Time:** 645**Prime Contractor:** American Bridge/Fluor Enterprises, a JV**OSM Departure Time:** 1845**Contractor:** Zhenhua Port Machinery Company, Ltd (ZPMC), Changxing Island **Location:** Shanghai, China**CWI Name:** As identified below**CWI Present:** Yes No**Inspected CWI report:** Yes No N/A**Rod Oven in Use:** Yes No N/A**Electrode to specification:** Yes No N/A**Weld Procedures Followed:** Yes No N/A**Qualified Welders:** Yes No N/A**Verified Joint Fit-up:** Yes No N/A**Approved Drawings:** Yes No N/A**Approved WPS:** Yes No N/A**Delayed / Cancelled:** Yes No N/A**Bridge No:** 34-0006**Component:** OBG**Summary of Items Observed:**

North of Blast 1-

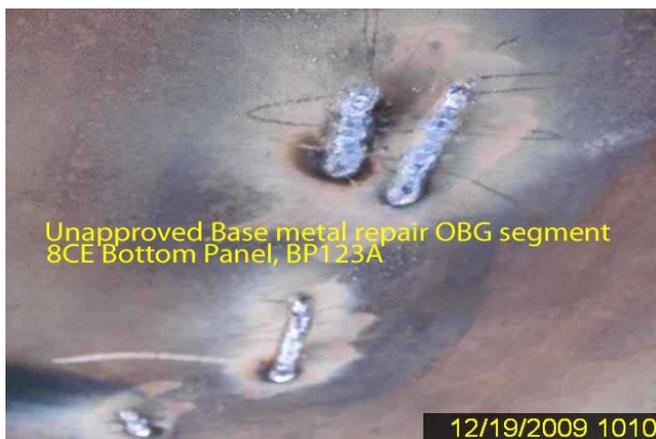
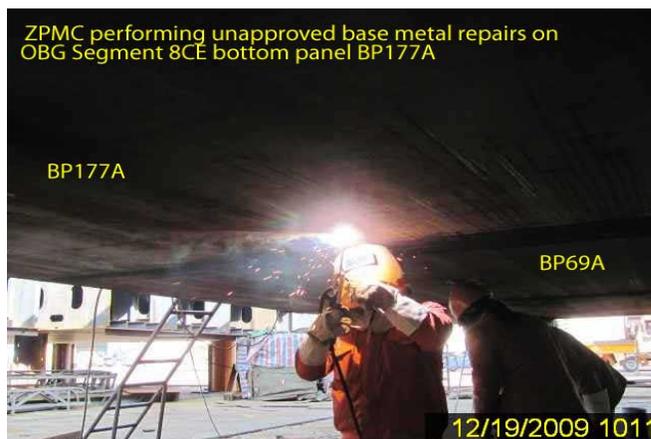
During a random visual inspection at OBG Segment 8CE of Seismic Performance Critical Members (SPCM) Bottom Panels (BP), the Quality Assurance (QA) Inspector observed ZPMC performing unapproved base metal repairs on SPCM BP's at temporary attachment removal areas. Approximately fifty (50) areas have been excavated and ten (10) areas have been welded prior to the QA inspector's arrival. An incident report was issued for the unapproved base metal repairs on segment 8CE. Additional information about the non-conforming base metal repairs are listed below.

- 1) The BP's are identified as: BP177A, BP069A and BP123A
 - 2) The material was identified as: A709 Grade 345 SPCM
 - 3) The locations of these non-conformances were located between PP67 to PP71
 - 4) ZPMC performed base metal repairs without the prior approval of the Engineer.
- For further information, please see the attached pictures below.
