DEPARTMENT OF TRANSPORTATION

Quality Assurance and Source Inspection

Contract #: 04-0120F4Cty: SF/ALA Rte: 80 PM: 13.2/13.9File #: 69.28**WELDING INSPECTION REPORT****Resident Engineer:** Pursell, Gary**Address:** 333 Burma Road**City:** Oakland, CA 94607**Report No:** WIR-010840**Date Inspected:** 24-Dec-2009**Project Name:** SAS Superstructure**OSM Arrival Time:** 645**Prime Contractor:** American Bridge/Fluor Enterprises, a JV**OSM Departure Time:** 1845**Contractor:** Zhenhua Port Machinery Company, Ltd (ZPMC), Changxing Island **Location:** Shanghai, China**CWI Name:** As identified below**CWI Present:** Yes No**Inspected CWI report:** Yes No N/A**Rod Oven in Use:** Yes No N/A**Electrode to specification:** Yes No N/A**Weld Procedures Followed:** Yes No N/A**Qualified Welders:** Yes No N/A**Verified Joint Fit-up:** Yes No N/A**Approved Drawings:** Yes No N/A**Approved WPS:** Yes No N/A**Delayed / Cancelled:** Yes No N/A**Bridge No:** 34-0006**Component:** OBG**Summary of Items Observed:**

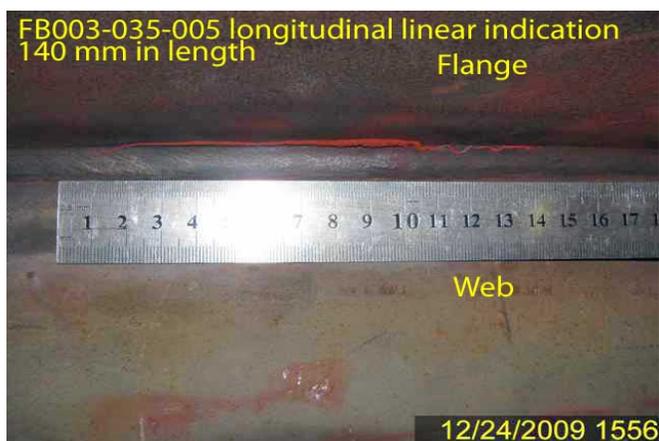
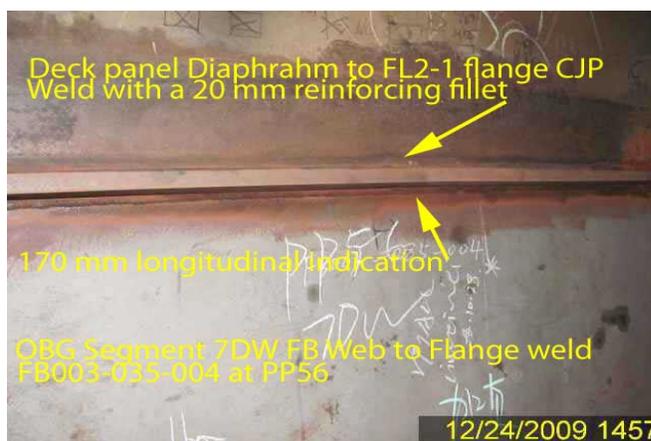
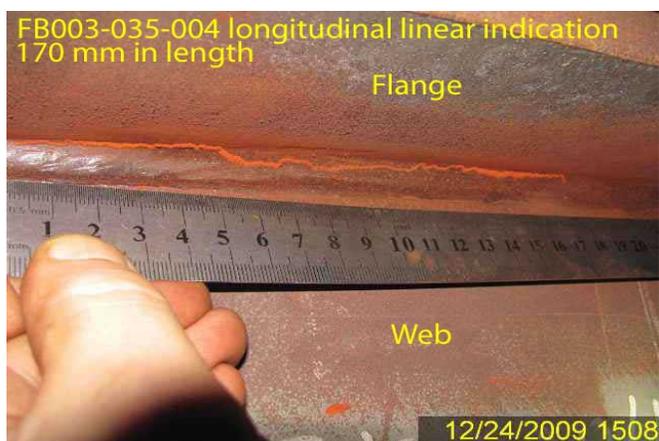
Caltrans Quality Assurance (QA) Inspector performed random visual inspection of OBG segment 7DW welds. During visual inspection Caltrans QA observed distortion of FL2-1 flange two (2) Longitudinal Linear Indications (LLI) were observed on sub-assembly floor beam FB003-035 flange to web 6 mm fillet welds, FB003-035-004 (LLI-170mm in length) and FB003-035-005 (LLI-140mm in length). The "Y" location of both indications, measured from the W4 line is approximately 4130mm. The indications were discovered visually and confirmed by Magnetic Particle Testing (MT) by Caltrans QA. Caltrans QA also observed negative flange distortion measuring approximately 15mm in 7200mm. This negative distortion appears to have been produced by the deck panel diaphragm Complete Joint Penetration (CJP) weld identified as SSD10-PP56-003 on the far side of this flange. This CJP weld has a reinforcing fillet weld measuring approximately 20mm. An Incident Report was issued for the longitudinal linear indications. Please see the attached digital photographs below of the longitudinal linear indications.

NOTE: Weld SSD10-PP56-003 was originally designed as two (2) 8mm fillet welds. The weld was changed to a CJP during segment fabrication due to a joint root opening in excess of 5mm.
