DEPARTMENT OF TRANSPORTATION

Contract #: 04-0120F4Cty: SF/Ala Rte: 80 PM: 13.2/13.9File #: 69.28**WELDING INSPECTION REPORT****Resident Engineer:** Pursell, Gary**Address:** 333 Burma Road**City:** Oakland, CA 94607**Report No:** WIR-010921**Date Inspected:** 28-Dec-2009**Project Name:** SAS Superstructure**OSM Arrival Time:** 1900**Prime Contractor:** American Bridge/Fluor Enterprises, a JV**OSM Departure Time:** 700**Contractor:** Zhenhua Port Machinery Company, Ltd (ZPMC), Changxing Island **Location:** Shanghai, China**CWI Name:** See below**CWI Present:** Yes No**Inspected CWI report:** Yes No N/A**Rod Oven in Use:** Yes No N/A**Electrode to specification:** Yes No N/A**Weld Procedures Followed:** Yes No N/A**Qualified Welders:** Yes No N/A**Verified Joint Fit-up:** Yes No N/A**Approved Drawings:** Yes No N/A**Approved WPS:** Yes No N/A**Delayed / Cancelled:** Yes No N/A**Bridge No:** 34-0006**Component:** Tower Components**Summary of Items Observed:**

WELDING INSPECTION REPORT

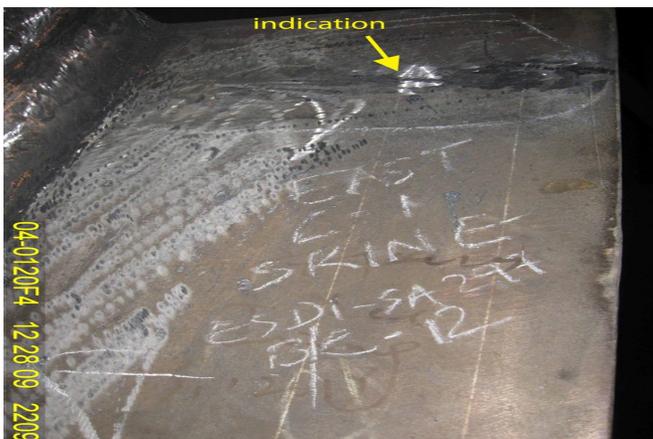
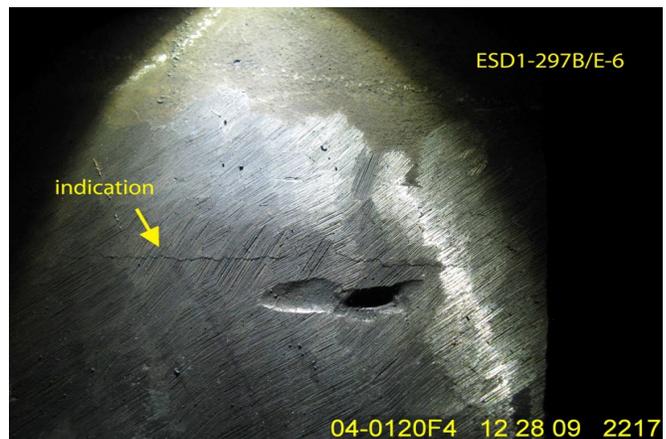
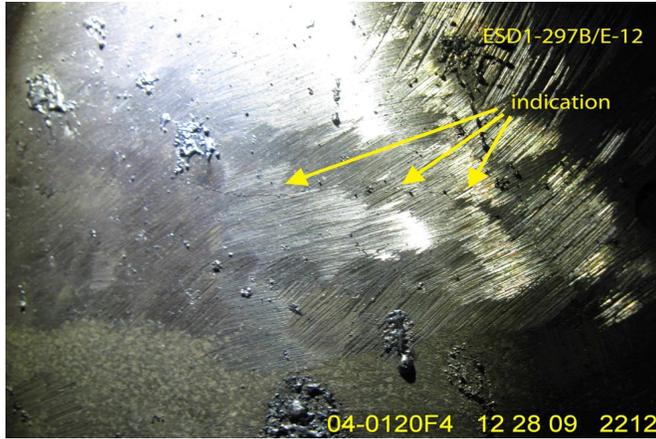
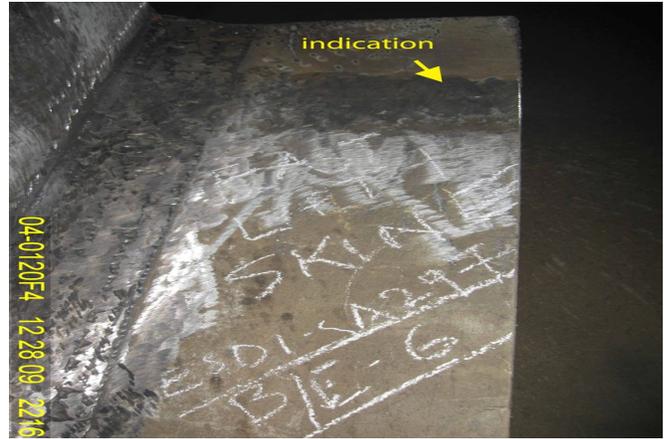
QA Inspector Amit Juvekar informed this QA Inspector of crack-like linear indications at temporary attachment areas inside east tower shaft, lift 1 and provided this QA Inspector with photos by way of email. This QA Inspector was instructed to observe these indications and monitor any work being performed by ZPMC personnel in this area. This QA Inspector proceeded to the area and visually observed and verified the indications near weld joints ESD1-297B/E-6, 10, 12 located inside the shaft at the bottom of PCMK east tower, lift 1, at skin E. This QA Inspector observed what appeared to be the same indications and same conditions as seen in the photos noted above. See photos taken by this QA Inspector below. No work was observed being performed at either of these locations.
