DEPARTMENT OF TRANSPORTATION

Contract #: 04-0120F4Cty: SF/ALA Rte: 80 PM: 13.2/13.9File #: 13.28**WELDING INSPECTION REPORT****Resident Engineer:** Pursell, Gary**Address:** 333 Burma Road**City:** Oakland, CA 94607**Report No:** WIR-010959**Date Inspected:** 31-Dec-2009**Project Name:** SAS Superstructure**OSM Arrival Time:** 700**Prime Contractor:** American Bridge/Fluor Enterprises, a JV**OSM Departure Time:** 1530**Contractor:** Oregon Iron Works Clackamas, Or.**Location:** Clackamas, OR**CWI Name:** M. Gregson, J. Salazar**CWI Present:** Yes No**Inspected CWI report:** Yes No N/A**Rod Oven in Use:** Yes No N/A**Electrode to specification:** Yes No N/A**Weld Procedures Followed:** Yes No N/A**Qualified Welders:** Yes No N/A**Verified Joint Fit-up:** Yes No N/A**Approved Drawings:** Yes No N/A**Approved WPS:** Yes No N/A**Delayed / Cancelled:** Yes No N/A**Bridge No:** 34-0006**Component:** Hinge K Pipe Beams**Summary of Items Observed:**

Hinge-K Pipe Beam Assembly 102A-3

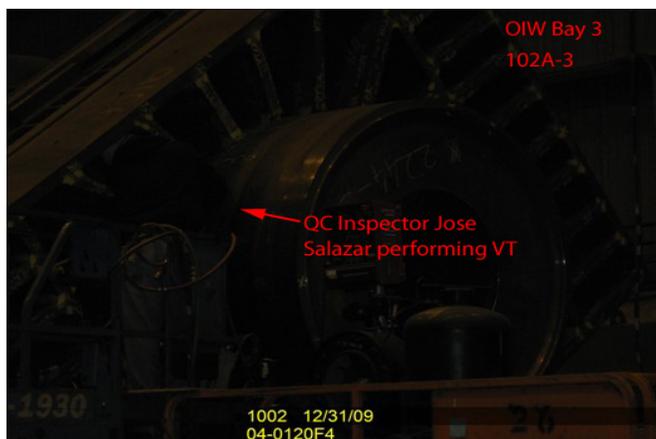
The QA Inspector noted that OIW welder # O6, Mr. Tim O'Brian was continuing to blend the weld start/stops, removing weld spatter and grinding all areas, which were previously marked by OIW QC Inspectors. The QA Inspector noted that these areas were on the previously completed submerged arc welded (SAW), HPS 485W stiffeners, designated as weld joints #W1-01 thru W1-163. The QA Inspector spoke with QC Inspector Jose Salazar and Mr. Salazar explained that the visual clean-up that was being performed by Mr. O'Brian, was intermittently monitored and areas that were completed, were then visually re-inspected. See attached picture below.

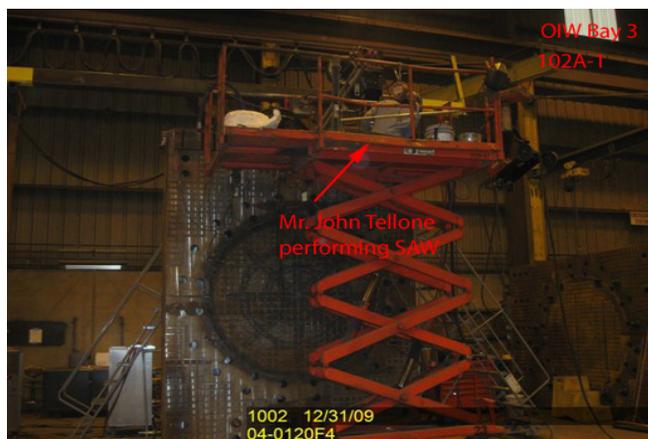
Hinge-K Pipe Beam Assembly 102A-1

The QA Inspector witnessed welder #T23, Mr. John Tellone, performing the submerged arc welding (SAW) on the a110-3 Base plate to b106 HPS 485W stiffener. The QA Inspector noted that this weld joint was designated as a partial joint penetration (AWS D1.5 TC-P4-S), weld joint #W2-02 and Mr. Tellone was performing the SAW in the flat (1G) position. The QA Inspector noted that Mr. Tellone was currently performing the SAW root pass and

noted that Mr. Tellone was utilizing OIW approved welding procedure specification (WPS 4020). The QA Inspector noted that QC Inspector Jose Salazar, was present and Mr. Salazar explained to the QA Inspector that the in-process welding parameters/pre-heat temperatures, were intermittently verified. Mr. Salazar explained that average welding parameters for the SAW root pass, was recorded at 412 amps/32.1 volts, with a pre-heat of approximately 350 degrees Fahrenheit (177 C). The QA Inspector randomly verified pre-heat of approximately 350 degrees Fahrenheit (177 C) and welding parameters to be in compliance with the WPS 4020. Mr. Salazar later informed the QA Inspector that the SAW root pass had been completed and 100% visual and magnetic particle testing had been performed. Mr. Salazar explained that no rejectable indications were found during the testing. The QA Inspector noted that the SAW performed by Mr. Tellone, appeared to be in-compliance with AWS D1.5 and the applicable WPS 4020. See attached picture below.
