DEPARTMENT OF TRANSPORTATION

Contract #: 04-0120F4Cty: SF/ALA Rte: 80 PM: 13.2/13.9File #: 69.28**WELDING INSPECTION REPORT****Resident Engineer:** Pursell, Gary**Address:** 333 Burma Road**City:** Oakland, CA 94607**Report No:** WIR-010964**Date Inspected:** 28-Dec-2009**Project Name:** SAS Superstructure**OSM Arrival Time:** 645**Prime Contractor:** American Bridge/Fluor Enterprises, a JV**OSM Departure Time:** 1845**Contractor:** Zhenhua Port Machinery Company, Ltd (ZPMC), Changxing Island **Location:** Shanghai, China**CWI Name:** Liu Fawen**CWI Present:** Yes No**Inspected CWI report:** Yes No N/A**Rod Oven in Use:** Yes No N/A**Electrode to specification:** Yes No N/A**Weld Procedures Followed:** Yes No N/A**Qualified Welders:** Yes No N/A**Verified Joint Fit-up:** Yes No N/A**Approved Drawings:** Yes No N/A**Approved WPS:** Yes No N/A**Delayed / Cancelled:** Yes No N/A**Bridge No:** 34-0006**Component:** Orthotropic Box Girder (OBG) Components**Summary of Items Observed:**

WELDING INSPECTION REPORT

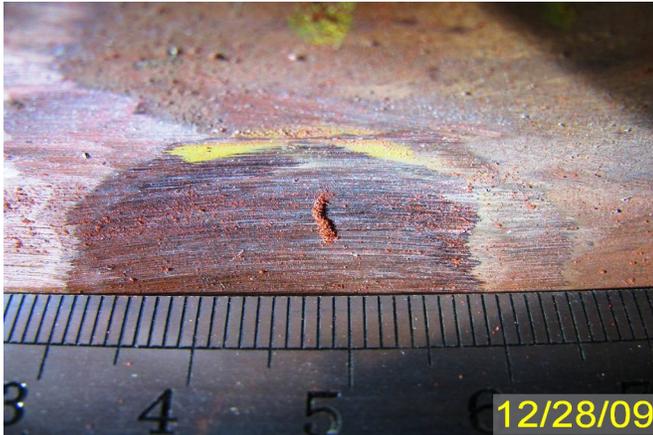
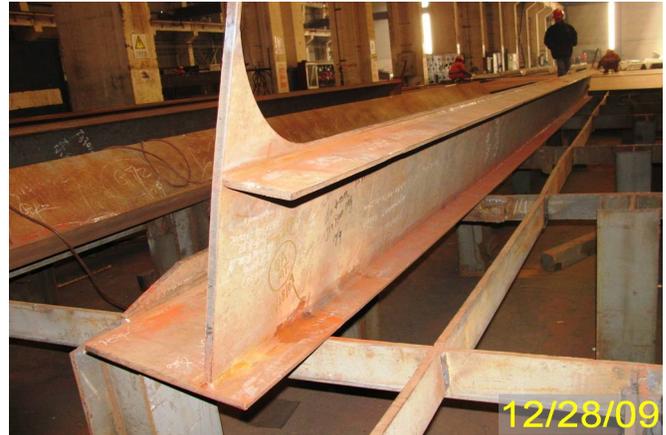
During Magnetic Particle Testing (MT) review of welds on Lift 12 Floor beam (FL2), this Quality Assurance Inspector (QA) discovered the following issues:

- One (1) transverse linear indication measuring approximately 5mm in length.
- The member is identified as Floor Beam FB3073-003.
- The weld is identified as FB3073-003-004.
- The weld is a Fillet weld T-joint joining the web plate (X3210C) to the diaphragm flange plate (X3160G).
- The member is located in OBG Bay 2.

The Notice of Witness Inspection Number (NWIT) is 004950. The indication is located inside the area that has been previously tested and accepted by ZPMC Quality Control (QC) personnel. As per the contract documents, ZPMC's QC personnel are required to perform Twenty five (25%) percent MT inspection of this weld.

AWS D1.5 (02) Section 6.26.2 – “Welds that are subject to MT in addition to visual inspection shall have no cracks.

This QA notified ZPMC QC identified as Mr.Zhang Hai Feng and ABF inspector identified as Mr. Luo Gui Lin of the above issue and that an incident report will be generated.
