**DEPARTMENT OF TRANSPORTATION**

Contract #: 04-0120F4Cty: SF/ALA Rte: 80 PM: 13.2/13.9File #: 69.28**WELDING INSPECTION REPORT****Resident Engineer:** Pursell, Gary**Address:** 333 Burma Road**City:** Oakland, CA 94607**Report No:** WIR-011061**Date Inspected:** 02-Jan-2010**Project Name:** SAS Superstructure**OSM Arrival Time:** 1900**Prime Contractor:** American Bridge/Fluor Enterprises, a JV**OSM Departure Time:** 700**Contractor:** Zhenhua Port Machinery Company, Ltd (ZPMC), Changxing Island **Location:** Shanghai, China**CWI Name:** Yu Qi Guo, Wu Zhi Zhang**CWI Present:** Yes No**Inspected CWI report:** Yes No N/A**Rod Oven in Use:** Yes No N/A**Electrode to specification:** Yes No N/A**Weld Procedures Followed:** Yes No N/A**Qualified Welders:** Yes No N/A**Verified Joint Fit-up:** Yes No N/A**Approved Drawings:** Yes No N/A**Approved WPS:** Yes No N/A**Delayed / Cancelled:** Yes No N/A**Bridge No:** 34-0006**Component:** TOWER / OBG**Summary of Items Observed:**

# WELDING INSPECTION REPORT

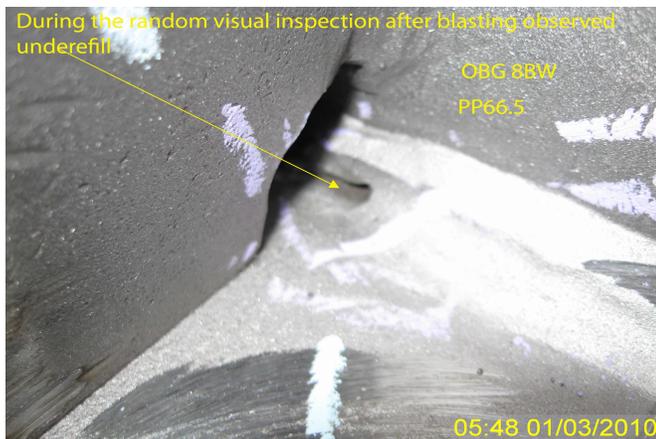
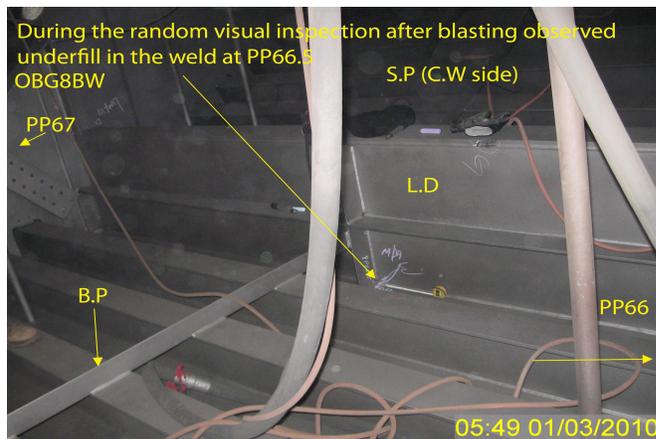
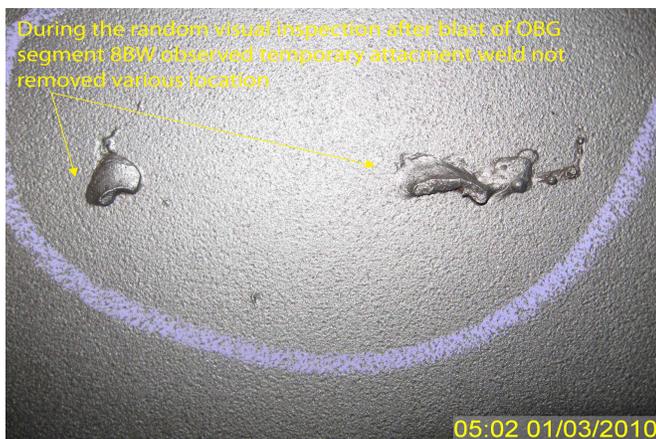
This Quality Assurance (QA) Inspector performed visual inspections along with Caltrans Quality Assurance (QA) Inspectors Mr. Paul Dawson and George Goulet of the interior ceiling, floor beams and floor of OBG 8BW in between PP66 and PP67 after it had been blasted prior to painting.

During the inspection we found normal minor gouges, arc strikes, pinhole, undercut, temporary attachments the major issue was this Quality Assurance (QA) Inspector observed that the weld between the horizontal diaphragm and the bottom plate at panel point 66.5 on the counterweight side requires a weld repair. This area, underneath a weld access hole, has a gap in the fillet weld where it had been welded from each side of the access hole and these two weld passes were never tied together. When we observed this problem all the ZPMC Inspectors had left the area. See attached photos below for additional information. ZPMC Inspection request number was 2423.
