Contract #: 04-0120F4Cty: SF/ALA Rte: 80 PM: 13.2/13.9File #: 69.28**WELDING INSPECTION REPORT****Resident Engineer:** Pursell, Gary**Address:** 333 Burma Road**City:** Oakland, CA 94607**Report No:** WIR-011082**Date Inspected:** 14-Dec-2009**Project Name:** SAS Superstructure**OSM Arrival Time:** 700**Prime Contractor:** American Bridge/Fluor Enterprises, a JV**OSM Departure Time:** 1900**Contractor:** Zhenhua Port Machinery Company, Ltd (ZPMC), Changxing Island **Location:** Shanghai, China**CWI Name:** Chen Ying Xin**CWI Present:** Yes No**Inspected CWI report:** Yes No N/A**Rod Oven in Use:** Yes No N/A**Electrode to specification:** Yes No N/A**Weld Procedures Followed:** Yes No N/A**Qualified Welders:** Yes No N/A**Verified Joint Fit-up:** Yes No N/A**Approved Drawings:** Yes No N/A**Approved WPS:** Yes No N/A**Delayed / Cancelled:** Yes No N/A**Bridge No:** 34-0006**Component:** Tower**Summary of Items Observed:**

WELDING INSPECTION REPORT

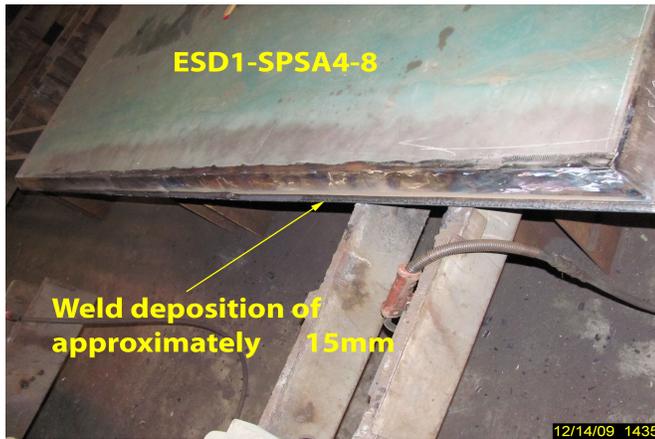
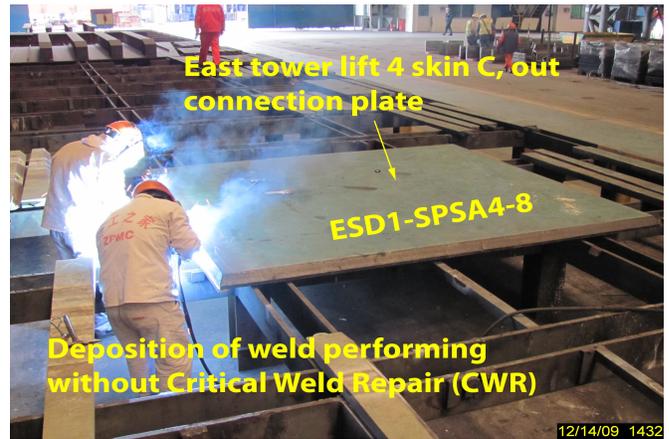
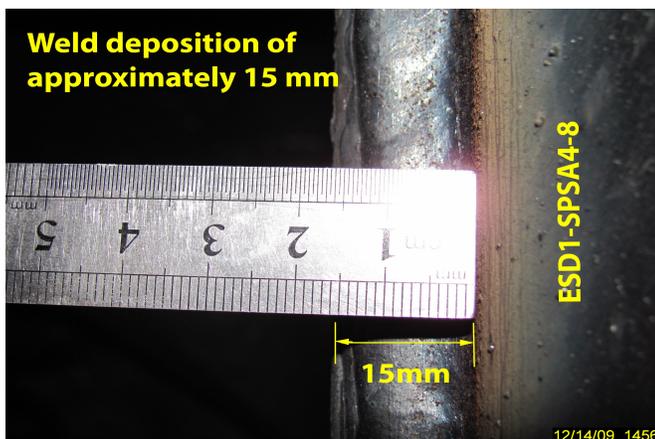
During random in-process Visual inspection of out connection plate of East tower LIFT 4 skin C, ESD1-SPSA4-8 this Caltrans Quality Assurance (QA) inspector observed the deposition of weld metal (buttering/build up) by Flux Core Arc Welding (FCAW) process on the base metal of out connection plate of skin C of East tower lift 4 measured to be approximately 15mm without approved Critical Welding Repair (CWR) report. The welders are identified as 059525 and 049220 with Welding Repair Report (WRR) T-WR2798. The maximum deposition of weld metal allowed is 10mm. This issue has an incident report.
