DEPARTMENT OF TRANSPORTATION

Contract #: 04-0120F4Cty: SF/ALA Rte: 80 PM: 13.2/13.9File #: 69.28**WELDING INSPECTION REPORT****Resident Engineer:** Pursell, Gary**Address:** 333 Burma Road**City:** Oakland, CA 94607**Report No:** WIR-011084**Date Inspected:** 16-Dec-2009**Project Name:** SAS Superstructure**OSM Arrival Time:** 700**Prime Contractor:** American Bridge/Fluor Enterprises, a JV**OSM Departure Time:** 1900**Contractor:** Zhenhua Port Machinery Company, Ltd (ZPMC), Changxing Island **Location:** Shanghai, China**CWI Name:** Chen Ying Xin**CWI Present:** Yes No**Inspected CWI report:** Yes No N/A**Rod Oven in Use:** Yes No N/A**Electrode to specification:** Yes No N/A**Weld Procedures Followed:** Yes No N/A**Qualified Welders:** Yes No N/A**Verified Joint Fit-up:** Yes No N/A**Approved Drawings:** Yes No N/A**Approved WPS:** Yes No N/A**Delayed / Cancelled:** Yes No N/A**Bridge No:** 34-0006**Component:** Tower**Summary of Items Observed:**

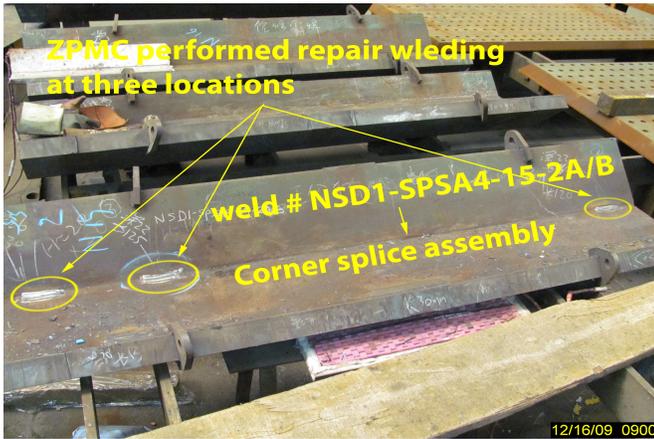
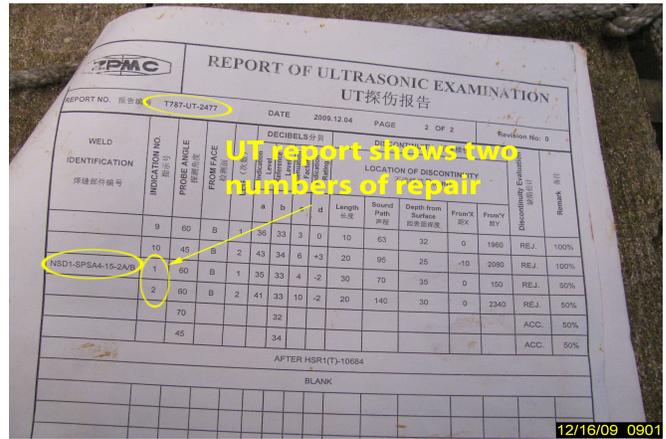
During random in-process Visual inspection of corner splice assembly of North tower lift 3 ~ lift 4, weld NSD1-SPSA4-15-2A/B, this Caltrans Quality Assurance (QA) inspector observed that the repair welding performed by ZPMC at three locations but as per Welding Repair Report (WRR) T-WR2796 with Ultrasonic Testing (UT) report no. T787-UT-2477 it shows only two numbers of repair found by ZPMC.
