DEPARTMENT OF TRANSPORTATION

Contract #: 04-0120F4Cty: SF/ALA Rte: 80 PM: 13.2/13.9File #: 69.28**WELDING INSPECTION REPORT****Resident Engineer:** Pursell, Gary**Address:** 333 Burma Road**City:** Oakland, CA 94607**Report No:** WIR-011106**Date Inspected:** 20-Dec-2009**Project Name:** SAS Superstructure**OSM Arrival Time:** 700**Prime Contractor:** American Bridge/Fluor Enterprises, a JV**OSM Departure Time:** 1900**Contractor:** Zhenhua Port Machinery Company, Ltd (ZPMC), Changxing Island **Location:** Shanghai, China**CWI Name:** Chen Ying Xin, Du Zhi Qun**CWI Present:** Yes No**Inspected CWI report:** Yes No N/A**Rod Oven in Use:** Yes No N/A**Electrode to specification:** Yes No N/A**Weld Procedures Followed:** Yes No N/A**Qualified Welders:** Yes No N/A**Verified Joint Fit-up:** Yes No N/A**Approved Drawings:** Yes No N/A**Approved WPS:** Yes No N/A**Delayed / Cancelled:** Yes No N/A**Bridge No:** 34-0006**Component:** Tower**Summary of Items Observed:**

TOWER INTERIOR SPLICE PLATE REPAIR

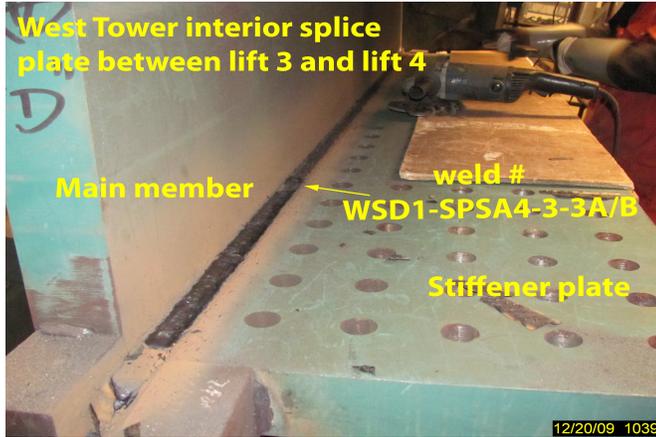
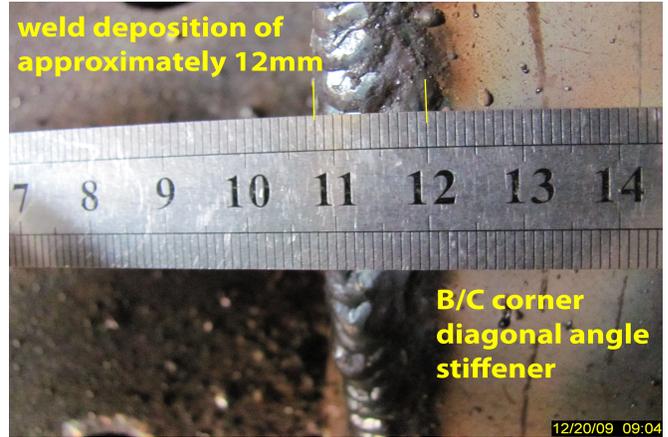
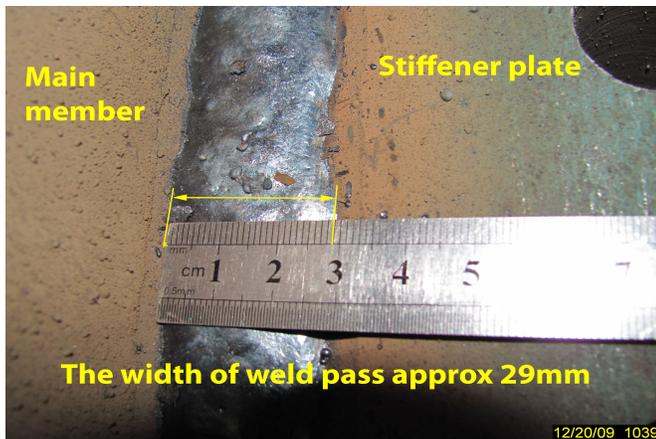
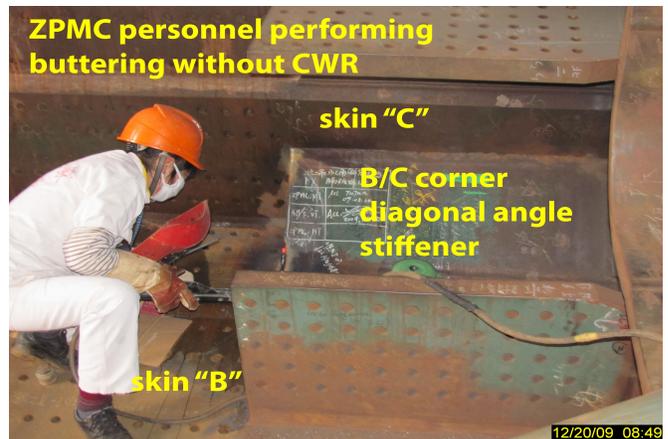
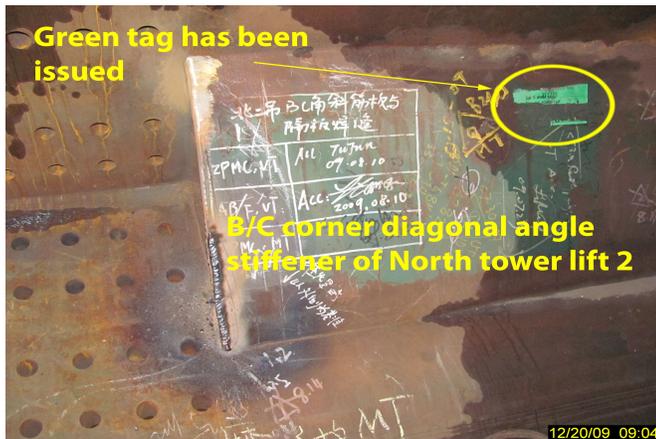
During random in-process Visual inspection of B/C corner diagonal angle stiffener of North Tower lift 2, this QA inspector discovered the deposition of weld metal (buttering/build up) by Shielded Metal Arc Welding (SMAW) process on the base metal of diagonal angle stiffener of B/C corner of North Tower lift 2. This build up measured to be approximately 12mm. This repair was performed without approved Critical Welding Repair (CWR) report. The welder is identified as 040581. The green tag has been already issued for this part. The member is identified as B/C corner diagonal angle stiffener. The member is located in Bay 10.

During the Quality Assurance (QA) random in-process Visual inspection of welds located on West Tower interior splice plate between lift 3 and lift 4, this QA inspector discovered the width of a weld pass measured to be approximately 29mm. This Flux Cored Arc Welding (FCAW) was performed for Complete Joint Penetration (CJP) weld in the flat position. The maximum FCAW weld pass width allowed in flat position for groove weld is 16mm. The weld is identified as: WSD1-SPSA4-3-3A/B. The Weld is a CJP weld joining the main member and stiffener plate. The member is located in Bay 11.
