DEPARTMENT OF TRANSPORTATION

Contract #: 04-0120F4Cty: SF/ALA Rte: 80 PM: 13.2/13.9File #: 69.28**WELDING INSPECTION REPORT****Resident Engineer:** Pursell, Gary**Address:** 333 Burma Road**City:** Oakland, CA 94607**Report No:** WIR-011108**Date Inspected:** 22-Dec-2009**Project Name:** SAS Superstructure**OSM Arrival Time:** 700**Prime Contractor:** American Bridge/Fluor Enterprises, a JV**OSM Departure Time:** 1900**Contractor:** Zhenhua Port Machinery Company, Ltd (ZPMC), Changxing Island **Location:** Shanghai, China**CWI Name:** Chen Ying Xin, Du Zhi Qun**CWI Present:** Yes No**Inspected CWI report:** Yes No N/A**Rod Oven in Use:** Yes No N/A**Electrode to specification:** Yes No N/A**Weld Procedures Followed:** Yes No N/A**Qualified Welders:** Yes No N/A**Verified Joint Fit-up:** Yes No N/A**Approved Drawings:** Yes No N/A**Approved WPS:** Yes No N/A**Delayed / Cancelled:** Yes No N/A**Bridge No:** 34-0006**Component:** Tower**Summary of Items Observed:**

BAY 10 TOWER SPARE STRUT

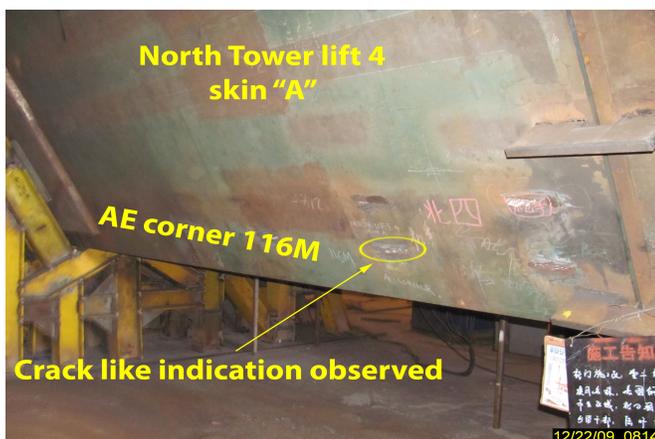
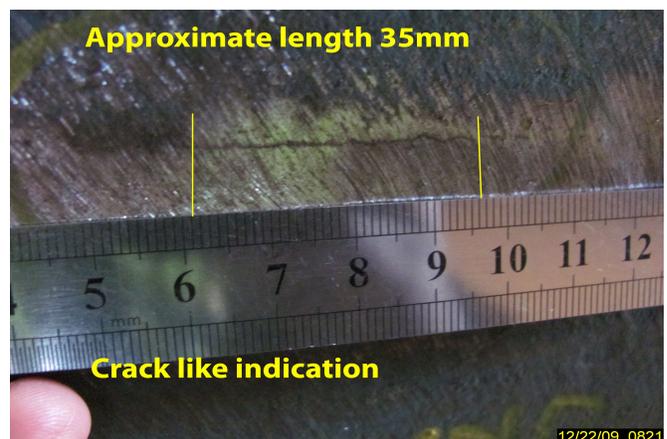
During random in-process Visual inspection of North Tower lift 4 skin A, this QA inspector observed the crack like indication of approximately 35mm in length on skin A near AE corner at 116M. The member is located in Bay 10.

The attached photographs provide additional detail.
