DEPARTMENT OF TRANSPORTATION

Contract #: 04-0120F4Cty: SF/ALA Rte: 80 PM: 13.2/13.9File #: 69.28**WELDING INSPECTION REPORT****Resident Engineer:** Pursell, Gary**Address:** 333 Burma Road**City:** Oakland, CA 94607**Report No:** WIR-011151**Date Inspected:** 04-Jan-2010**Project Name:** SAS Superstructure**OSM Arrival Time:** 700**Prime Contractor:** American Bridge/Fluor Enterprises, a JV**OSM Departure Time:** 1900**Contractor:** Zhenhua Port Machinery Company, Ltd (ZPMC), Changxing Island **Location:** Shanghai**CWI Name:** ZPMC and ABF**CWI Present:** Yes No**Inspected CWI report:** Yes No N/A**Rod Oven in Use:** Yes No N/A**Electrode to specification:** Yes No N/A**Weld Procedures Followed:** Yes No N/A**Qualified Welders:** Yes No N/A**Verified Joint Fit-up:** Yes No N/A**Approved Drawings:** Yes No N/A**Approved WPS:** Yes No N/A**Delayed / Cancelled:** Yes No N/A**Bridge No:** 34-0006**Component:** Tower**Summary of Items Observed:**

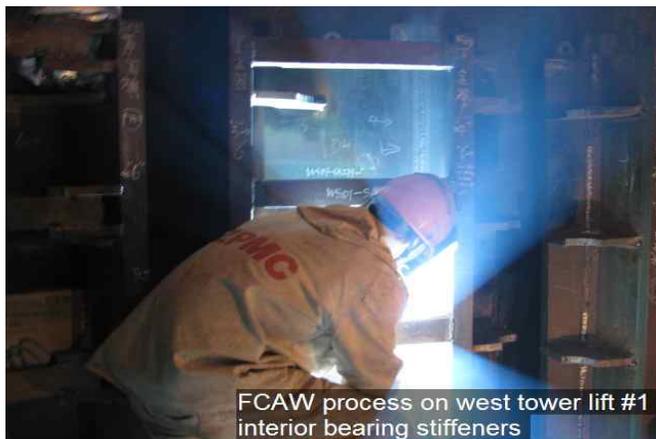
West tower lift #1:- Caltrans QA Inspector observed six ZPMC welders in process FCAW process on interior bearing stiffeners for skin B and C of west tower lift #1. The weld is designed PJP weld use ZPMC joint detail WT10 with welded in 3G position. The welds ID are WSD1-SA279-4/6/12/15, WSD1-SA294-F/G-20/22. The bearing stiffeners weld joint has been pre heat prior welding. The FCAW was monitored and recorded by ZPMC and ABF QC inspector. Based on Caltrans QAI observations, no discrepancies were noted.

FCAW process on west tower lift #1 interior bearing stiffeners

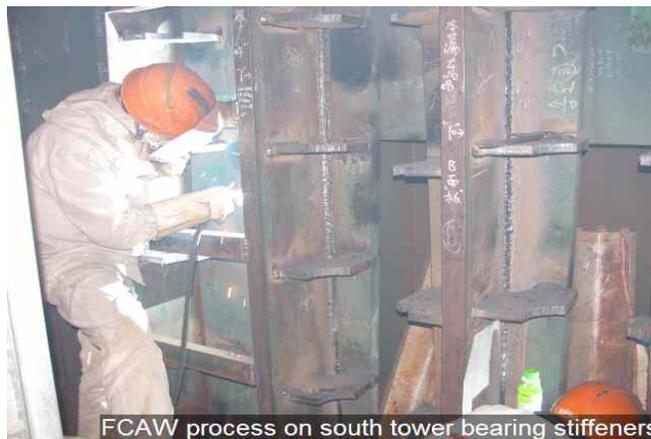
South tower lift #1 bearing stiffeners: - Caltrans QA Inspector observed seven ZPMC welders in process FCAW process on exterior bearing stiffeners for skin A, B and C of south tower lift #1. The weld is designed PJP weld use ZPMC joint detail WT10 with welded in 3G position. The welds ID are SSD1-SA15-DF-14, SSD1-SA18-24, SSD1-SA18-33, SSD1-SA17-F/G-79, SSD1-SA17-F/G-67, SSD1-SA17-F/G-55 and SSD1-SA17-F/G-53. The bearing stiffeners weld joint has been pre heat prior welding. The FCAW was monitored and recorded by ZPMC

and ABF QC inspector. Based on Caltrans QAI observations, no discrepancies were noted.

FCAW process on south tower bearing stiffeners
