DEPARTMENT OF TRANSPORTATION

Contract #: 04-0120F4Cty: SF/ALA Rte: 80 PM: 13.2/13.9File #: 69.28**WELDING INSPECTION REPORT****Resident Engineer:** Pursell, Gary**Address:** 333 Burma Road**City:** Oakland, CA 94607**Report No:** WIR-011181**Date Inspected:** 03-Jan-2010**Project Name:** SAS Superstructure**OSM Arrival Time:** 700**Prime Contractor:** American Bridge/Fluor Enterprises, a JV**OSM Departure Time:** 1900**Contractor:** Zhenhua Port Machinery Company, Ltd (ZPMC), Changxing Island **Location:** Shanghai, China**CWI Name:** Mr. Chen Ying Xin**CWI Present:** Yes No**Inspected CWI report:** Yes No N/A**Rod Oven in Use:** Yes No N/A**Electrode to specification:** Yes No N/A**Weld Procedures Followed:** Yes No N/A**Qualified Welders:** Yes No N/A**Verified Joint Fit-up:** Yes No N/A**Approved Drawings:** Yes No N/A**Approved WPS:** Yes No N/A**Delayed / Cancelled:** Yes No N/A**Bridge No:** 34-0006**Component:** Tower**Summary of Items Observed:**

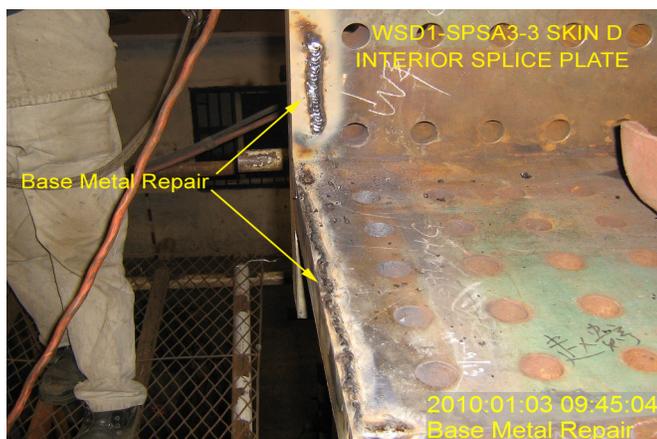
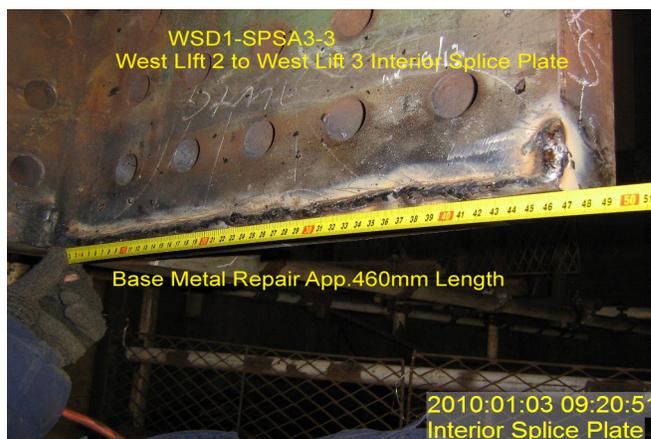
During the Quality Assurance (QA) random in-process visual inspection of Bay 11,this QA inspector discovered the following issue:

Base metal repairs(BMR)were being performed that were caused by the removal of temporary attachments on Interior Splice Plate, without the prior approval of the Engineer. The approximate length of the BMR is:1300mm. The Interior Splice Plate is identified as:WSD1-SPSA3-3.The associated welds in between the BMR areas are identified as:WSD1-SPSA3-3-1A/B,2A/B,3A/B,4A/B.This Green Tag inspection was identified as:Green Tag No:10444.The material is A709M Grade 345 non SPCM.Interior Splice Plate is located in Shop Bay 11.Incident report for the same has been raised.

The incident report is issued for the above mentioned discrepancy observed in Tower, Bay#11,Interior Splice plate and prior to issue it was informed to ZPMC QC and ABF QA.
