Contract #: 04-0120F4Cty: SF/ALA Rte: 80 PM: 13.2/13.9File #: 69.28**WELDING INSPECTION REPORT****Resident Engineer:** Pursell, Gary**Address:** 333 Burma Road**City:** Oakland, CA 94607**Report No:** WIR-011186**Date Inspected:** 09-Jan-2010**Project Name:** SAS Superstructure**OSM Arrival Time:** 700**Prime Contractor:** American Bridge/Fluor Enterprises, a JV**OSM Departure Time:** 1900**Contractor:** Zhenhua Port Machinery Company, Ltd (ZPMC), Changxing Island **Location:** Shanghai, China**CWI Name:** Chen Ying Xin, Tu Jun**CWI Present:** Yes No**Inspected CWI report:** Yes No N/A**Rod Oven in Use:** Yes No N/A**Electrode to specification:** Yes No N/A**Weld Procedures Followed:** Yes No N/A**Qualified Welders:** Yes No N/A**Verified Joint Fit-up:** Yes No N/A**Approved Drawings:** Yes No N/A**Approved WPS:** Yes No N/A**Delayed / Cancelled:** Yes No N/A**Bridge No:** 34-0006**Component:** Tower**Summary of Items Observed:**

BAY 10 TOWER LIFT 3 CONNECT BEAM

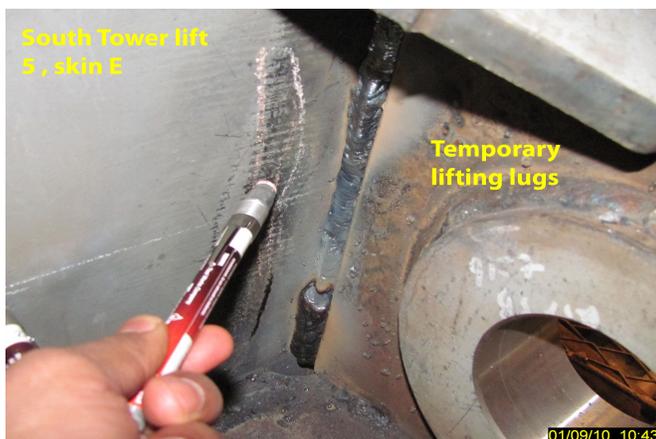
This QA Caltrans Quality Assurance (QA) Inspector observed ZPMC personnel performing Flux Cored Arc Welding (FCAW) of complete joint penetration (CJP) weld attaching a temporary lifting lugs plate to outside of South Tower, lift 5, skin E (70 mm thickness), without sufficient base material preheat. This work was observed approximately 175mm from top of lift 5. This QA Inspector observed a 160 degree Celsius Tempilstik temperature indicator mark applied to the adjacent base material within approximately 30mm from the point of welding did not melt.
