DEPARTMENT OF TRANSPORTATION

Office of Structural Materials

Contract #: 04-0120F4Cty: SF/Ala Rte: 80 PM: 13.2/13.9File #: 69.28**WELDING INSPECTION REPORT****Resident Engineer:** Pursell, Gary**Address:** 333 Burma Road**City:** Oakland, CA 94607**Report No:** WIR-011489**Date Inspected:** 19-Dec-2009**Project Name:** SAS Superstructure**OSM Arrival Time:** 1900**Prime Contractor:** American Bridge/Fluor Enterprises, a JV**OSM Departure Time:** 700**Contractor:** Zhenhua Port Machinery Company, Ltd (ZPMC), Changxing Island **Location:** Shanghai, China**CWI Name:** See below**CWI Present:** Yes No**Inspected CWI report:** Yes No N/A**Rod Oven in Use:** Yes No N/A**Electrode to specification:** Yes No N/A**Weld Procedures Followed:** Yes No N/A**Qualified Welders:** Yes No N/A**Verified Joint Fit-up:** Yes No N/A**Approved Drawings:** Yes No N/A**Approved WPS:** Yes No N/A**Delayed / Cancelled:** Yes No N/A**Bridge No:** 34-0006**Component:** Tower Components**Summary of Items Observed:**

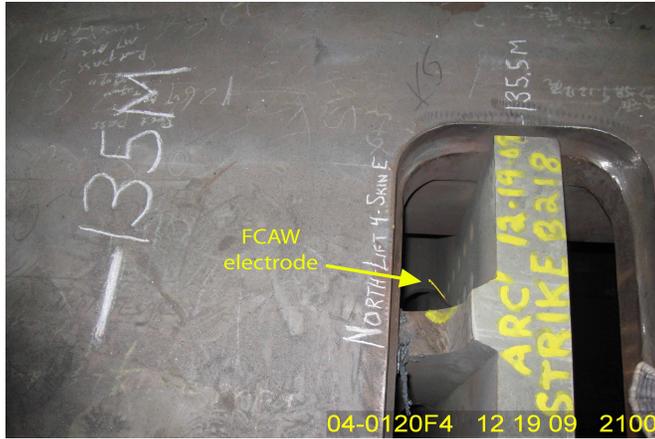
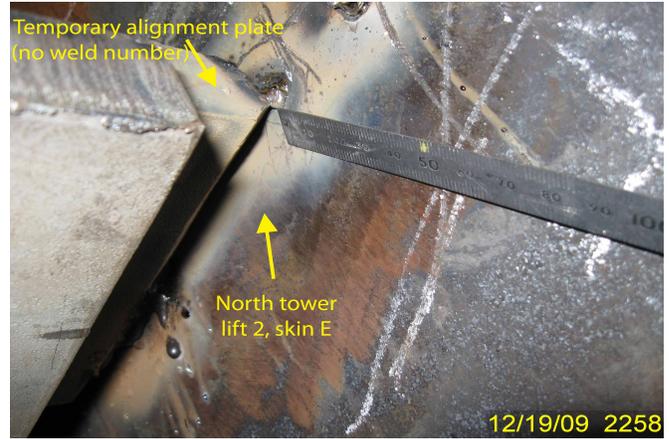
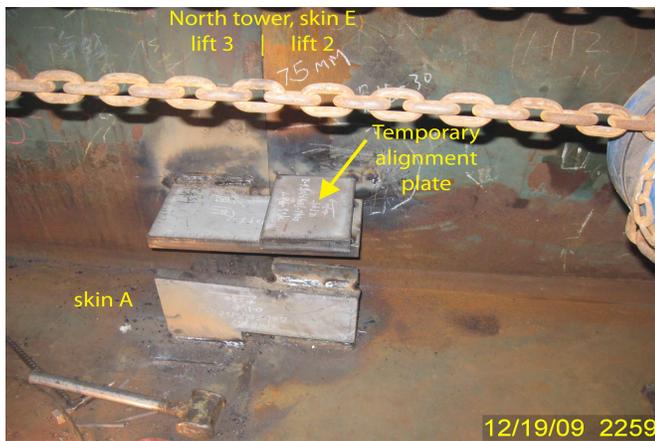
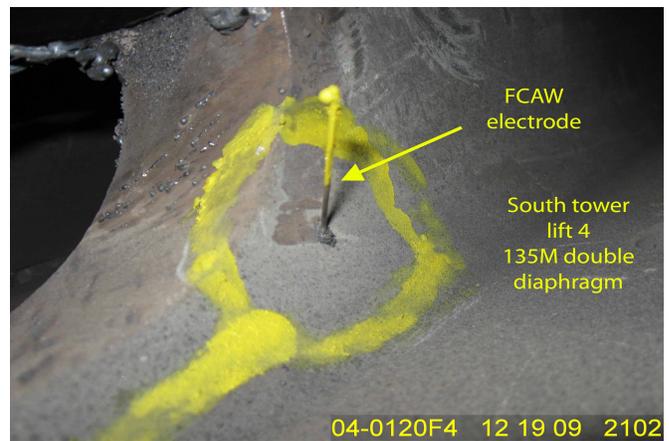
An arc strike with FCAW electrode attached was observed by this QA Inspector at PCMK north tower, lift 4, skin E on the 135M double diaphragm at 135.5M elevation. This QA Inspector marked the location and notified QC1 of the issue. QC1 assured this QA Inspector that the arc strike would be ground and magnetic particle tested. See

photos below.
