**DEPARTMENT OF TRANSPORTATION**

Contract #: 04-0120F4Cty: SF/ALA Rte: 80 PM: 13.2/13.9File #: 69.28**WELDING INSPECTION REPORT****Resident Engineer:** Pursell, Gary**Address:** 333 Burma Road**City:** Oakland, CA 94607**Report No:** WIR-011534**Date Inspected:** 11-Jan-2010**Project Name:** SAS Superstructure**OSM Arrival Time:** 700**Prime Contractor:** American Bridge/Fluor Enterprises, a JV**OSM Departure Time:** 1900**Contractor:** Zhenhua Port Machinery Company, Ltd (ZPMC), Changxing Island **Location:** Shanghai, China**CWI Name:** Wang Chuan Qing, Tu Jun**CWI Present:** Yes No**Inspected CWI report:** Yes No N/A**Rod Oven in Use:** Yes No N/A**Electrode to specification:** Yes No N/A**Weld Procedures Followed:** Yes No N/A**Qualified Welders:** Yes No N/A**Verified Joint Fit-up:** Yes No N/A**Approved Drawings:** Yes No N/A**Approved WPS:** Yes No N/A**Delayed / Cancelled:** Yes No N/A**Bridge No:** 34-0006**Component:** Tower**Summary of Items Observed:**

**BAY 10 SOUTH TOWER LIFT 2 MECHANICAL SUPPORT**

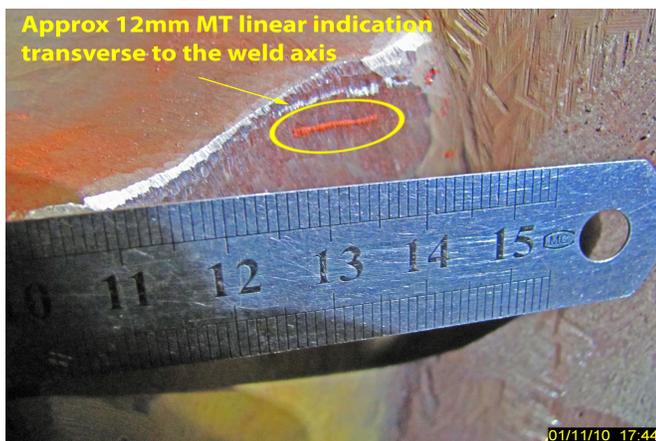
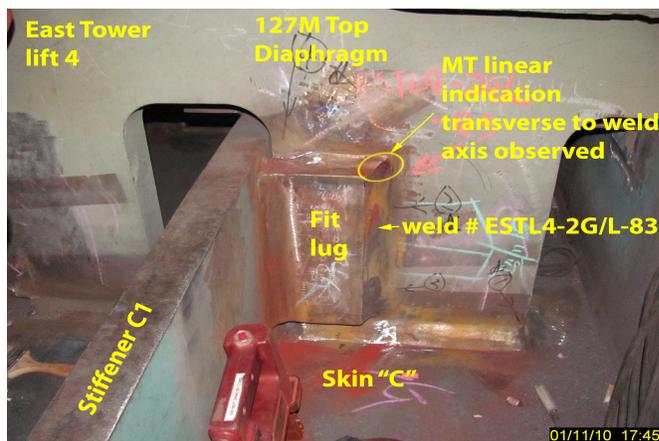
ESTL4-2G/L-83 (MT TRANSVERSE INDICATION OF APPROX 12mm IN LENGTH OBSERVED)

During the Quality Assurance(QA) Magnetic Particle Testing (MT) review of welds located in East Tower lift 4 fit lug on skin C, ESTL4-2G/L-83, this Quality Assurance (QA) Inspector discovered One (1) linear indication transverse to the weld axis measuring approximately 12mm in length. The weld is identified as: ESTL4-2G/L-83. The Weld is a fillet weld joining the 127M top diaphragm to fit lug near stiffener C1. The member is located in Bay 11. The Notice of Witness Inspection Number (NWIT) is 005045. The indication is located inside the area that has been previously tested and accepted by ZPMC Quality Control (QC) personnel. As per the contract documents, ZPMC's QC personnel are required to perform one hundred (100) percent MT inspection of this weld. The attached photographs provide additional detail.
