Contract #: 04-0120F4Cty: SF/ALA Rte: 80 PM: 13.2/13.9File #: 1.28**WELDING INSPECTION REPORT****Resident Engineer:** Pursell, Gary**Address:** 333 Burma Road**City:** Oakland, CA 94607**Report No:** WIR-011752**Date Inspected:** 29-Jan-2010**Project Name:** SAS Superstructure**OSM Arrival Time:** 700**Prime Contractor:** American Bridge/Fluor Enterprises, a JV**OSM Departure Time:** 1100**Contractor:** American Bridge/Fluor Enterprises, a JV**Location:** Job Site

Bridge No: 34-0006**Component:** Orthotropic Box Girder (OBG) Lift 1 East**Summary of Items Observed:**

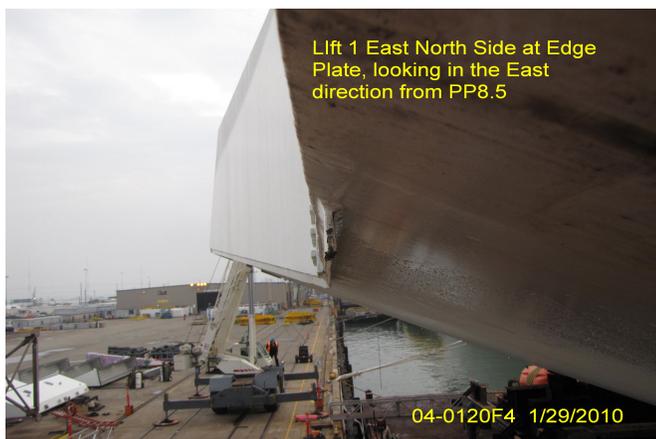
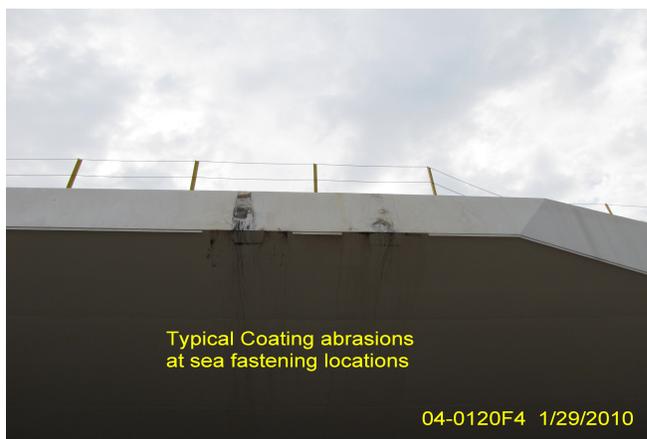
- a. Support #2 – Minor Coating Damage.
- b. Support # 2A – Minor coating abrasions.
- c. Support #4 – No apparent issues observed.

- d. Support # 5 – No apparent issues observed.
- e. Support #8 – Minor Coating Damage.

Item 2 Top Deck Plate Wood Support Frame - No apparent issues observed. It was noted the lifting block attachments will stay in place on the top deck plate until the OBG is erected in the field. The contact points of the attachments will need to be reviewed at these locations at a later date. No apparent issues were observed in the general area surrounding them at this time.

Item 3 Bottom Plate Wood Support Frame – No apparent issues observed. The contact points from the barge and the OBG currently have bearing pads in place with no apparent issues observed in the general area.

Item 4 Transverse Tie Locations – No apparent issues observed.

Item 5 W OBG connection point – No apparent issues observed.
