**DEPARTMENT OF TRANSPORTATION**

# WELDING INSPECTION REPORT

Item 1~ Lift 1 East; South side exterior sea fastening support locations.

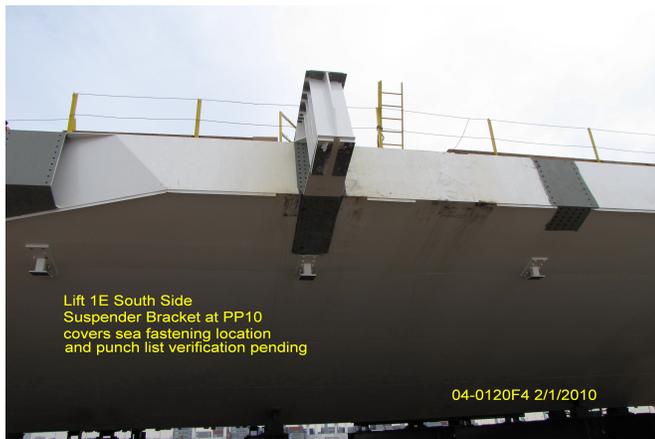
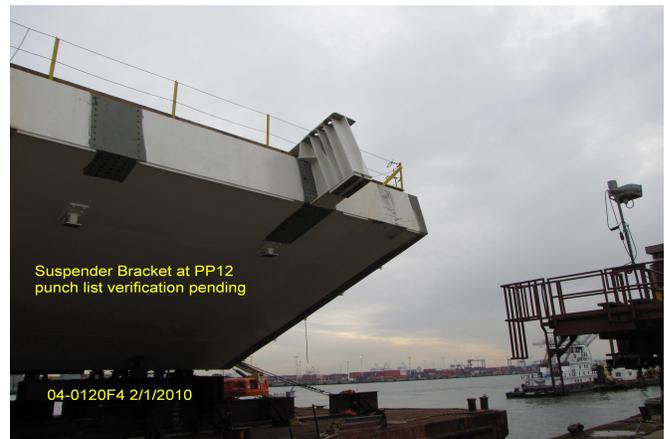
- a. Support #2 – Minor Coating abrasions.
- b. Support # 2A – Minor coating abrasions.
- c. Support #8 – Minor Coating Damage.

After the completion of lift 1 East, it was determined the arrival inspection for the exterior of the South side of lifts 2E, 3E and 4E should be performed while access was available prior to the placement of any additional suspender brackets. This review was completed with minor coating abrasions noted in each sea fastening locations.
