DEPARTMENT OF TRANSPORTATION

Contract #: 04-0120F4Cty: SF/ALA Rte: 80 PM: 13.2/13.9File #: 69.28**WELDING INSPECTION REPORT****Resident Engineer:** Pursell, Gary**Address:** 333 Burma Road**City:** Oakland, CA 94607**Report No:** WIR-011812**Date Inspected:** 05-Feb-2010**Project Name:** SAS Superstructure**OSM Arrival Time:** 645**Prime Contractor:** American Bridge/Fluor Enterprises, a JV**OSM Departure Time:** 1845**Contractor:** Zhenhua Port Machinery Company, Ltd (ZPMC), Changxing Island **Location:** Shanghai, China**CWI Name:** Wu Zhi Cheng**CWI Present:** Yes No**Inspected CWI report:** Yes No N/A**Rod Oven in Use:** Yes No N/A**Electrode to specification:** Yes No N/A**Weld Procedures Followed:** Yes No N/A**Qualified Welders:** Yes No N/A**Verified Joint Fit-up:** Yes No N/A**Approved Drawings:** Yes No N/A**Approved WPS:** Yes No N/A**Delayed / Cancelled:** Yes No N/A**Bridge No:** 34-0006**Component:** OBG**Summary of Items Observed:**

On this day CALTRANS OSM Quality Assurance Inspector (QA) Joe Alaniz was present during the times noted above for observations relative to the fabrication of the SAS Superstructure being performed by Zhenhua Port Machinery Company (ZPMC

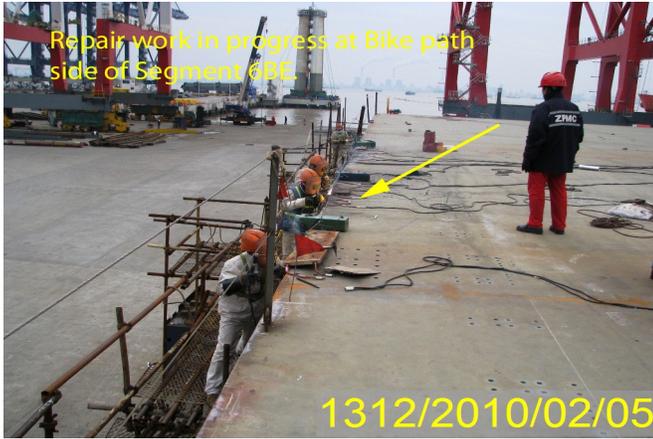
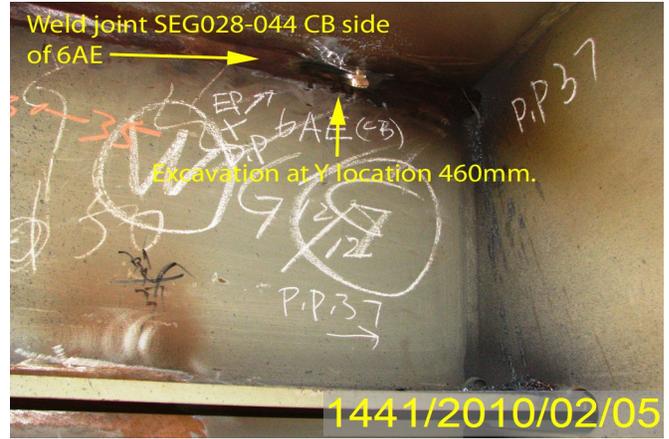
This QA Inspector observed repair area (Y location 460mm) on weld joint SEG028-044 has been inspected and accepted by ZPMC and ABF QC department. ZPMC had excavated the noted area for no reason and without notifying ABF and Caltrans. ZPMC did not record excavation performed area for Caltrans MT/UT required inspection verification nor submitted a WWR or CWR. ABF representative Mr. Raymond Mah was present at the time of this QA Inspector observation and stated he will issue an NCR for this matter.
