**DEPARTMENT OF TRANSPORTATION**

Contract #: 04-0120F4Cty: SF/ALA Rte: 80 PM: 13.2/13.9File #: 1.28**WELDING INSPECTION REPORT****Resident Engineer:** Pursell, Gary**Address:** 333 Burma Road**City:** Oakland, CA 94607**Report No:** WIR-011834**Date Inspected:** 03-Feb-2010**Project Name:** SAS Superstructure**OSM Arrival Time:** 700**Prime Contractor:** American Bridge/Fluor Enterprises, a JV**OSM Departure Time:** 1530**Contractor:** American Bridge/Fluor Enterprises, a JV**Location:** Job Site**CWI Name:** Bernard Docena/Jim Bowers**CWI Present:** Yes No**Inspected CWI report:** Yes No N/A**Rod Oven in Use:** Yes No N/A**Electrode to specification:** Yes No N/A**Weld Procedures Followed:** Yes No N/A**Qualified Welders:** Yes No N/A**Verified Joint Fit-up:** Yes No N/A**Approved Drawings:** Yes No N/A**Approved WPS:** Yes No N/A**Delayed / Cancelled:** Yes No N/A**Bridge No:** 34-0006**Component:** Orthotropic Box Girder (OBG) Lift 2 and 3 East**Summary of Items Observed:**

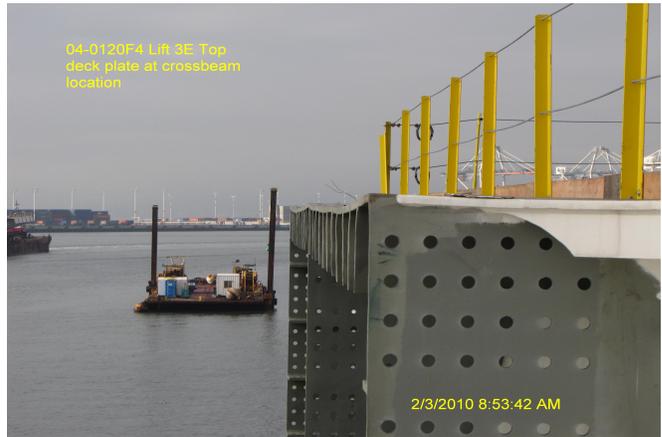
Deflection of 8mm was observed at the location just prior to PP13 at the E3 and E4 line of the top deck plate along the edge of the OBG. These areas are in the location where the full height diaphragm plates intersect with the top deck plate. See digital photo included further in the body of this report. This information was relayed to the Structure Material Representative (SMR) Anthony Mullen and China liaison John Kinsey in which Mr. Kinsey relayed this condition was discussed previously and determined to exist prior to the shipment voyage. General waviness of the top deck plate along the edge of the crossbeam connection was observed and this condition was also confirmed to exist previously by Mr. Kinsey. Mr. Kinsey also relayed this condition will exist at the crossbeam location for lift 3 East also. See digital photo in the body of this report for lift 3E example.

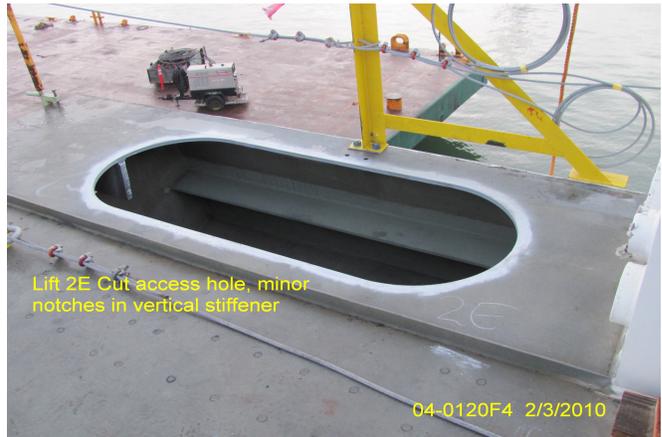
It was noted the contractor performed flame cutting of the top deck plate in order to install access points at the Northwest and Southeast corners of the OBG prior to the arrival inspection. An additional access point was scribed on the top deck plate at the Southwest corner of the OBG and the QA inspectors spoke with the QCM regarding this issue. The QCM relayed these access hatches were detailed in a request for information (RFI) and he would need to research the submittal number and relay this information to QA. Further discussions took place regarding the contractor notifying Caltrans when work is scheduled in order for review of the in-process work being performed. This information was relayed to the SMR for future discussion and disposition. See digital photo below for general information.
