DEPARTMENT OF TRANSPORTATION

Quality Assurance and Source Inspection

Contract #: 04-0120F4Cty: SF/ALA Rte: 80 PM: 13.2/13.9File #: 69.28**WELDING INSPECTION REPORT****Resident Engineer:** Pursell, Gary**Address:** 333 Burma Road**City:** Oakland, CA 94607**Report No:** WIR-011967**Date Inspected:** 04-Feb-2010**Project Name:** SAS Superstructure**OSM Arrival Time:** 700**Prime Contractor:** American Bridge/Fluor Enterprises, a JV**OSM Departure Time:** 1900**Contractor:** Zhenhua Port Machinery Company, Ltd (ZPMC), Changxing Island **Location:** Shanghai, China**CWI Name:** Du Zhiqun.**CWI Present:** Yes No**Inspected CWI report:** Yes No N/A**Rod Oven in Use:** Yes No N/A**Electrode to specification:** Yes No N/A**Weld Procedures Followed:** Yes No N/A**Qualified Welders:** Yes No N/A**Verified Joint Fit-up:** Yes No N/A**Approved Drawings:** Yes No N/A**Approved WPS:** Yes No N/A**Delayed / Cancelled:** Yes No N/A**Bridge No:** 34-0006**Component:** Tower**Summary of Items Observed:**

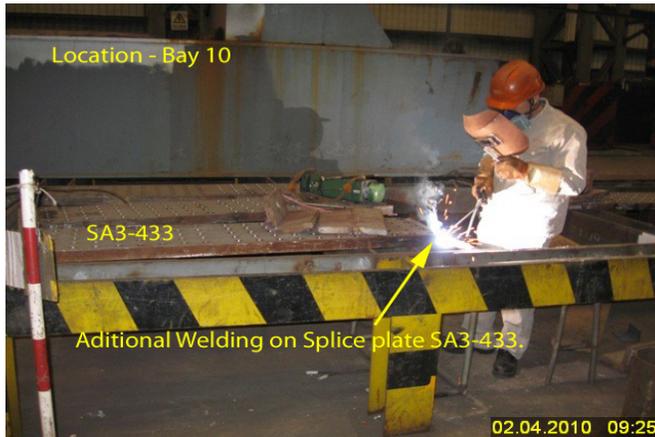
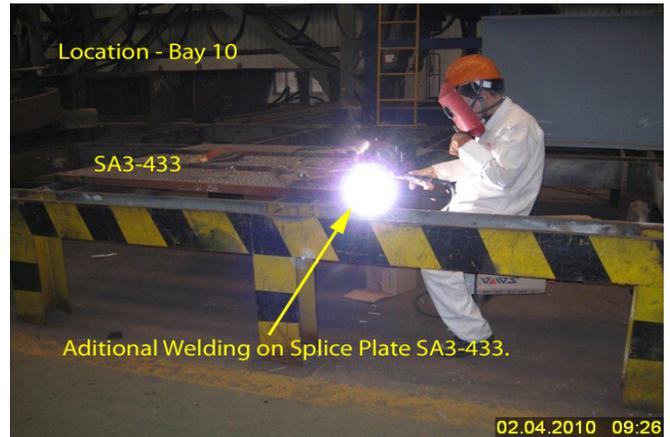
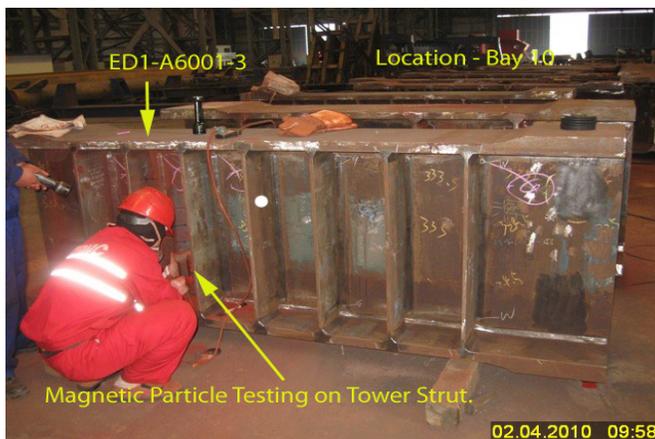
This QA Inspector observed ZPMC qualified welding personnel identified as 052930, 050289. Perform Shielded Metal Arc Welding (SMAW) on Splice Plate. Plate identified as SA3-433 . ZPMC CWI Identified as Gang Liang Zhu with Temporary welding repair report. The welding parameters as measured using QC's calibrated instrument appeared to be in general compliance with WPS-485-SMAW-2G(2F)-Repair-1. For more information see attached photos.

This QA Inspector observed during random Visual inspection, ZPMC Magnetic Particle Testing (MT) Inspector performed MT on Tower Strut Plate, The Item identified as ED1-A6001-3, For more information see attached
