**DEPARTMENT OF TRANSPORTATION**

Contract #: 04-0120F4Cty: SF/ALA Rte: 80 PM: 13.2/13.9File #: 69.28**WELDING INSPECTION REPORT****Resident Engineer:** Pursell, Gary**Address:** 333 Burma Road**City:** Oakland, CA 94607**Report No:** WIR-011972**Date Inspected:** 05-Feb-2010**Project Name:** SAS Superstructure**OSM Arrival Time:** 700**Prime Contractor:** American Bridge/Fluor Enterprises, a JV**OSM Departure Time:** 1900**Contractor:** Zhenhua Port Machinery Company, Ltd (ZPMC), Changxing Island **Location:** Shanghai, China

SEG 7DW.

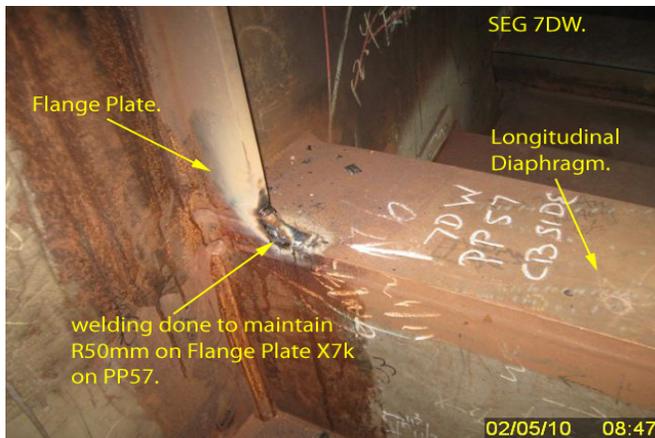
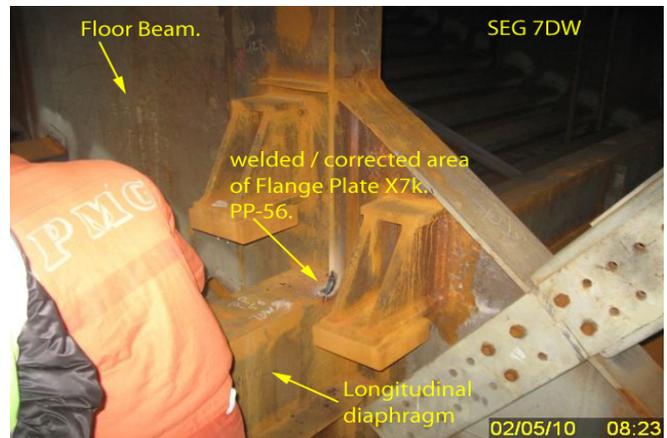
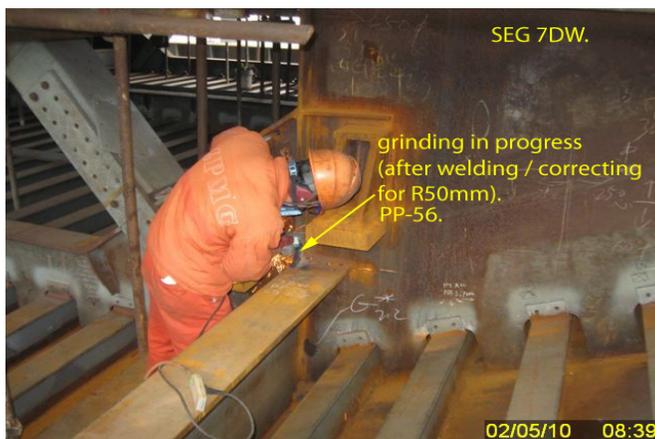
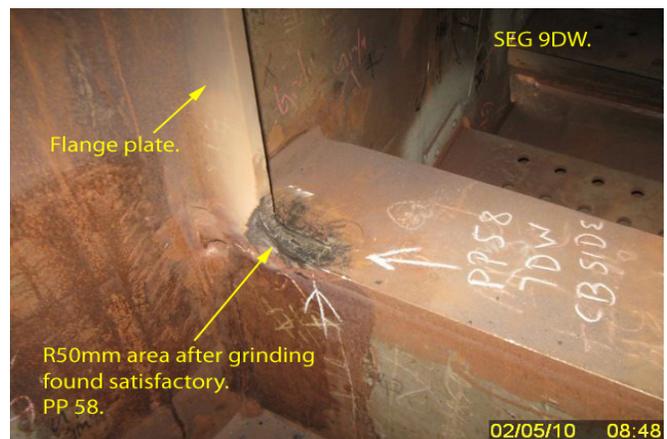
- During inprocess visual inspection this QA Inspector observed ZPMC personnel grinding the 50mm radii at the bottom end of Floor Beam Flange of X7k Flange Plate.
- On DT: 02/04/10, as per Welding Repair Report (WRR) B-WR10642, repair welding was done on this R50mm area for its correction / rectification. Welding process used was Shielded Metal Arc Welding (SMAW). Welder was identified as 045133. ZPMC QC was identified as Wang Wei Ming. The welding variables recorded by QC appeared to comply with the applicable WPS: 345-SMAW-1G (1F)-Repair.
- After completion of grinding of R50mm radii (on PP56, PP57 & PP58), this corrected area appeared to comply with drawing or contract documents.
- For details, refer attached photos.
