DEPARTMENT OF TRANSPORTATION

Contract #: 04-0120F4Cty: SF/ALA Rte: 80 PM: 13.2/13.9File #: 69.28**WELDING INSPECTION REPORT****Resident Engineer:** Pursell, Gary**Address:** 333 Burma Road**City:** Oakland, CA 94607**Report No:** WIR-011974**Date Inspected:** 08-Feb-2010**Project Name:** SAS Superstructure**OSM Arrival Time:** 700**Prime Contractor:** American Bridge/Fluor Enterprises, a JV**OSM Departure Time:** 1900**Contractor:** Zhenhua Port Machinery Company, Ltd (ZPMC), Changxing Island **Location:** Shanghai, China

SEG 9BW:

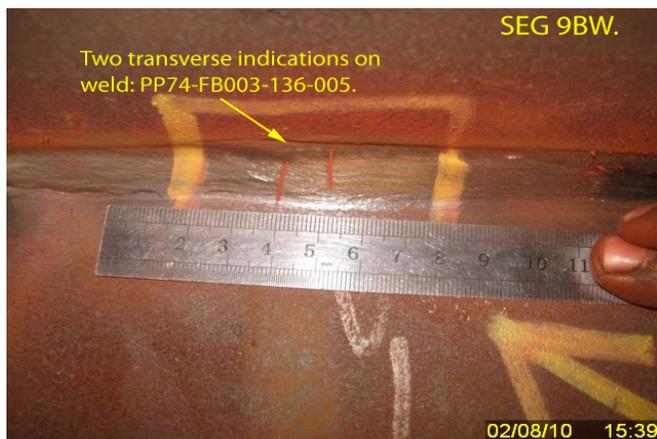
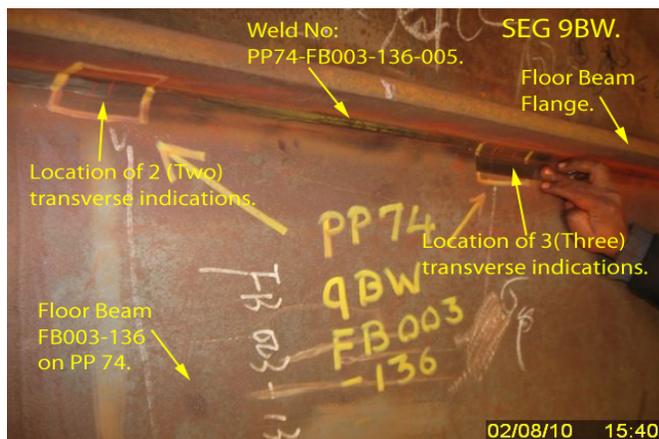
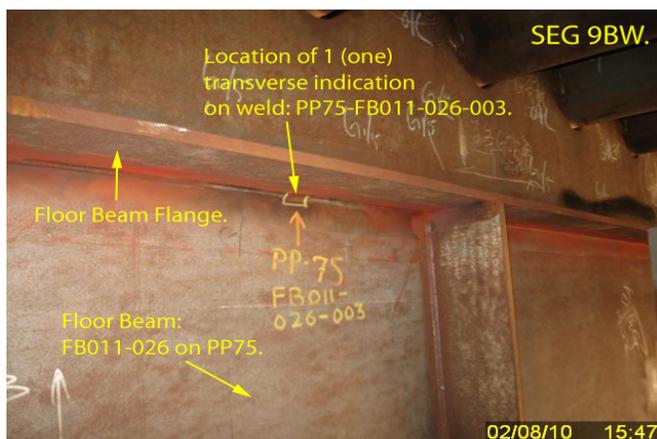
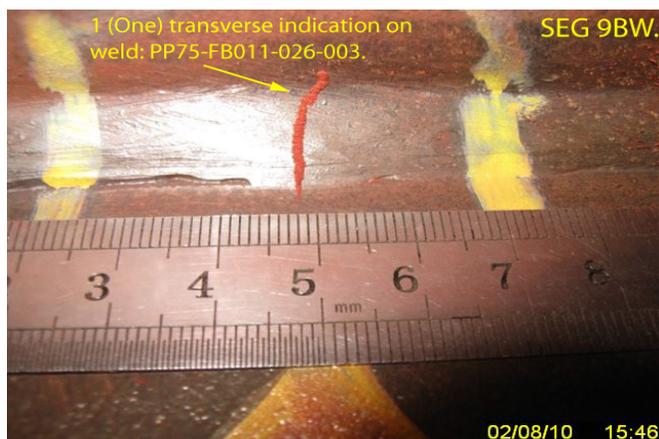
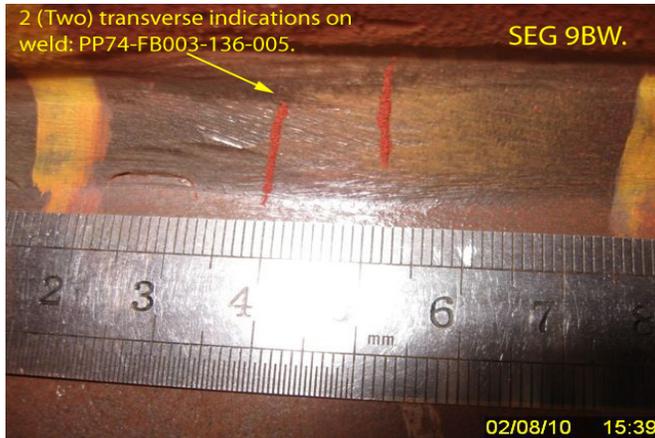
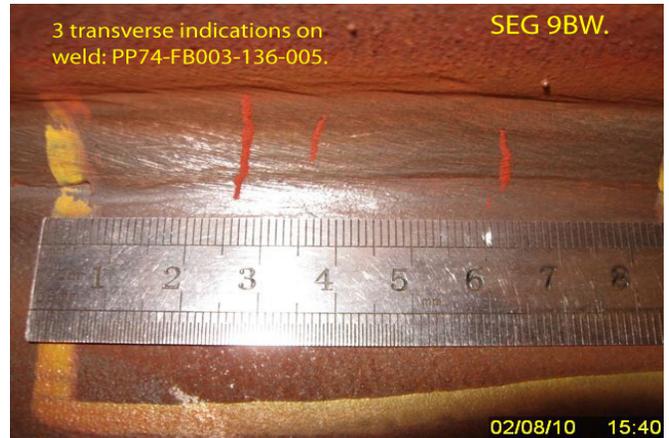
- Visually, both these welds do not appeared to comply with the contract documents due to the below mentioned points:

- For PP74-FB003-136 – 005:
 - During inprocess visual inspection of the above mentioned weld, this QA observed Five (5) transverse indications.
- For PP75-FB011-026 - 003:
 - During inprocess visual inspection of the above mentioned weld, this QA observed One (1) transverse indication.
- The above mentioned indications were confirmed with MT and the lengths of these cracks were observed as approximately 8mm to 15mm.
- These welds were previously Magnetic Particle Testing (MT) tested and accepted by ZPMC Quality Control (QC) personnel.
- The member(s) are identified as OBG components – Floor Beam & Floor Beam Flange on PP74 & PP75.
- This QA Inspector has generated MT report for this date.
- This QA Inspector had informed ZPMC QA identified as Mr. Zhong Wei, of this issue and that an incident report would be generated.
- For further information, please see the attached photos.
