DEPARTMENT OF TRANSPORTATION

Contract #: 04-0120F4Cty: SF/ALA Rte: 80 PM: 13.2/13.9File #: 1.28**WELDING INSPECTION REPORT****Resident Engineer:** Pursell, Gary**Address:** 333 Burma Road**City:** Oakland, CA 94607**Report No:** WIR-011996**Date Inspected:** 11-Feb-2010**Project Name:** SAS Superstructure**OSM Arrival Time:** 730**Prime Contractor:** American Bridge/Fluor Enterprises, a JV**OSM Departure Time:** 1600**Contractor:** American Bridge/Fluor Enterprises, a JV**Location:** Job Site

LIFT 4 EAST

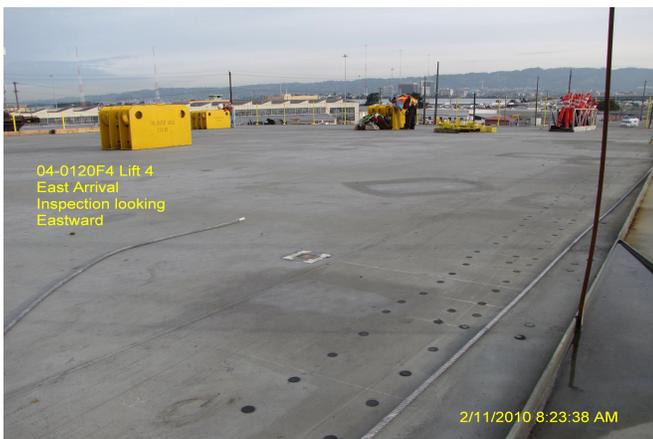
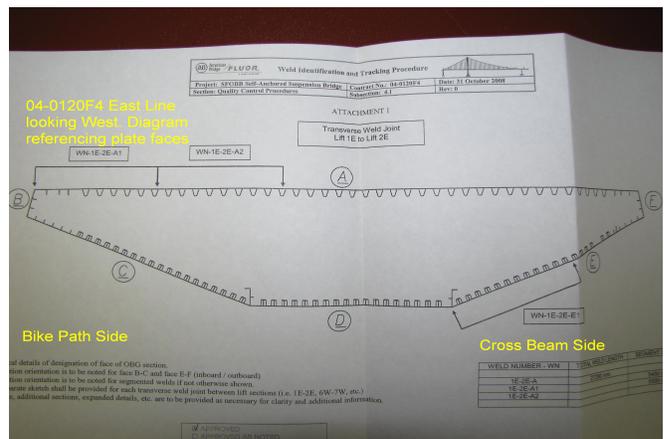
The QA inspector noted ABF personnel are in the process of periodically placing the components for scaffolding, welding, lighting, walkways, temporary bolts and other miscellaneous items in preparation of mobilizing lift 4 East to the erection site. QC personnel Steve McConnell, Jesus Cayabyab and Bernard Docena were noted to be present at the West and East end of the OBG verifying and documenting the bevel preparation for the transverse field splice locations for each plate face. See the diagram in this report for the face designations. The QC personnel were observed measuring and documenting the field measurement locations for future Ultrasonic Testing purposes in regards to how the location of the closed ribs, fillet weld at the closed ribs and the root face will all interact with one another during ultrasonic testing after field welding. This item is being performed at the request of QCM Jim Bowers with the intent to assist in the interpretation of the multiple UT reflectors anticipated to be present during future testing. The QA inspector spoke with the QC inspectors and the QC lead Leonard Cross briefly in regards to how this process will be documented and initiated in the field. The items observed appeared to be in general conformance with the contract documents.
