DEPARTMENT OF TRANSPORTATION

Contract #: 04-0120F4Cty: SF/ALA Rte: 80 PM: 13.2/13.9File #: 1.28**WELDING INSPECTION REPORT****Resident Engineer:** Pursell, Gary**Address:** 333 Burma Road**City:** Oakland, CA 94607**Report No:** WIR-012002**Date Inspected:** 12-Feb-2010**Project Name:** SAS Superstructure**OSM Arrival Time:** 700**Prime Contractor:** American Bridge/Fluor Enterprises, a JV**OSM Departure Time:** 1530**Contractor:** American Bridge/Fluor Enterprises, a JV**Location:** Job Site

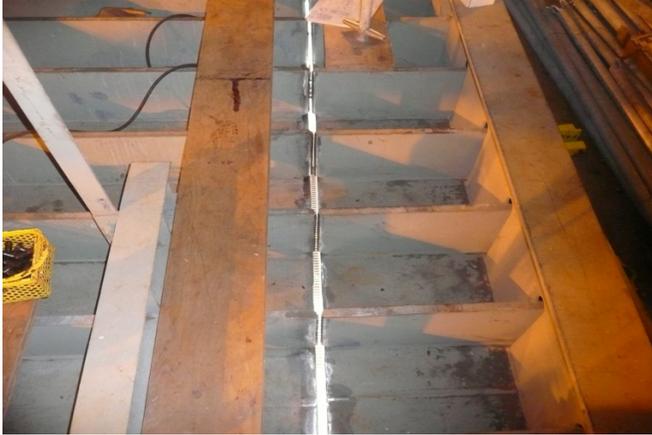
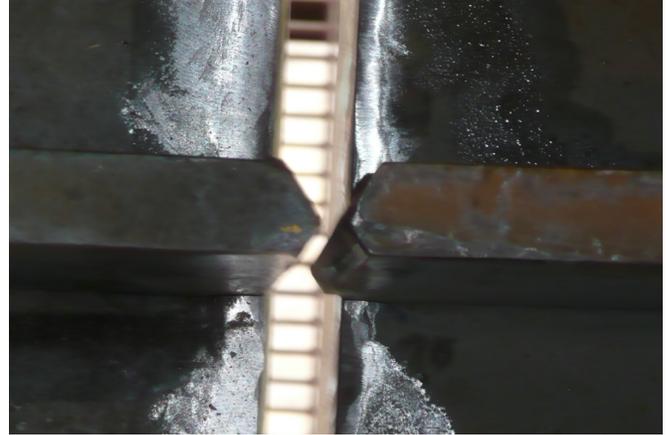
"D" Face "I" Ribs

The QA Inspector randomly observed the fit up of the "I" ribs on the bottom of the OBG or the "D" face. The QA Inspector performed a preliminary inspection of the fit up prior to ABF personnel performing any dimensional tolerance inspections. Upon the random preliminary inspection it was observed the "I" ribs appeared to be with in the dimensional tolerances of the contract documents (pictured below). The QA Inspector noted it is unknown whether the OBG is in the final resting position at the time of the random preliminary dimensional inspection.
