DEPARTMENT OF TRANSPORTATION

Contract #: 04-0120F4Cty: SF/ALA Rte: 80 PM: 13.2/13.9File #: 69.28**WELDING INSPECTION REPORT****Resident Engineer:** Pursell, Gary**Address:** 333 Burma Road**City:** Oakland, CA 94607**Report No:** WIR-012023**Date Inspected:** 16-Feb-2010**Project Name:** SAS Superstructure**OSM Arrival Time:** 645**Prime Contractor:** American Bridge/Fluor Enterprises, a JV**OSM Departure Time:** 1845**Contractor:** Zhenhua Port Machinery Company, Ltd (ZPMC), Changxing Island **Location:** Shanghai, China**CWI Name:** Li Yang**CWI Present:** Yes No**Inspected CWI report:** Yes No N/A**Rod Oven in Use:** Yes No N/A**Electrode to specification:** Yes No N/A**Weld Procedures Followed:** Yes No N/A**Qualified Welders:** Yes No N/A**Verified Joint Fit-up:** Yes No N/A**Approved Drawings:** Yes No N/A**Approved WPS:** Yes No N/A**Delayed / Cancelled:** Yes No N/A**Bridge No:** 34-0006**Component:** OBG COMPONENT**Summary of Items Observed:**

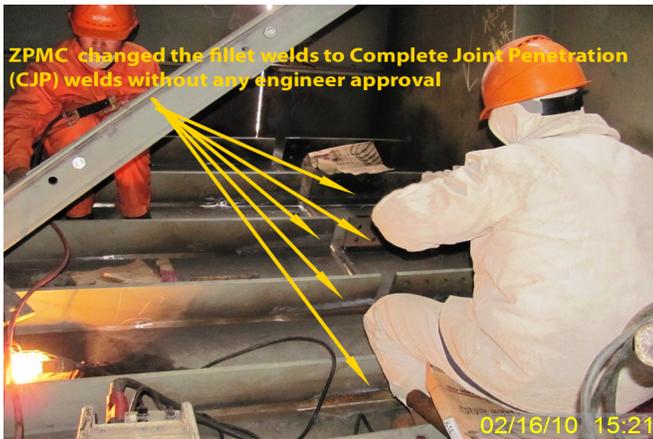
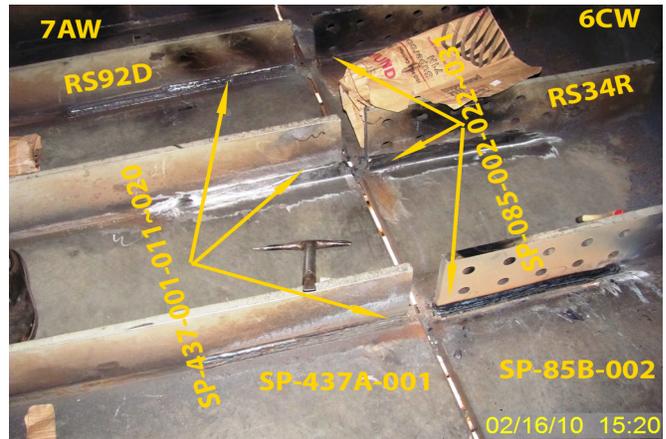
During Quality Assurance random in-process observations of the assembly of Orthotropic Box Girder (OBG) segments 6CW and 7AW, this Quality Assurance Inspector (QA) discovered that the ZPMC has deviated from the approved weld joint design without the Engineers approval. ZPMC has changed the hold back fillet welds to Complete Joint Penetration (CJP) welds. The affected joints on segment 6CW are identified as SP085-002-022~031. The affected joints on segment 7AW are identified as SP437-001-011~020. According to the approved drawings (SP085 and SP437) the joints are designated as fillet weld joints. The welds are located in between Panel Point 47 (PP47) and PP48 on the crossbeam side. The welds are joining I-ribs RS34R to side panel SP085B-002 on segment 6CW and I-ribs RS92D to side panel SP437A-001 on segment 7AW.
