DEPARTMENT OF TRANSPORTATION

Contract #: 04-0120F4Cty: SF/ALA Rte: 80 PM: 13.2/13.9File #: 69.28**WELDING INSPECTION REPORT****Resident Engineer:** Pursell, Gary**Address:** 333 Burma Road**City:** Oakland, CA 94607**Report No:** WIR-012040**Date Inspected:** 12-Jan-2010**Project Name:** SAS Superstructure**OSM Arrival Time:** 700**Prime Contractor:** American Bridge/Fluor Enterprises, a JV**OSM Departure Time:** 1900**Contractor:** Zhenhua Port Machinery Company, Ltd (ZPMC), Changxing Island **Location:** Shanghai, China**CWI Name:** Wang Chuan Qing, Tu Jun**CWI Present:** Yes No**Inspected CWI report:** Yes No N/A**Rod Oven in Use:** Yes No N/A**Electrode to specification:** Yes No N/A**Weld Procedures Followed:** Yes No N/A**Qualified Welders:** Yes No N/A**Verified Joint Fit-up:** Yes No N/A**Approved Drawings:** Yes No N/A**Approved WPS:** Yes No N/A**Delayed / Cancelled:** Yes No N/A**Bridge No:** 34-0006**Component:** Tower**Summary of Items Observed:**

BAY 10 SOUTH TOWER LIFT 2 SKIN A LADDERS

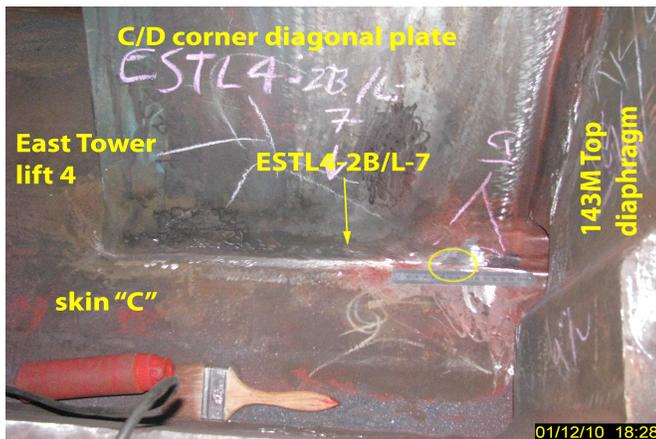
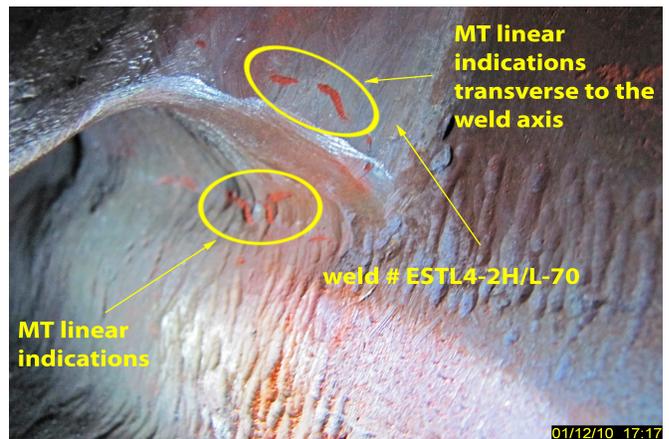
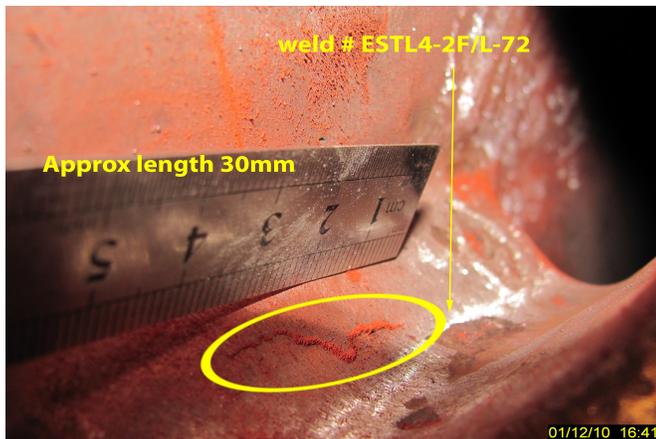
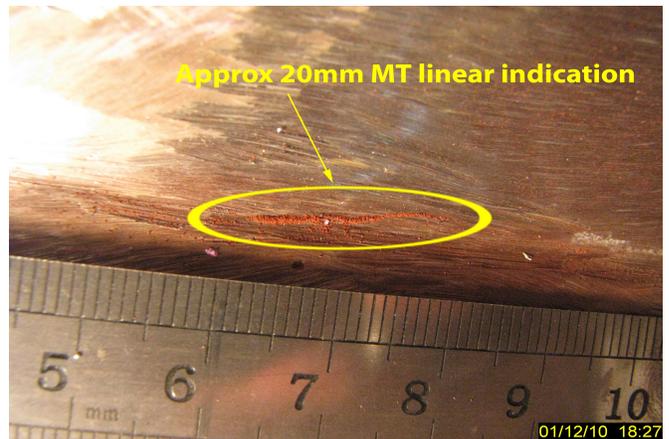
During the Quality Assurance(QA) Magnetic Particle Testing (MT) review of welds located in East Tower lift 4, this Quality Assurance (QA) Inspector discovered Linear indications on the following welds:

-Weld #ESTL4-2B/L-7: One (1) longitudinal linear indication measuring approximately 20mm in length.

- Weld #ESTL4-2F/L-72: One (1) longitudinal linear indication measuring approximately 30mm in length.
 - Weld #ESTL4-2F/L-73: Two (2) transverse linear indications measuring approximately 10mm and 8mm in length.

- Weld #ESTL4-2H/L-1: Three (3) longitudinal linear indications measuring approximately 12mm, 9mm and 6mm in length.
 - Weld #ESTL4-2H/L-70: Two (2) longitudinal linear indications measuring approximately 13mm and 10mm in length and two (2) transverse linear indications measuring approximately 8mm and 5mm in length.

- Weld #ESTL4-2K/L-1: One (1) longitudinal linear indication measuring approximately 13mm in length.
 - Weld #ESTL4-2K/L-2: Two (2) transverse linear indications measuring approximately 8mm and 6mm in length.

- East tower, lift 4 is located in Tower Bay 11.
- The Notice of Witness Inspection Number (NWIT) is 005049. The indications are located inside the area that has been previously tested and accepted by ZPMC Quality Control (QC) personnel. As per the contract documents, ZPMC's QC personnel are required to perform 100% MT inspection of these welds. See attached photos for additional information.
