**DEPARTMENT OF TRANSPORTATION**

Contract #: 04-0120F4Cty: SF/ALA Rte: 80 PM: 13.2/13.9File #: 69.28**WELDING INSPECTION REPORT****Resident Engineer:** Pursell, Gary**Address:** 333 Burma Road**City:** Oakland, CA 94607**Report No:** WIR-012049**Date Inspected:** 17-Jan-2010**Project Name:** SAS Superstructure**OSM Arrival Time:** 700**Prime Contractor:** American Bridge/Fluor Enterprises, a JV**OSM Departure Time:** 1900**Contractor:** Zhenhua Port Machinery Company, Ltd (ZPMC), Changxing Island **Location:** Shanghai, China**CWI Name:** An Qing Xiang, Du Zhi Qun**CWI Present:** Yes No**Inspected CWI report:** Yes No N/A**Rod Oven in Use:** Yes No N/A**Electrode to specification:** Yes No N/A**Weld Procedures Followed:** Yes No N/A**Qualified Welders:** Yes No N/A**Verified Joint Fit-up:** Yes No N/A**Approved Drawings:** Yes No N/A**Approved WPS:** Yes No N/A**Delayed / Cancelled:** Yes No N/A**Bridge No:** 34-0006**Component:** Tower**Summary of Items Observed:**

**BAY 11 EAST TOWER LIFT 4 C/D CORNER SEAM**

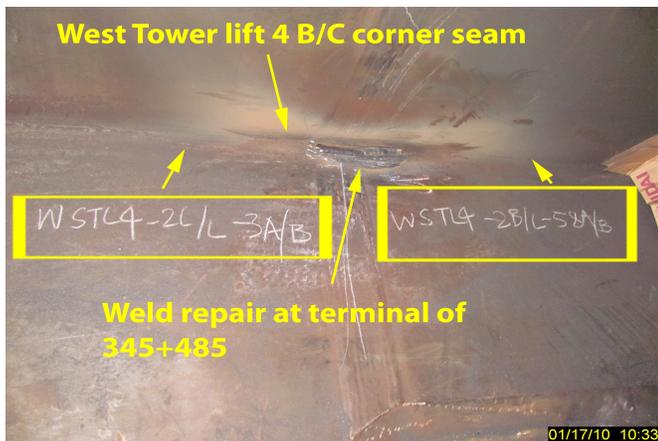
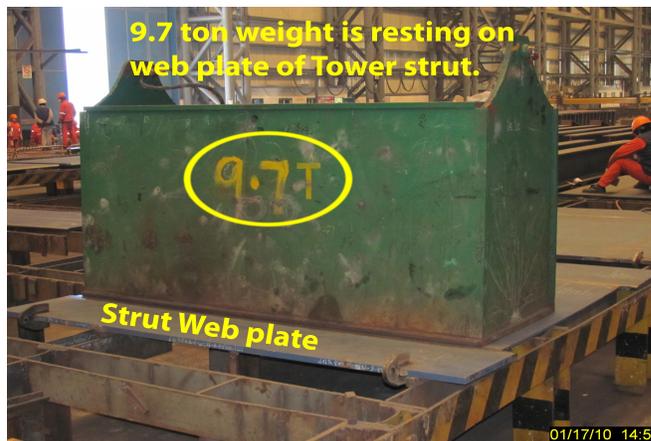
During the random Quality Assurance(QA) in process verification of West Tower lift 4, this QA Inspector observed that ZPMC welding personnel performing weld repair of B/C corner seam of West tower lift 4 using Flux Cored Arc Welding (FCAW) process. The weld numbers are identified as WSTL4-2L/L-3A/B for 485 grade material and WSTL4-2B/L-58A/B for 345 grade material. ZPMC personnel performing the weld repair at the terminal of 345 grade and 485 grade material by using WPS-345-FCAW-1G(1F)-REPAIR with Supercored 71H filler wire. The required filler wire for welding of these joints is K-71TSR with WPS-345+485-FCAW-1G-REPAIR. The weld joint is Complete Joint Penetration (CJP) weld. The material is designated as non Seismic Performance Critical Member (non SPCM). The member is located at Tower bay no. 11.

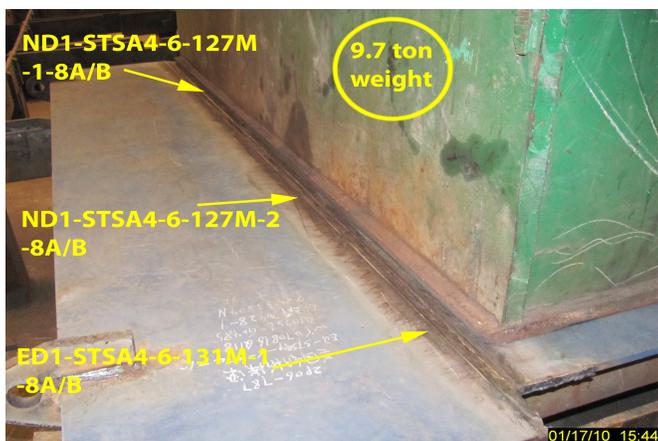
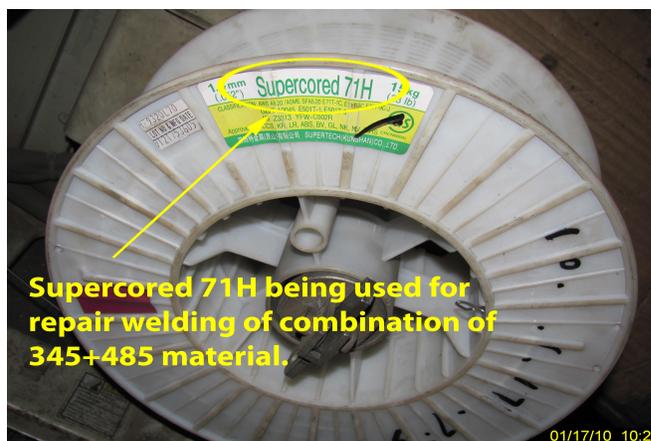
During the random Quality Assurance(QA) in process verification of Tower Strut plate, this QA Inspector observed that ZPMC placed a 9.7 ton weight on a 16mm thick Tower Strut web for the purpose of straightening. ZPMC CWI Yu Dong Ping referenced heat straightening document HSR1 (T)-11020 Rev. 0 as being the controlling document. The referenced document does not indicate any weight and/or mechanical force being used for straightening. 66 degree Celcius "Tempilstick" did not melt when applied to material. The weld numbers are identified as ED1-STSA4-6-131-1-7A/B, 8A/B; ND1-STSA4-6-127M-1-7A/B, 8A/B; ND1-STSA4-6-127M-2-7A/B, 8A/B. The material is designated as Seismic Performance Critical Member (SPCM). The member is located at Tower Bay No. 11.
