DEPARTMENT OF TRANSPORTATION

Contract #: 04-0120F4Cty: SF/ALA Rte: 80 PM: 13.2/13.9File #: 69.28**WELDING INSPECTION REPORT****Resident Engineer:** Pursell, Gary**Address:** 333 Burma Road**City:** Oakland, CA 94607**Report No:** WIR-012056**Date Inspected:** 24-Jan-2010**Project Name:** SAS Superstructure**OSM Arrival Time:** 700**Prime Contractor:** American Bridge/Fluor Enterprises, a JV**OSM Departure Time:** 1900**Contractor:** Zhenhua Port Machinery Company, Ltd (ZPMC), Changxing Island **Location:** Shanghai, China

BAY 10 NORTH TOWER LIFT 2, GRATING BRACKETS (GREEN TAG NO. 11596)

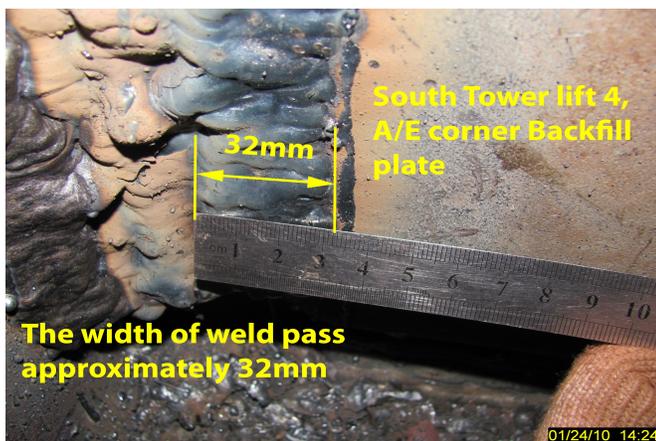
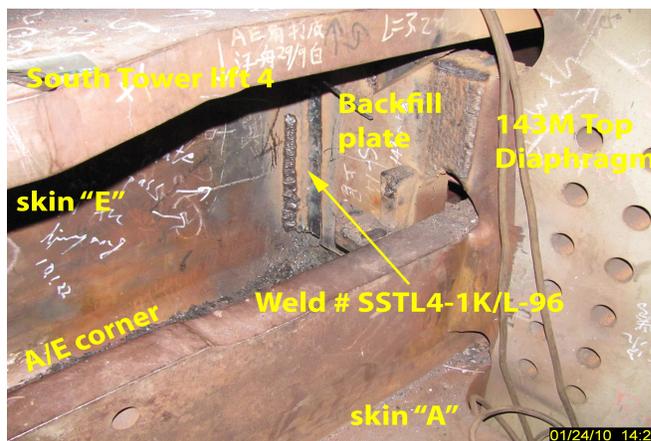
During the Quality Assurance (QA) random in-process Visual inspection of South Tower lift 4, A/E corner Backfill plate at 143M Top diaphragm, this QA inspector observed the width of a weld pass measured to be approximately 30mm and the length of weld pass measured to be approximately 480mm. This Flux Core Arc Weld (FCAW) is a Partial Joint Penetration (PJP) groove weld performed in vertical position. The maximum FCAW weld pass width allowed in vertical position for groove weld is 25mm. The weld is identified as: SSTL4-1K/L-96. The weld joining the Backfill plate and skin E of South Tower lift 4. The material is designated as non Seismic Performance Critical Member (non SPCM). The member is located in Bay 10. This issue has an incident report.

The attached photographs provide additional detail.
