DEPARTMENT OF TRANSPORTATION

Contract #: 04-0120F4Cty: SF/ALA Rte: 80 PM: 13.2/13.9File #: 69.28**WELDING INSPECTION REPORT****Resident Engineer:** Pursell, Gary**Address:** 333 Burma Road**City:** Oakland, CA 94607**Report No:** WIR-012062**Date Inspected:** 01-Feb-2010**Project Name:** SAS Superstructure**OSM Arrival Time:** 700**Prime Contractor:** American Bridge/Fluor Enterprises, a JV**OSM Departure Time:** 1900**Contractor:** Zhenhua Port Machinery Company, Ltd (ZPMC), Changxing Island **Location:** Shanghai, China

BAY 10 SOUTH TOWER LIFT 4, A/E CORNER BACKFILL PLATE

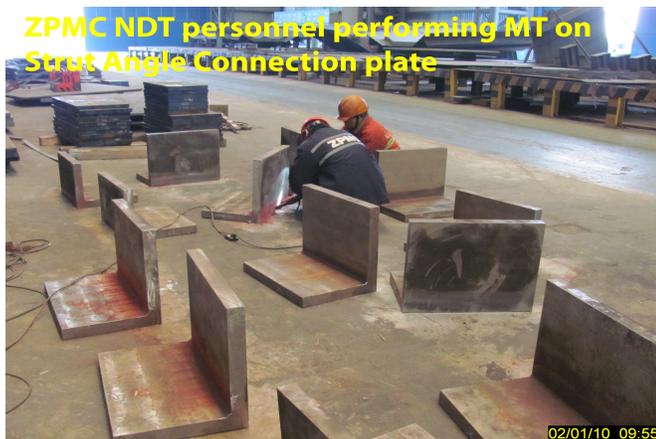
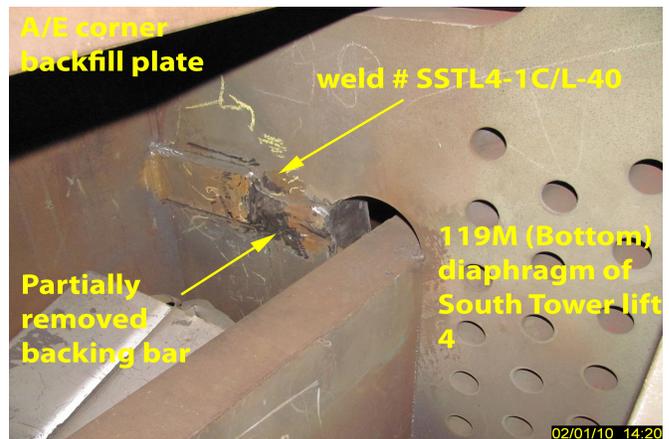
During random in process verification, this QA Inspector witnessed the Magnetic Particle Testing (MT) of Strut angle connection plate performed by ZPMC QC personnel. The members are identified as Tower Components. The weld designations reviewed are as follows. One of the Angle connection plate ZPMC found MT linear indication and after grinding, the excavation was about approximately 10mm in depth. Attached photographs

ND1-A5012-29-1A/B (ZPMC found MT linear indication)

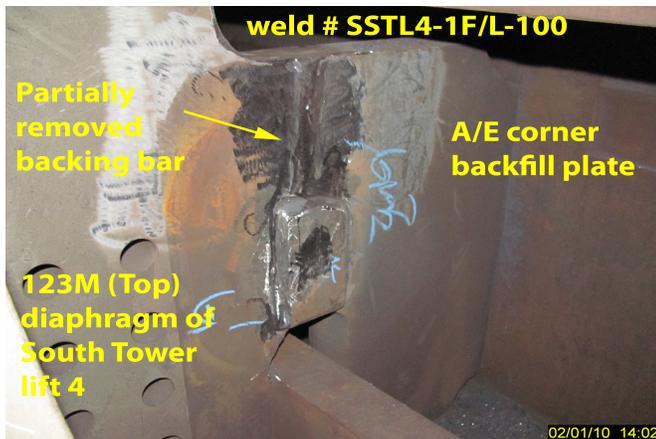
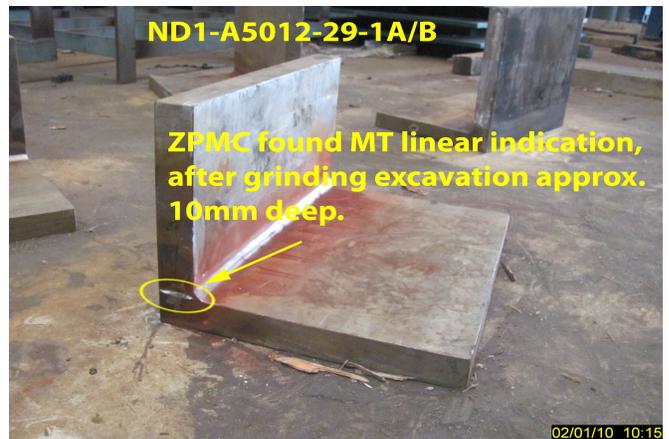
During random verification Ultrasonic Testing (UT) of A/E corner backfill plate of South Tower Lift 4, this Quality Assurance (QA) Inspector observed the backing has been removed on weld joint SSSL4-1J/L-28 at 139M (bottom) diaphragm. Approved weld details indicate that backing bar is to remain on this weld joint. Backing has been partially removed at two weld locations. These welds are identified as SSSL4-1C/L-40 at 119M (bottom) diaphragm and SSSL4-1F/L-100 at 123M (top) diaphragm. These welds join the backfill plates and double diaphragm plates of South Tower lift 4. The members are located in Tower Bay 10. This issue has an incident report.
