**DEPARTMENT OF TRANSPORTATION**

Contract #: 04-0120F4Cty: SF/ALA Rte: 80 PM: 13.2/13.9File #: 69.28**WELDING INSPECTION REPORT****Resident Engineer:** Pursell, Gary**Address:** 333 Burma Road**City:** Oakland, CA 94607**Report No:** WIR-012068**Date Inspected:** 19-Jan-2010**Project Name:** SAS Superstructure**OSM Arrival Time:** 700**Prime Contractor:** American Bridge/Fluor Enterprises, a JV**OSM Departure Time:** 1900**Contractor:** Zhenhua Port Machinery Company, Ltd (ZPMC), Changxing Island **Location:** Shanghai**CWI Name:** ZPMC and ABF**CWI Present:** Yes No**Inspected CWI report:** Yes No N/A**Rod Oven in Use:** Yes No N/A**Electrode to specification:** Yes No N/A**Weld Procedures Followed:** Yes No N/A**Qualified Welders:** Yes No N/A**Verified Joint Fit-up:** Yes No N/A**Approved Drawings:** Yes No N/A**Approved WPS:** Yes No N/A**Delayed / Cancelled:** Yes No N/A**Bridge No:** 34-0006**Component:** Tower**Summary of Items Observed:**

# WELDING INSPECTION REPORT

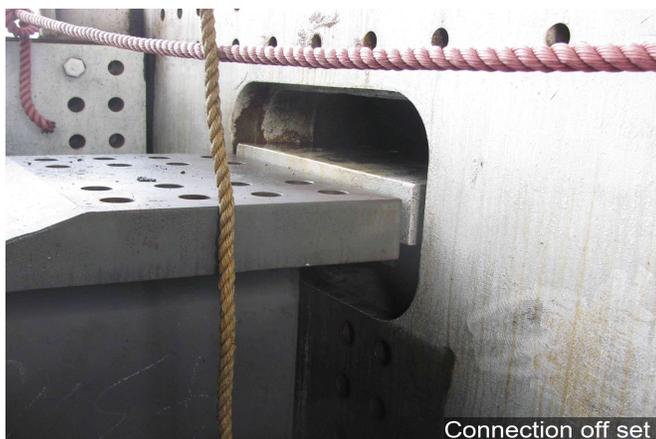
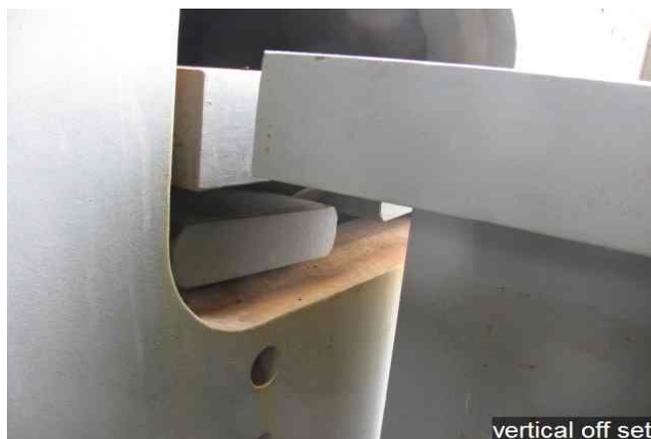
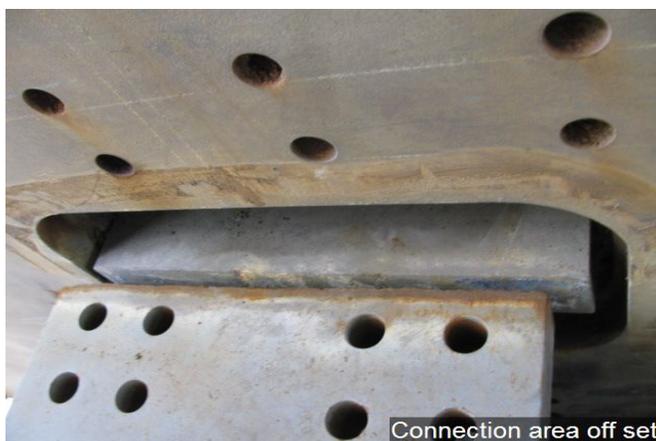
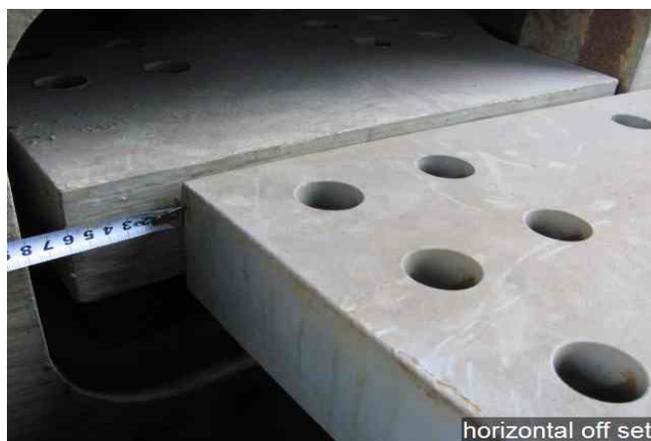
Strut connection U shape plate: - Caltrans QA Inspector observed seven ZPMC welders performed SMAW process on CJP weld of strut connection U shape plates. The material of strut connection U shape plate is ASTM 485 with 40mm wall thickness. The CJP weld and plate ID are ED1-SA4-8-135M-1-1B, ED1-SA4-68-135M-2-1B, ED1-SA4-68-135M-3-1B, ED1-SA-68-131M-8-1B, ND1-SA4-68-131M-1-1B, ND1-SA4-68-131M-2-1B, ED1-SA4-68-123M-1-1B, ED1-SA4-68-123M-2-1B, ED1-SA4-68-123M-3-1B, ND1-SA4-68-131M-5-1B, ND1-SA4-68-131M-4-1B and ND1-SA4-68-131M-3-1B. The SMAW process was monitored and recorded by ZPMC and ABF QC inspector. Based on Caltrans QA inspector observations, no discrepancies were noted.

Strut connection flat plate: - Caltrans QA Inspector observed a ZPMC welding operator performed SAW process on CJP weld of tower strut connection flat plate for tower elevation 135m, 149m and 143m. The material of strut connection flat plate is ASTM 345 with 25mm wall thickness. The CJP weld and plate ID are ND1-STSA4-6-153M-1-7B, ED1-STSA4-6-135M-2-7B, ED1-STSA4-6-135M-1-7B, ED1-STSA4-6-143M-1-7B, ND1-STSA4-6-139M-2-7B and ND1-STSA4-6-139M-1-7B. The SAW welding was monitored and recorded by ZPMC and ABF QC inspector. Based on Caltrans QA inspector observations, no discrepancies were noted.

West tower lift #4:- Caltrans QA Inspector observed two welders performed FCAW repair process on the interior corner longitudinal seam welds that connected skin plate C to D. All the repair weld areas have been pre heat prior welding. The repair welding located at elevation 119m and 123m. The FCAW repair processes were monitored and recorded by ZPMC and ABF QC inspector. Based on Caltrans QA inspector observations, no discrepancies were noted.

West tower lift#4:- Caltrans QA Inspector observed seven welders performed FCAW process on CJP weld for corner diagonal stiffener that connected skin plate C to D of east tower lift #4. The welding located at elevation 114m to 146.28m. The FCAW was monitored and recorded by ZPMC and ABF QC inspector. Based on Caltrans QAI observations, no discrepancies were noted.

Tower lift #1:- Caltrans QA Inspector with ASMR Mr. Michael Ng performed in process alignment inspection on the connection areas of the tower strut plates to tower skin plates which installed on north, south, east and west tower lift #1 with various elevations. Caltrans QA found every alignment of tower strut plates to skin plates have been either horizontal or vertical off set more than 10mm as requirement. However, ABF office informed that survey of north, south, east and west tower lift #1 have not been accepted by ABF. Caltrans QA Inspector will continuous monitor and record the alignment of tower strut plates in the further.
