DEPARTMENT OF TRANSPORTATION

Contract #: 04-0120F4Cty: SF/ALA Rte: 80 PM: 13.2/13.9File #: 69.28**WELDING INSPECTION REPORT****Resident Engineer:** Pursell, Gary**Address:** 333 Burma Road**City:** Oakland, CA 94607**Report No:** WIR-012075**Date Inspected:** 09-Feb-2010**Project Name:** SAS Superstructure**OSM Arrival Time:** 700**Prime Contractor:** American Bridge/Fluor Enterprises, a JV**OSM Departure Time:** 1900**Contractor:** Zhenhua Port Machinery Company, Ltd (ZPMC), Changxing Island **Location:** Shanghai, China

BAY 10 SOUTH TOWER LIFT 4 A/E CORNER BACKFILL PLATE AT 127M AND 131M DIAPHRAGM

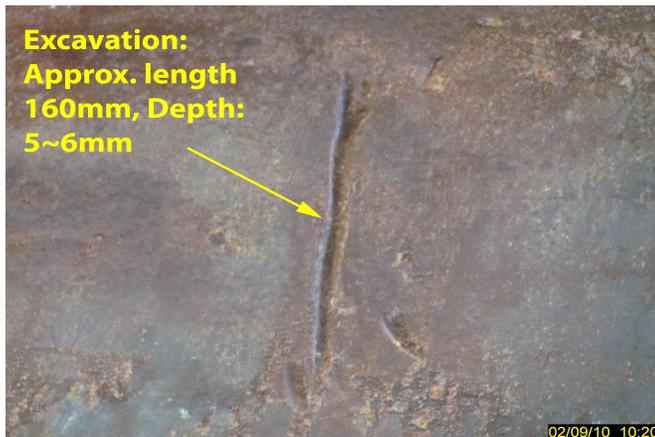
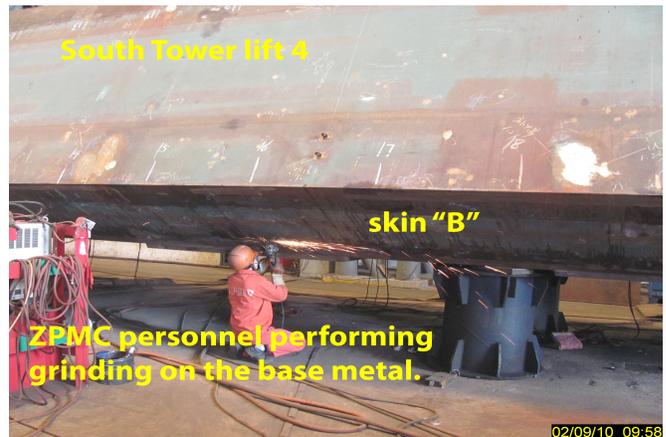
SOUTH TOWER LIFT 4

During random Visual Inspection this QA inspector observed ZPMC personnel performing grinding on base metal of skin B of South Tower lift 4 at 135M diaphragm. The components are identified as Tower components. Attached photographs provide additional detail.

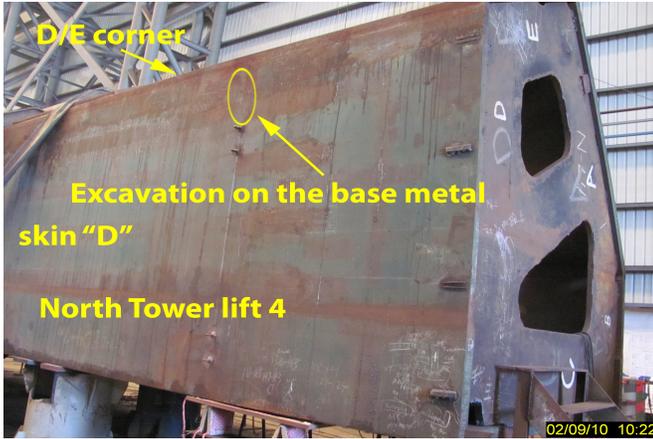
NORTH TOWER LIFT 4

During random Visual Inspection this QA inspector observed the excavation on the base metal of skin D of North Tower lift 4 near D/E corner at 116m elevation. The length is approximately 160mm and depth approximately 5~6mm. The components are identified as Tower components. Attached photographs provide additional detail.
