DEPARTMENT OF TRANSPORTATION

Quality Assurance and Source Inspection

Contract #: 04-0120F4Cty: SF/ALA Rte: 80 PM: 13.2/13.9File #: 69.28**WELDING INSPECTION REPORT****Resident Engineer:** Pursell, Gary**Address:** 333 Burma Road**City:** Oakland, CA 94607**Report No:** WIR-012135**Date Inspected:** 11-Feb-2010**Project Name:** SAS Superstructure**OSM Arrival Time:** 1900**Prime Contractor:** American Bridge/Fluor Enterprises, a JV**OSM Departure Time:** 700**Contractor:** Zhenhua Port Machinery Company, Ltd (ZPMC), Changxing Island **Location:** Shanghai, China**CWI Name:** See Below**CWI Present:** Yes No**Inspected CWI report:** Yes No N/A**Rod Oven in Use:** Yes No N/A**Electrode to specification:** Yes No N/A**Weld Procedures Followed:** Yes No N/A**Qualified Welders:** Yes No N/A**Verified Joint Fit-up:** Yes No N/A**Approved Drawings:** Yes No N/A**Approved WPS:** Yes No N/A**Delayed / Cancelled:** Yes No N/A**Bridge No:** 34-0006**Component:** OBG & Tower**Summary of Items Observed:**

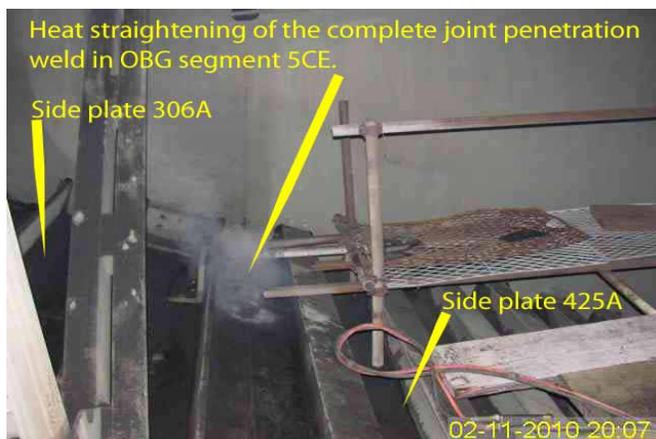
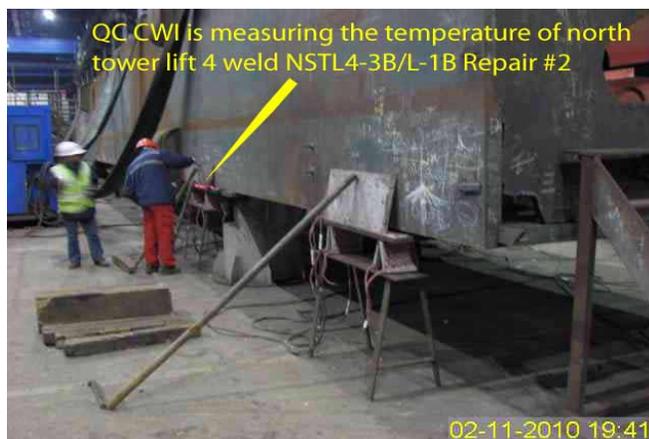
perform heat straightening of the complete joint penetration weld in OBG segment 5CE, between side plate 425A and side plate 306A. This QA Inspector observed the two workers do not appear to have any equipment to measure the base material temperature and that no ZPMC QC Inspection personnel appeared to be in the vicinity where this work is taking place. This QA Inspector asked the ZPMC workers if this work is being monitored by any QC Inspector and one of the workers used his cell phone to call ZPMC QC Inspector Mr. Wang Xu, who is not a Certified Welding Inspector. Mr. Wang Xu, who speaks a limited amount of the English language, informed this QA Inspector that he is located in his office and he is working on his daily report. This QA Inspector asked Mr. Wang Xu to come to where this heat straightening is taking place and approximately 15 minutes later Mr. Wang Xu arrived. Mr. Wang Xu showed this QA Inspector that this work is being performed in accordance with heat straightening document HSR-B-353. This QA Inspector informed Mr. Wang Xu that the workers that were performing the heat straightening do not appear to have any equipment to monitor the temperature of the steel. Mr. Wang Xu informed this QA Inspector that the workers are done working, and no more heat straightening will be taking place this shift.

This QA Inspector observed ZPMC welder Mr. Shi Xingyu, stencil 052930 has recently completed using shielded metal arc process procedure WPS-345-SMAW-2G(2F)-Repair to perform north tower lift 4 weld NSTL4-3B/L-1B Repair #2. The repair weld was required due to ultrasonic rejections at location Y=26520 and the first weld repair apparently had not resolved the original ultrasonic rejection. This QA Inspector observed the area that was recently welded has an electric heating element which is maintaining the base material temperature and ZPMC CWI Mr. Liu Zhong An is monitoring the post welding base material temperature. See the photograph below for additional information. Items observed on this date appeared to generally comply with applicable contract documents.
