DEPARTMENT OF TRANSPORTATION

Contract #: 04-0120F4Cty: SF/ALA Rte: 80 PM: 13.2/13.9File #: 69.28**WELDING INSPECTION REPORT****Resident Engineer:** Pursell, Gary**Address:** 333 Burma Road**City:** Oakland, CA 94607**Report No:** WIR-012139**Date Inspected:** 17-Feb-2010**Project Name:** SAS Superstructure**OSM Arrival Time:** 1900**Prime Contractor:** American Bridge/Fluor Enterprises, a JV**OSM Departure Time:** 700**Contractor:** Zhenhua Port Machinery Company, Ltd (ZPMC), Changxing Island **Location:** Shanghai, China**CWI Name:** See Below**CWI Present:** Yes No**Inspected CWI report:** Yes No N/A**Rod Oven in Use:** Yes No N/A**Electrode to specification:** Yes No N/A**Weld Procedures Followed:** Yes No N/A**Qualified Welders:** Yes No N/A**Verified Joint Fit-up:** Yes No N/A**Approved Drawings:** Yes No N/A**Approved WPS:** Yes No N/A**Delayed / Cancelled:** Yes No N/A**Bridge No:** 34-0006**Component:** OBG and Tower**Summary of Items Observed:**

WELDING INSPECTION REPORT

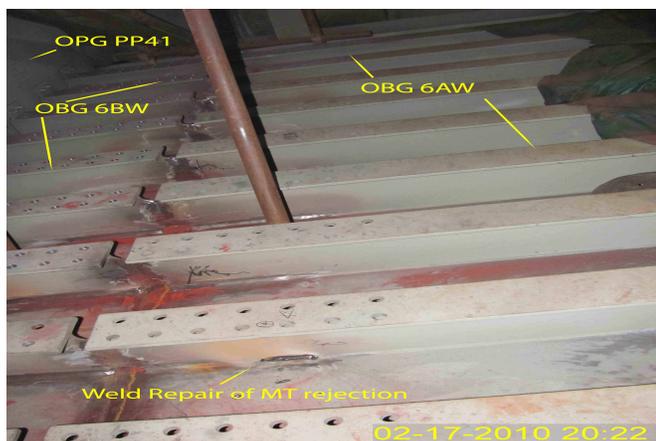
This QA Inspector observed ZPMC welder Mr. Hu Yanming, stencil 62092 is using shielded metal arc procedure WPS-345-SMAW-1G(1F)-FCM-Repair-1 to make a repair weld on a “T” stiffener to side plate on a “hold back” weld where a magnetic particle rejection had been removed. This weld is located on the 8th rib from the top corner assembly on the bikepath side of OBG segment 6AW between panel point 40 and 41. ZPMC CWI Mr. Li Yang informed this QA Inspector that he did not have the weld repair document were the weld was being made and he also did not know the weld number. This QA Inspector observed the welding electrodes are being stored in a portable rod oven that is connected to an electric power cable. This QA Inspector observed the base material was preheated with a torch and that ZPMC CWI Mr. Li Yang verified the base material had been preheated prior to commencement of welding. This QA Inspector measured a welding current of approximately 160 amps and Mr. Bu Ciqiang appears to be certified to make this weld. Items observed on this date appeared to generally comply with applicable contract documents. See the photograph, below, for additional information.

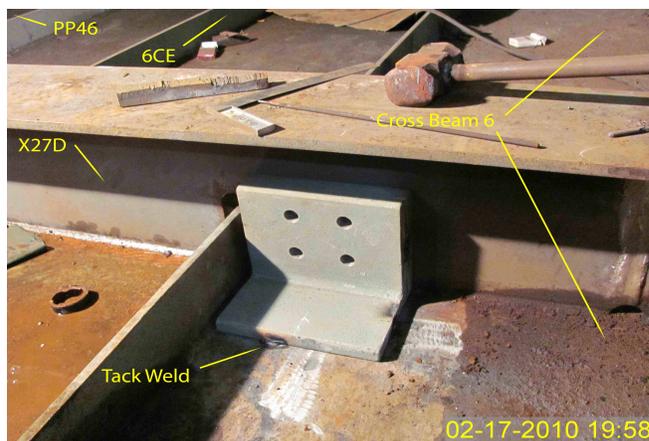
This QA Inspector observed ZPMC welder Mr. Zhang Zhengjia, stencil 205769 is using shielded metal arc procedure WPS-B-P-2112-FCM-1 to tack weld an angle bracket to cross beam CB6 bottom plate adjacent to item X27D. This QA Inspector asked Mr. Zhang Zhengjia if he had a ZPMC issued welder identification card and Mr. Zhang Zhengjia indicated that he had left his welder identification card at home. This QA Inspector informed ZPMC CWI Mr. Li Yang that Mr. Zhang Zhengjia did not have a welder identification card and Mr. Li Yang informed this QA Inspector that Mr. Zhang Zhengjia will bring his welder identification card to work tomorrow. ZPMC CWI Mr. Li Yang informed this QA Inspector that he did not know the weld number and since this was a tack weld he is not documenting this welding on his daily report. This QA Inspector observed the welding electrodes are being stored in a portable rod oven that is connected to an electric power cable and the base material was preheated with a torch prior to welding. Items observed on this date appeared to generally comply with applicable contract documents. See the photograph, below, for additional information.

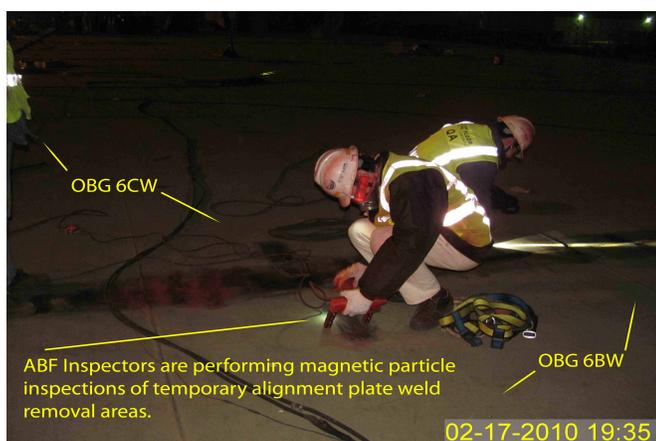
This QA Inspector observed ABF personnel performing magnetic particle inspections of OBG segments 6AW and 6BW where temporary alignment plate welds had been removed. Items observed on this date appeared to generally comply with applicable contract documents. This QA Inspector observed ABF has located and marked a linear indication on the bikepath side corner assembly vertical weld #3 located at Y=803. See the photograph, below, for additional information.
