DEPARTMENT OF TRANSPORTATION

Contract #: 04-0120F4Cty: SF/ALA Rte: 80 PM: 13.2/13.9File #: 19.28**WELDING INSPECTION REPORT****Resident Engineer:** Pursell, Gary**Address:** 333 Burma Road**City:** Oakland, CA 94607**Report No:** WIR-012141**Date Inspected:** 17-Feb-2010**Project Name:** SAS Superstructure**OSM Arrival Time:** 1500**Prime Contractor:** American Bridge/Fluor Enterprises, a JV**OSM Departure Time:** 2330**Contractor:** American Bridge/Fluor Enterprises, a JV**Location:** Job Site

Bridge No: 34-0006**Summary of Items Observed:**

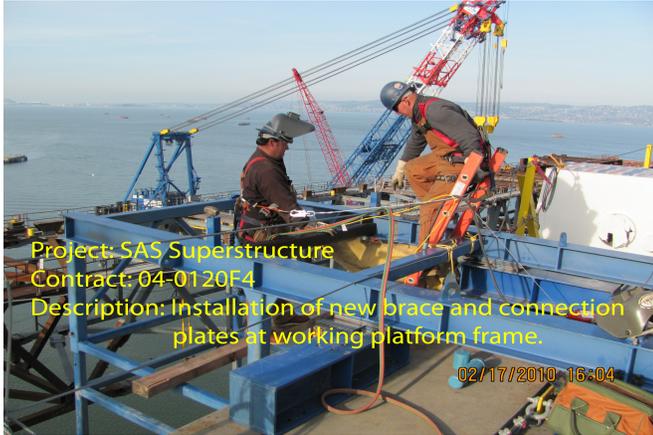
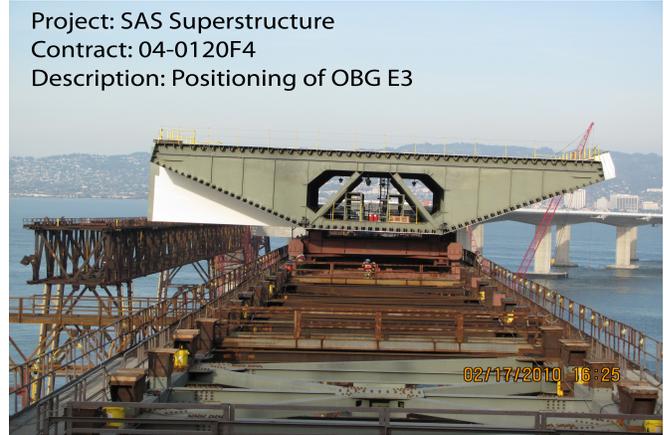
The QAI observed and confirmed the installation of the temporary bolts as per the American Bridge/Fluor reference drawing identified as DE234AB Rev. 1. The bolting installation process appeared to be complete at the U-Ribs and six (6) stiffener plates located at the deck plate and side plates and appeared to comply with the contract documents. The QAI also observed the root openings at the deck and bottom plate field splices to measure at approximately 16 mm. The final assembly fit-up of the splices appeared not to be completed at this time.

Later in the shift the QAI also observed the positioning of the OBG identified as E3 to the OBG identified as E2, which has been installed and appeared to be positioned in its proper location.

The QAI also observed AB/F personnel relocating the tube steel bracing and connection plates at the working platform frame located on the exterior face of the north and south sides of the OBG E1 to E2 field splice. It appeared this working platform frame will be utilized during the assembly fit-up and the Complete Joint Penetration (CJP) groove welding of the edge and side plate field splice connections.

See the digital photographs, below, in regards to the work performed and observed on this date.
