Contract #: 04-0120F4Cty: SF/ALA Rte: 80 PM: 13.2/13.9File #: 1.28**WELDING INSPECTION REPORT****Resident Engineer:** Pursell, Gary**Address:** 333 Burma Road**City:** Oakland, CA 94607**Report No:** WIR-012142**Date Inspected:** 17-Feb-2010**Project Name:** SAS Superstructure**OSM Arrival Time:** 700**Prime Contractor:** American Bridge/Fluor Enterprises, a JV**OSM Departure Time:** 1530**Contractor:** American Bridge/Fluor Enterprises, a JV**Location:** Job Site

# WELDING INSPECTION REPORT

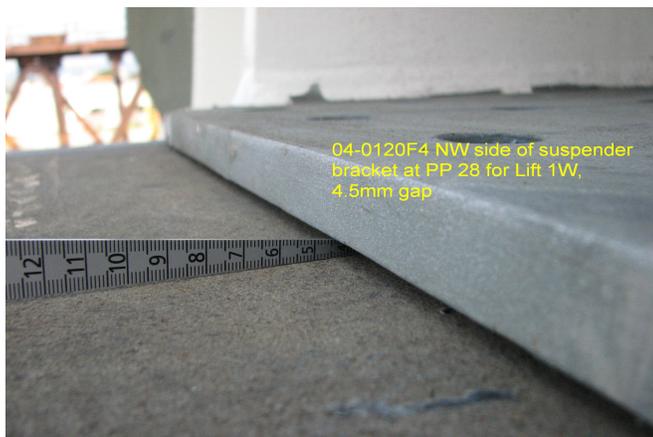
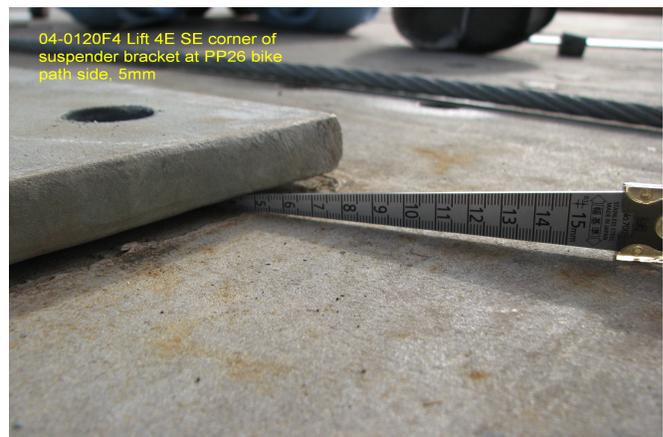
The QA inspector periodically observed ABF personnel placing the suspender brackets at Panel Point (PP) 26 and 28 on the South side (Bike Path side) of the OBG. The QA inspector reviewed the gap between the faying surfaces of the deck plate and the suspender brackets. At the time of review for the bracket at PP26 only a few bolts were in place and the contractor was in the process of placing the shim plates between the side plate and the brackets. At the time of review the gap between the surfaces were measured to be up to 5mm and 4.5mm for the bracket at PP28. See digital photo included in the body of this report for clarification. These items were relayed to QCM Jim Bowers and QA Lead inspector Bill Levell via phone. Later in the shift the QA inspector reviewed the in process work again after the installation of the shim plates and additional bolts and the suspender bracket at PP26 appeared to be within intimate contact; however the suspender bracket at PP28 still appeared to have a gap of 2mm in a localized area. This information was also relayed to Mr. Bowers and Mr. Levell via phone. As a general item it was noted lift 3E was re-located to the field in order to lift it and push it into place.

The QA inspector noted and periodically observed ABF personnel placing the suspender bracket at PP 12 for the North side (counter weight side) of the OBG and the installation of the suspender bracket at PP10 was pending. It was noted these areas have not been closely reviewed as part of the arrival inspection as access to these locations required a man lift which was unavailable due to craft personnel utilizing it. These areas were reviewed generally from the edge of the deck plate and the ground with no major issues observed. This information was relayed to QCM Jim Bowers who relayed he would take it under advisement.

The contractor is in the process of flame cutting the access holes in the deck plate between PP 10 and 12 on the North and South side of the OBG. The flame cut edges appeared to be of a uniform kerf and free from significant notches in the stiffeners inside the OBG and no notches were noted in the deck plate. QC personnel Tom Pascalone, Steve McConnell, James Cunningham and Bonafacio Daquinag were noted to be present monitoring the work. In addition to this the QC personnel were measuring and recording dimensions along the deck plate transverse field splice in regards to bevel angle, closed (U-rib) rib location and the weld toe in relation to the edge of the bevel prep in order to assist in the ultrasonic testing interpretation of the completed joint later in the field. The QA inspector reviewed a portion of these dimensions and verified QC was utilizing a low stress stamp for the identification of the set back utilizing a 70 degree angle. The work progressed throughout a majority of the shift and the items appeared to be progressing in conformance with the contract documents.

The QA inspector noted and periodically observed ABF personnel performing the grinding/buffing of the bevel edge preparation for the transverse field splice location for this lift. The QA inspector noted ABF personnel are in the process of periodically placing the components for scaffolding, welding, lighting, walkways, temporary bolts and other miscellaneous items in preparation of mobilizing lift 4 West to the erection site.
