DEPARTMENT OF TRANSPORTATION

Office of Structural Materials

Contract #: 04-0120F4Cty: SF/ALA Rte: 80 PM: 13.2/13.9File #: 69.28**WELDING INSPECTION REPORT****Resident Engineer:** Pursell, Gary**Address:** 333 Burma Road**City:** Oakland, CA 94607**Report No:** WIR-012144**Date Inspected:** 19-Feb-2010**Project Name:** SAS Superstructure**OSM Arrival Time:** 700**Prime Contractor:** American Bridge/Fluor Enterprises, a JV**OSM Departure Time:** 1900**Contractor:** Zhenhua Port Machinery Company, Ltd (ZPMC), Changxing Island **Location:** Shanghai, China**CWI Name:** Li Yang**CWI Present:** Yes No**Inspected CWI report:** Yes No N/A**Rod Oven in Use:** Yes No N/A**Electrode to specification:** Yes No N/A**Weld Procedures Followed:** Yes No N/A**Qualified Welders:** Yes No N/A**Verified Joint Fit-up:** Yes No N/A**Approved Drawings:** Yes No N/A**Approved WPS:** Yes No N/A**Delayed / Cancelled:** Yes No N/A**Bridge No:** 34-0006**Component:** OBG**Summary of Items Observed:**

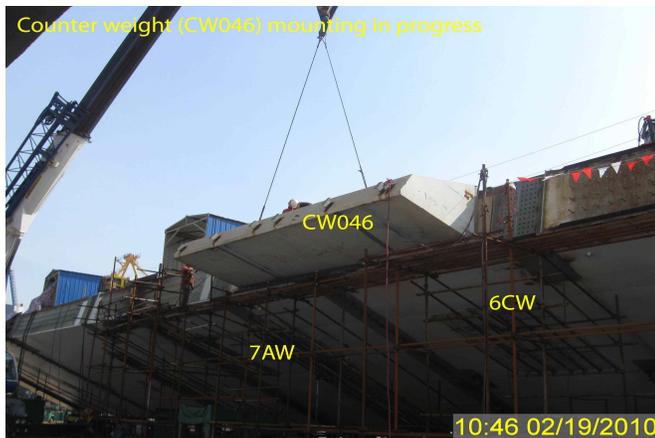
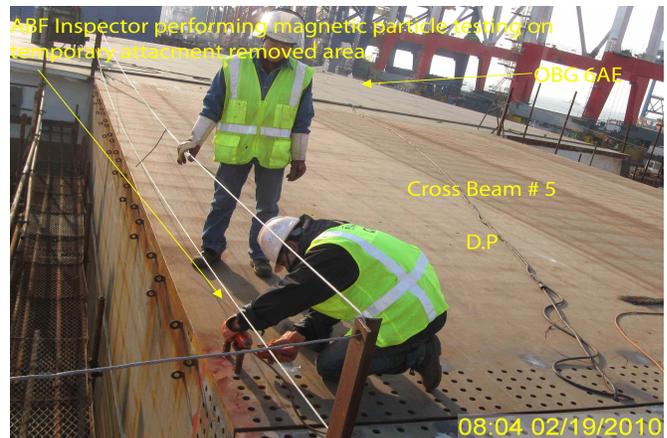
OBG SEGMENT 7BW-7AW

This Quality Assurance (QA) Inspector observed mounting of counter weight CW-46 is in progress. See attached photo.
