DEPARTMENT OF TRANSPORTATION

Contract #: 04-0120F4Cty: SF/ALA Rte: 80 PM: 13.2/13.9File #: 69.28**WELDING INSPECTION REPORT****Resident Engineer:** Pursell, Gary**Address:** 333 Burma Road**City:** Oakland, CA 94607**Report No:** WIR-012148**Date Inspected:** 14-Feb-2010**Project Name:** SAS Superstructure**OSM Arrival Time:** 700**Prime Contractor:** American Bridge/Fluor Enterprises, a JV**OSM Departure Time:** 1500**Contractor:** Zhenhua Port Machinery Company, Ltd (ZPMC), Changxing Island **Location:** Shanghai, China

SEG 9BW:

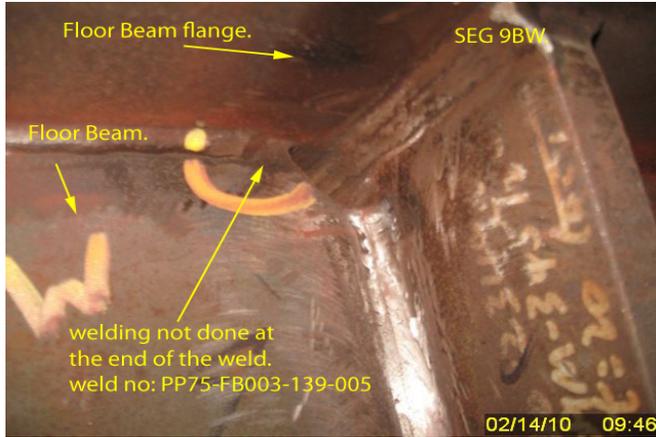
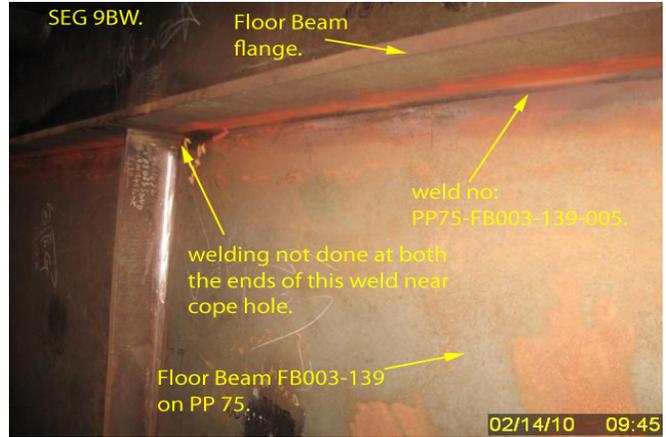
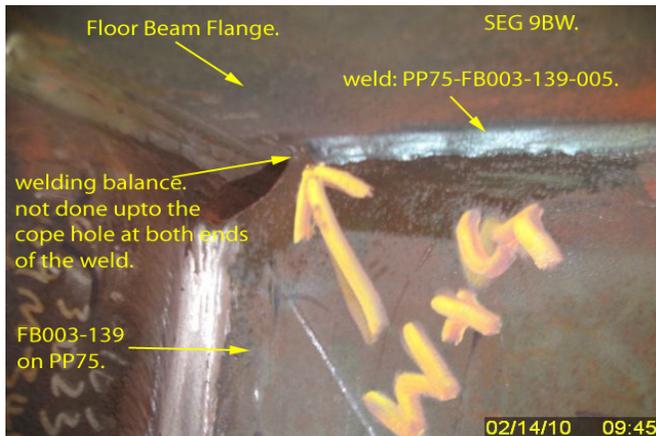
1) PP75-FB003-139 – 005.

- Visually, this weld do not appeared to comply with the contract documents as the welding was not done completely at both the ends of the joint (i.e. at cope holes).

- The ends of this weld need to be welded and this location is clearly marked and identified on the weld.
