Contract #: 04-0120F4Cty: SF/ALA Rte: 80 PM: 13.2/13.9File #: 69.28**WELDING INSPECTION REPORT****Resident Engineer:** Pursell, Gary**Address:** 333 Burma Road**City:** Oakland, CA 94607**Report No:** WIR-012149**Date Inspected:** 12-Feb-2010**Project Name:** SAS Superstructure**OSM Arrival Time:** 700**Prime Contractor:** American Bridge/Fluor Enterprises, a JV**OSM Departure Time:** 1900**Contractor:** Zhenhua Port Machinery Company, Ltd (ZPMC), Changxing Island **Location:** Shanghai, China

SEG 10BE:

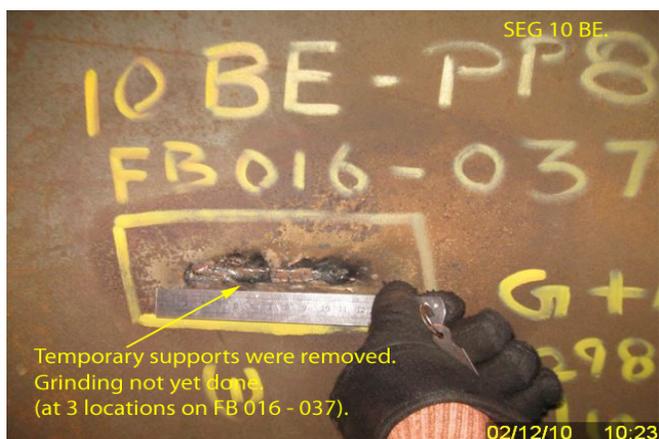
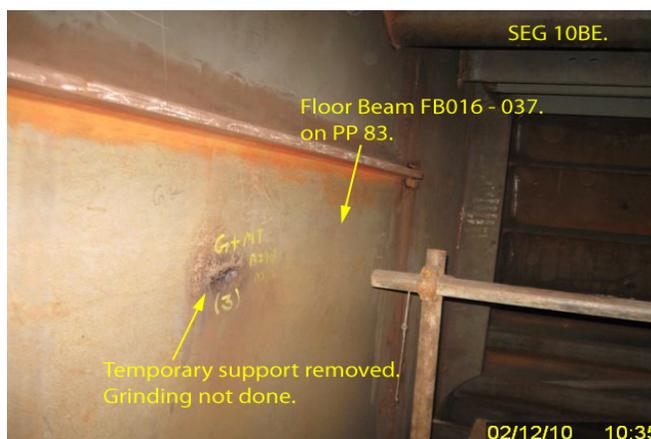
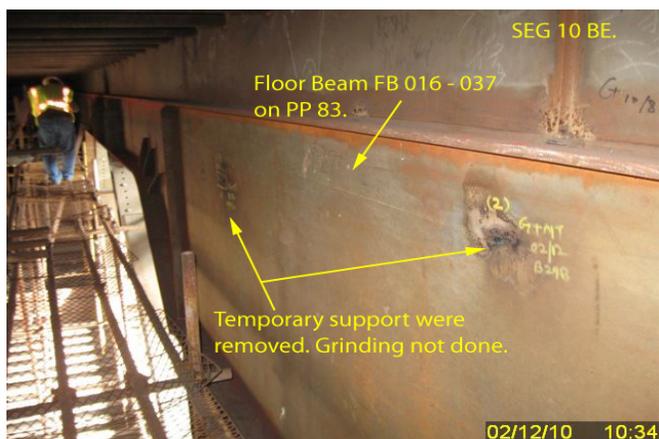
1) PP83-FB016-037 – 003 & 004.

- Visually, these welds appeared to comply with the contract documents.

- However, this QA inspector observed that the temporary welds after removal of the temporary supports on Floor Beam - FB016-037, were not ground completely. Three such locations were identified and clearly marked on this

Floor Beam which needs grinding followed by MT. Inspection of this segment by ZPMC is still in progress and is not yet released for Caltrans inspection.
