**DEPARTMENT OF TRANSPORTATION**

Contract #: 04-0120F4Cty: SF/ALA Rte: 80 PM: 13.2/13.9File #: 1.28**WELDING INSPECTION REPORT****Resident Engineer:** Pursell, Gary**Address:** 333 Burma Road**City:** Oakland, CA 94607**Report No:** WIR-012171**Date Inspected:** 19-Feb-2010**Project Name:** SAS Superstructure**OSM Arrival Time:** 700**Prime Contractor:** American Bridge/Fluor Enterprises, a JV**OSM Departure Time:** 1530**Contractor:** American Bridge/Fluor Enterprises, a JV**Location:** Job Site

LIFT 2 West

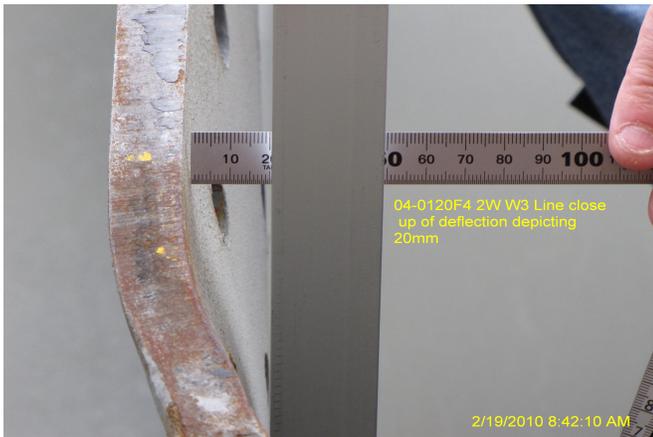
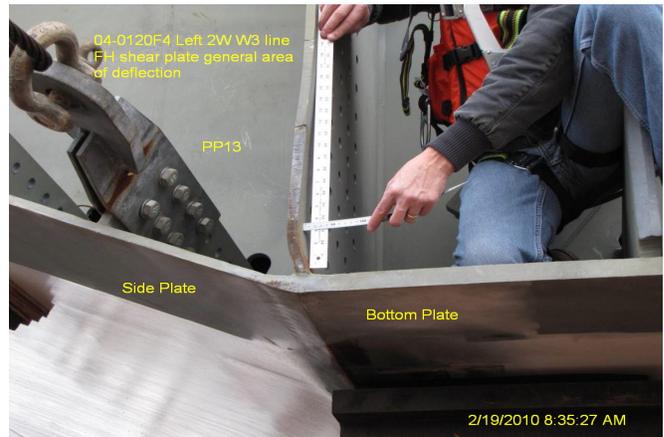
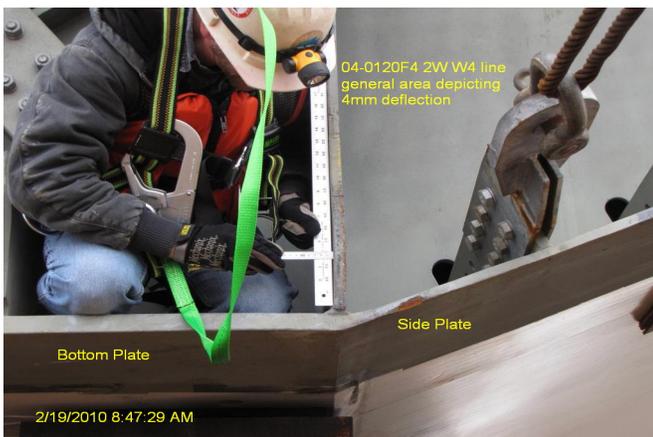
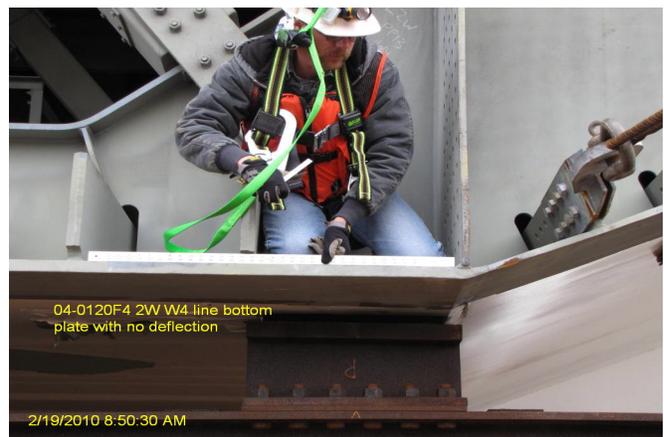
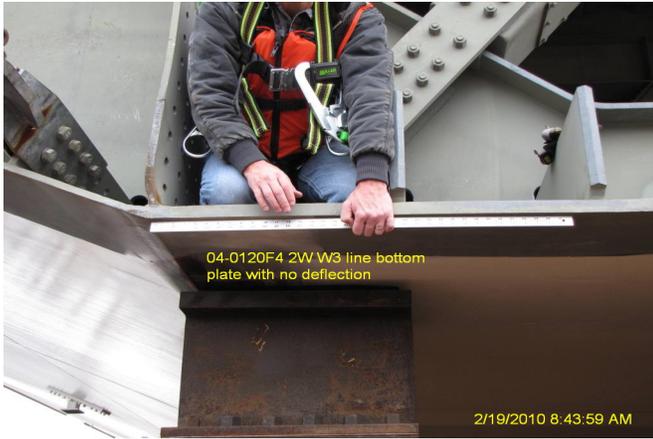
No apparent issues observed; however, apparent transportation damage was noted on the full height shear plates located along the W3 and W4 lines adjacent to PP13 where the shear plates meet with the bottom plate. See digital photos included in the body of this report for clarification. The shear plates appeared to have received a lateral force deflecting the plates in the outward direction. The bottom and side plates were reviewed with a straight edge for any vertical upset which could have caused the deflection and no evidence was discovered. The horizontal deflection of the shear plate at the W3 Line was measured to be 20mm affecting an area over 500mm in the vertical direction and approximately 115mm towards PP13. The horizontal deflection of the shear plate at the W4 Line was measured to be 4mm affecting an area approximately 300mm in the vertical direction and less than 150mm towards PP13. QCM Jim Bowers relayed to QA ABF was already aware of these items and had the QC department document this previously.

LIFT 1 West - two crews of ABF personnel are in the process of temporarily placing the splice plates for the closed ribs along the top deck plate. This work continued periodically throughout the shift.

LIFT 4 West – ABF personnel are in the process of grinding and buffing the bevel edges in preparation of performing the fit up and welding of the transverse weld seam in the field. The QA inspector noted and periodically observed ABF personnel performing the grinding/buffing of the bevel edge preparation for the transverse field splice location for this lift and performing the cutting of the access holes in the deck plate. The QA inspector noted ABF personnel are in the process of periodically placing the components for scaffolding, welding, lighting, walkways, temporary bolts and other miscellaneous items in preparation of mobilizing lift 4 West to the erection site.
