DEPARTMENT OF TRANSPORTATION

Contract #: 04-0120F4Cty: SF/ALA Rte: 80 PM: 13.2/13.9File #: 69.28**WELDING INSPECTION REPORT****Resident Engineer:** Pursell, Gary**Address:** 333 Burma Road**City:** Oakland, CA 94607**Report No:** WIR-012189**Date Inspected:** 25-Jan-2010**Project Name:** SAS Superstructure**OSM Arrival Time:** 645**Prime Contractor:** American Bridge/Fluor Enterprises, a JV**OSM Departure Time:** 1845**Contractor:** Zhenhua Port Machinery Company, Ltd (ZPMC), Changxing Island **Location:** Shanghai, China

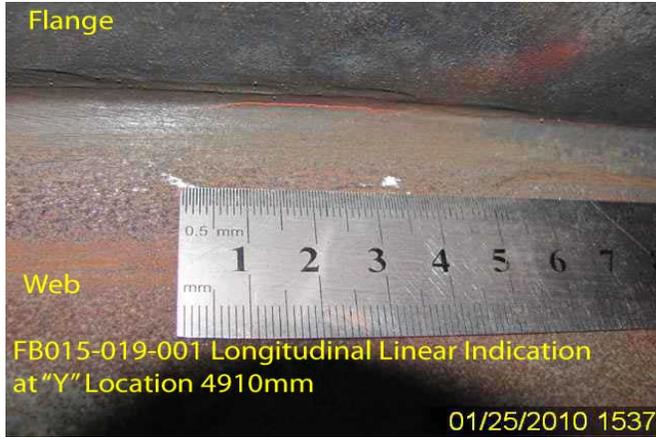
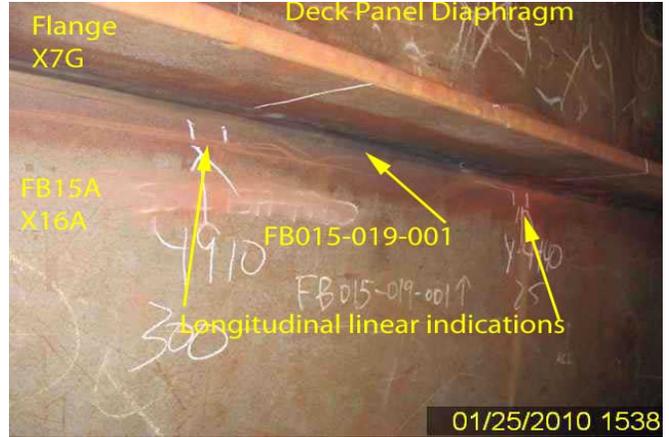
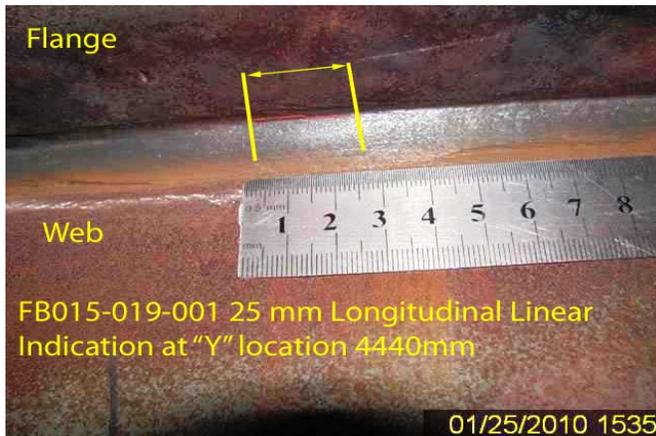
During Visual Inspection 2 (two) Longitudinal Linear Indications (LLI) were found on OBG Segment 7EW Floor Beam FB15A web to flange weld, FB015-019-001 at "Y" Location 4440mm (LLI-25mm) and 4910 (LLI-30mm). These indications were confirmed with MT by Caltrans QA. An incident report was issue for the above mentioned indications. For further detail see the attached photos below.
