Contract #: 04-0120F4Cty: SF/ALA Rte: 80 PM: 13.2/13.9File #: 69.28**WELDING INSPECTION REPORT****Resident Engineer:** Pursell, Gary**Address:** 333 Burma Road**City:** Oakland, CA 94607**Report No:** WIR-012223**Date Inspected:** 15-Feb-2010**Project Name:** SAS Superstructure**OSM Arrival Time:** 645**Prime Contractor:** American Bridge/Fluor Enterprises, a JV**OSM Departure Time:** 1845**Contractor:** Zhenhua Port Machinery Company, Ltd (ZPMC), Changxing Island **Location:** Shanghai, China**CWI Name:** Chen Xi.**CWI Present:** Yes No**Inspected CWI report:** Yes No N/A**Rod Oven in Use:** Yes No N/A**Electrode to specification:** Yes No N/A**Weld Procedures Followed:** Yes No N/A**Qualified Welders:** Yes No N/A**Verified Joint Fit-up:** Yes No N/A**Approved Drawings:** Yes No N/A**Approved WPS:** Yes No N/A**Delayed / Cancelled:** Yes No N/A**Bridge No:** 34-0006**Component:** Orthotropic Box Girder (OBG)**Summary of Items Observed:**

WELDING INSPECTION REPORT

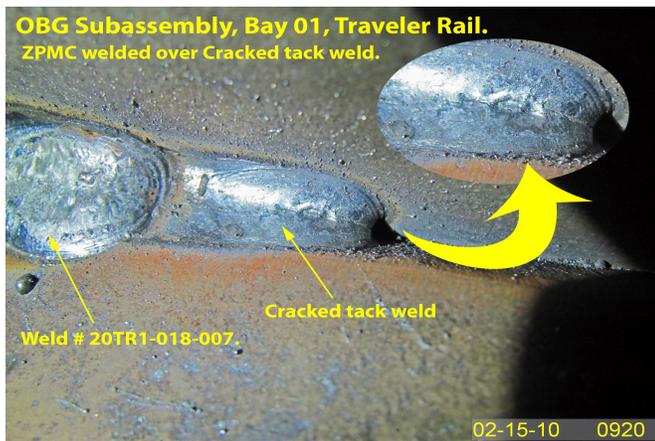
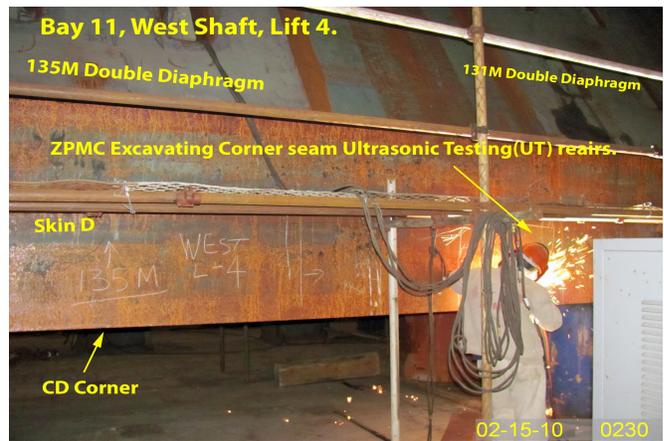
-ZPMC welded over Cracked Tack weld.

-The weld is a Complete Joint Penetration (CJP) T-joint joining the web to flange.

-The weld is identified as 20TR1-018-007.

-Cracks were detected visually for the above mentioned weld found cracked at the ends.

This QA inspector also submitted Incident Report on the same date. The attached photographs provide additional detail.
