Quality Assurance and Source Inspection

Contract #: 04-0120F4Cty: SF/ALA Rte: 80 PM: 13.2/13.9File #: 1.28**WELDING INSPECTION REPORT****Resident Engineer:** Pursell, Gary**Address:** 333 Burma Road**City:** Oakland, CA 94607**Report No:** WIR-012226**Date Inspected:** 18-Feb-2010**Project Name:** SAS Superstructure**OSM Arrival Time:** 700**Prime Contractor:** American Bridge/Fluor Enterprises, a JV**OSM Departure Time:** 1530**Contractor:** American Bridge/Fluor Enterprises, a JV**Location:** Job Site

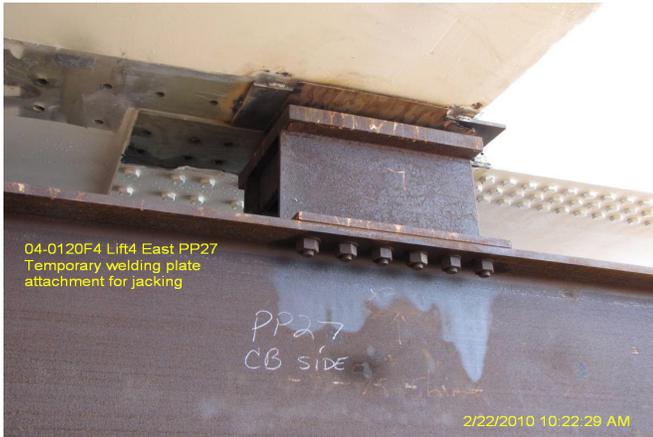
The QA inspector noted QC inspector Steve McConnell was present at PP27 and PP25 observing the set up being performed by ABF welding personnel. After a brief discussion between QA, QC and the WQCM it was noted the welder present has not been submitted for this particular project at this time. Mr. Bowers relayed he would inform the welding foreman Tom Gibson of this issue. A short time later Mr. Bowers relayed approved ABF welding personnel Richard Bazewicz would be performing the welding for this item. The QA inspector periodically observed the welding of these locations by Mr. Bazewicz utilizing the shielded metal arc welding (SMAW) process with QC personnel Steve McConnell being present in order to ensure the welding was in conformance with the established welding procedure specification (WPS) noted as ABF-WPS-D15-F1200A. The welder was observed removing the coating at the joint surface and pre heating the area to 65° C. The welding parameters were verified to be 125 amps utilizing 3.2mm diameter Esab Atom Arc 7018 welding electrodes (E7018). The welding progressed throughout the balance of the morning shift with QC inspector Bernard Docena replacing Mr. McConnell mid way through. The work was completed on this date and appeared to be within general conformance with the contract documents with the exception noted above. A digital photo of the in process work is included in the body of this report.

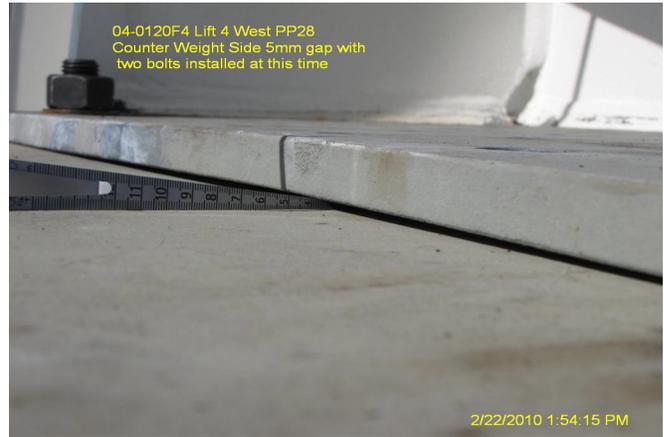
The QA inspector did not observe any work being performed at this location during the time of review. Later in the shift the QA inspector periodically observed ABF personnel placing the suspender brackets for this lift at PP 26 and PP28. The crew lifted and aligned the bracket at PP28, installed the shim and placed several preliminary bolts. After this was performed the crew moved to PP26 and proceeded to follow the same procedure. Towards the end of the shift the shim for this suspender bracket was still in process. The QA inspector reviewed the fit up of the bracket at PP28 and measured the the gap between the faying surfaces of the deck plate and suspender bracket to be 3.5mm and 4mm at the time of review with two bolts being placed at this time. See digital photo included in the body of this report for clarification.
