DEPARTMENT OF TRANSPORTATION

Contract #: 04-0120F4Cty: SF/ALA Rte: 80 PM: 13.2/13.9File #: 1.28**WELDING INSPECTION REPORT****Resident Engineer:** Pursell, Gary**Address:** 333 Burma Road**City:** Oakland, CA 94607**Report No:** WIR-012228**Date Inspected:** 19-Feb-2010**Project Name:** SAS Superstructure**OSM Arrival Time:** 700**Prime Contractor:** American Bridge/Fluor Enterprises, a JV**OSM Departure Time:** 1530**Contractor:** American Bridge/Fluor Enterprises, a JV**Location:** Job Site

CWI Name:	Mike Johnson, Steve McConnell, Jesse Cayab	CWI Present:	Yes	No
Inspected CWI report:	Yes No N/A	Rod Oven in Use:	Yes	No N/A
Electrode to specification:	Yes No N/A	Weld Procedures Followed:	Yes	No N/A
Qualified Welders:	Yes No N/A	Verified Joint Fit-up:	Yes	No N/A
Approved Drawings:	Yes No N/A	Approved WPS:	Yes	No N/A
		Delayed / Cancelled:	Yes	No N/A
Bridge No:	34-0006	Component:	SAS OBG 1E/2E

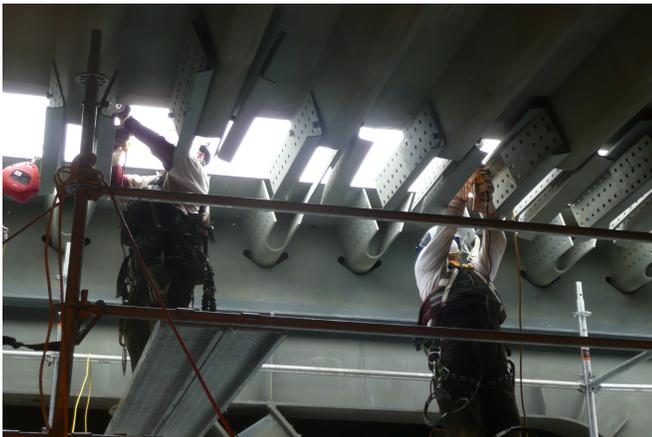
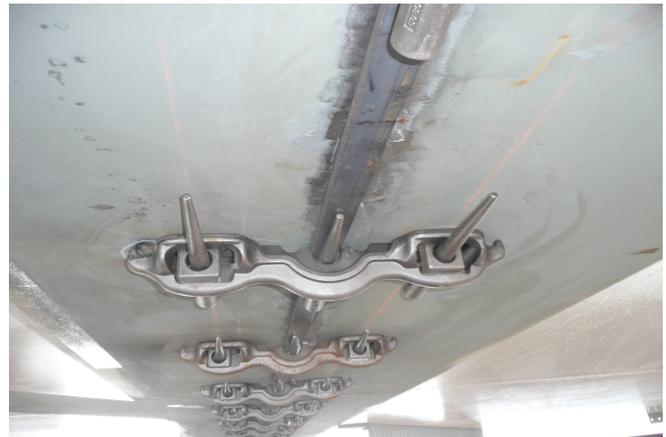
2E/3E-A

The QA Inspector randomly observed the above identified CJP weld joint is being prepared prior to completing the pushing together of the two OBG's. The QA Inspector noted the two OBG's appeared to be approximately 2' apart and ABF personnel utilizing flapper discs removing the paint from the bevel and root face along with the paint up to approximately 3" from the edge of the joint (pictured below).
