DEPARTMENT OF TRANSPORTATION

Contract #: 04-0120F4Cty: SF/ALA Rte: 80 PM: 13.2/13.9File #: 13.28**WELDING INSPECTION REPORT****Resident Engineer:** Pursell, Gary**Address:** 333 Burma Road**City:** Oakland, CA 94607**Report No:** WIR-012234**Date Inspected:** 17-Feb-2010**Project Name:** SAS Superstructure**OSM Arrival Time:** 1000**Prime Contractor:** American Bridge/Fluor Enterprises, a JV**OSM Departure Time:** 1830**Contractor:** Oregon Iron Works Clackamas, Or.**Location:** Clackamas, OR**CWI Name:** M. Gregson, J. Salazar**CWI Present:** Yes No**Inspected CWI report:** Yes No N/A**Rod Oven in Use:** Yes No N/A**Electrode to specification:** Yes No N/A**Weld Procedures Followed:** Yes No N/A**Qualified Welders:** Yes No N/A**Verified Joint Fit-up:** Yes No N/A**Approved Drawings:** Yes No N/A**Approved WPS:** Yes No N/A**Delayed / Cancelled:** Yes No N/A**Bridge No:** 34-0006**Component:** Hinge K Pipe Beams**Summary of Items Observed:**

Hinge-K Pipe Beam Assembly 102A-3:

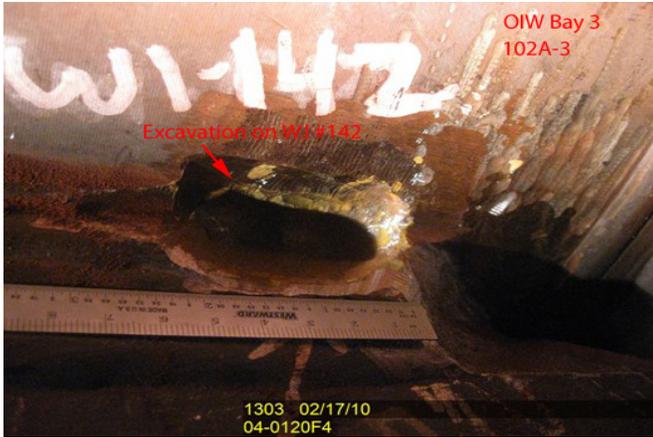
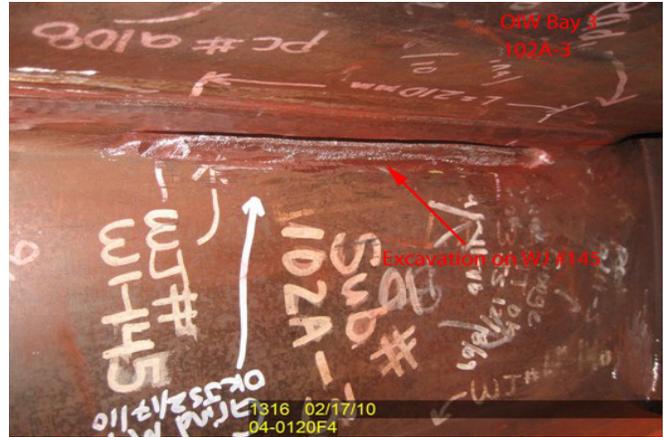
The QA Inspector was informed by OIW QC Inspector Jose Salazar that the Visual (VT) and Magnetic Particle testing (MT) was completed on the excavated areas, for the Critical Weld Repairs (CWR's). QC Inspector Salazar explained that these linear indications were excavated, that were discovered during the Final MT of CWR's #2244-016 and #2244-017. QC Inspector Salazar explained that the indications were discovered in different locations than the original repairs. QC Inspector Salazar explained that due to the locations in the weld joints, that 2 new CWR's will be submitted by OIW, detailing the locations, measurements and conditions of the linear indications. QC Inspector Salazar explained that the VT/MT was performed in accordance to OIW approved MT procedure QC-113, Rev. #3 and AWS D1.5. QC Inspector Salazar explained that no rejectable indications were found. The QA Inspector then performed 100% VT/MT on the completed excavations and found no rejectable indications. The QA Inspector measured the excavations and recorded the measurements as follows: Weld Joint #142 (c107 to a111-3), 60 mm L x 20 mm W x 15 mm D and Weld Joint #145 (a108 to a111-3), 280 mm L x 20 mm W x 15 mm D. The QA Inspector was informed by QC Inspector Salazar that no welding will be performed until OIW submits the applicable Critical Weld Repair Report (CWR) and receives State approval to continue. The QA Inspector then notified OIW Lead QC Inspector Mike Gregson of the testing results and completed an applicable Magnetic Testing Report (TL 6028), on this date. See attached pictures below.
